Report on
Geotechnical Assessment

Proposed Balcony
48 Beacon Avenue, Beacon Hill

Project 86822.00
July 2019

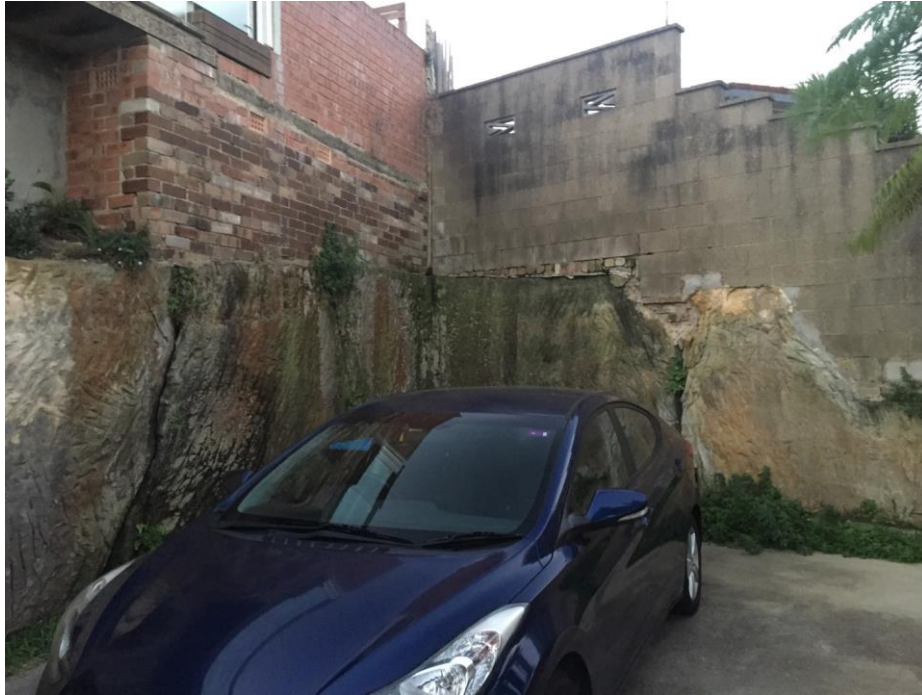
- Medium to high strength Hawkesbury Sandstone was exposed along the eastern site boundary. The cutting was about 2 m high, with an approximate 1 m high retaining wall bearing on the bedrock (refer to Photo 1). Sandstone outcrops were also observed in cuttings along Beacon Hill Road, in proximity to the site;
- The ground surface levels either side of the northern and southern site boundaries are similar. The ground surface in the subject site lies about 1 m above the property to the east, and is supported by a masonry retaining wall;
- The external walls of the existing two-storey brick building show no signs of cracking or ground movement.

Photo 1 – Medium to high strength sandstone exposed along eastern boundary. Top of rock approximately 1m below surface level in rear garden of 48 Beacon Avenue.

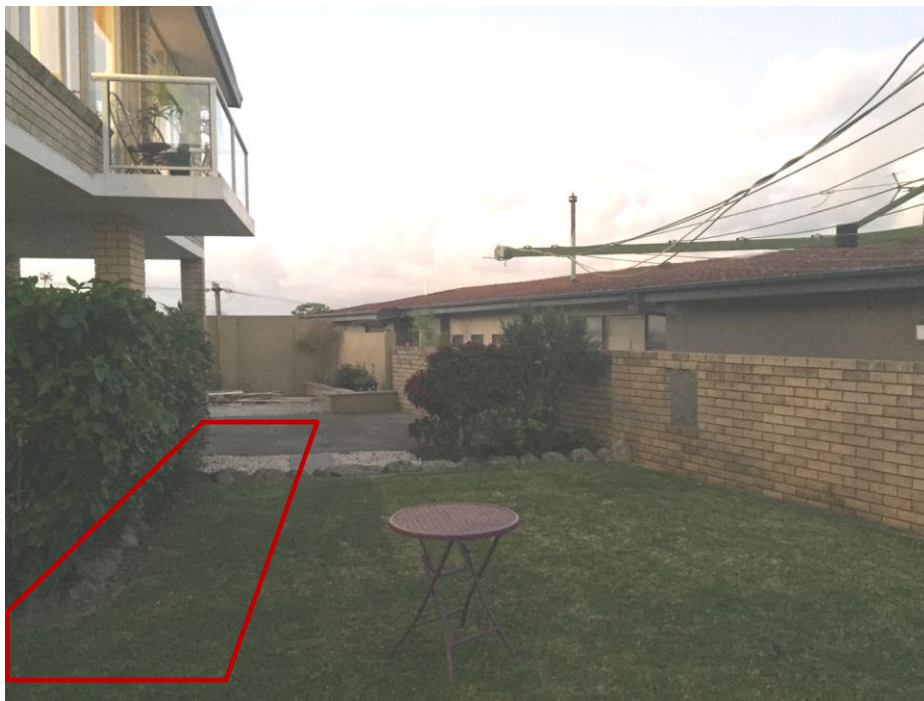
Photo 2 – Approximate area of proposed balcony footings (view south)

All structures should be uniformly founded on sandstone bedrock. Strip and pad footings bearing on at least very low strength bedrock are likely to be suitable to support the balcony and stair loads.

All footings should be inspected by a geotechnical engineer to confirm that foundation conditions are suitable for the design parameters.
