Geotechnical Assessment

Project: Alterations & Additions
29 Innes Road, Manly Vale NSW

Prepared for:
Sam & Christie Johnston

Ref: AG 24514
21 November 2024

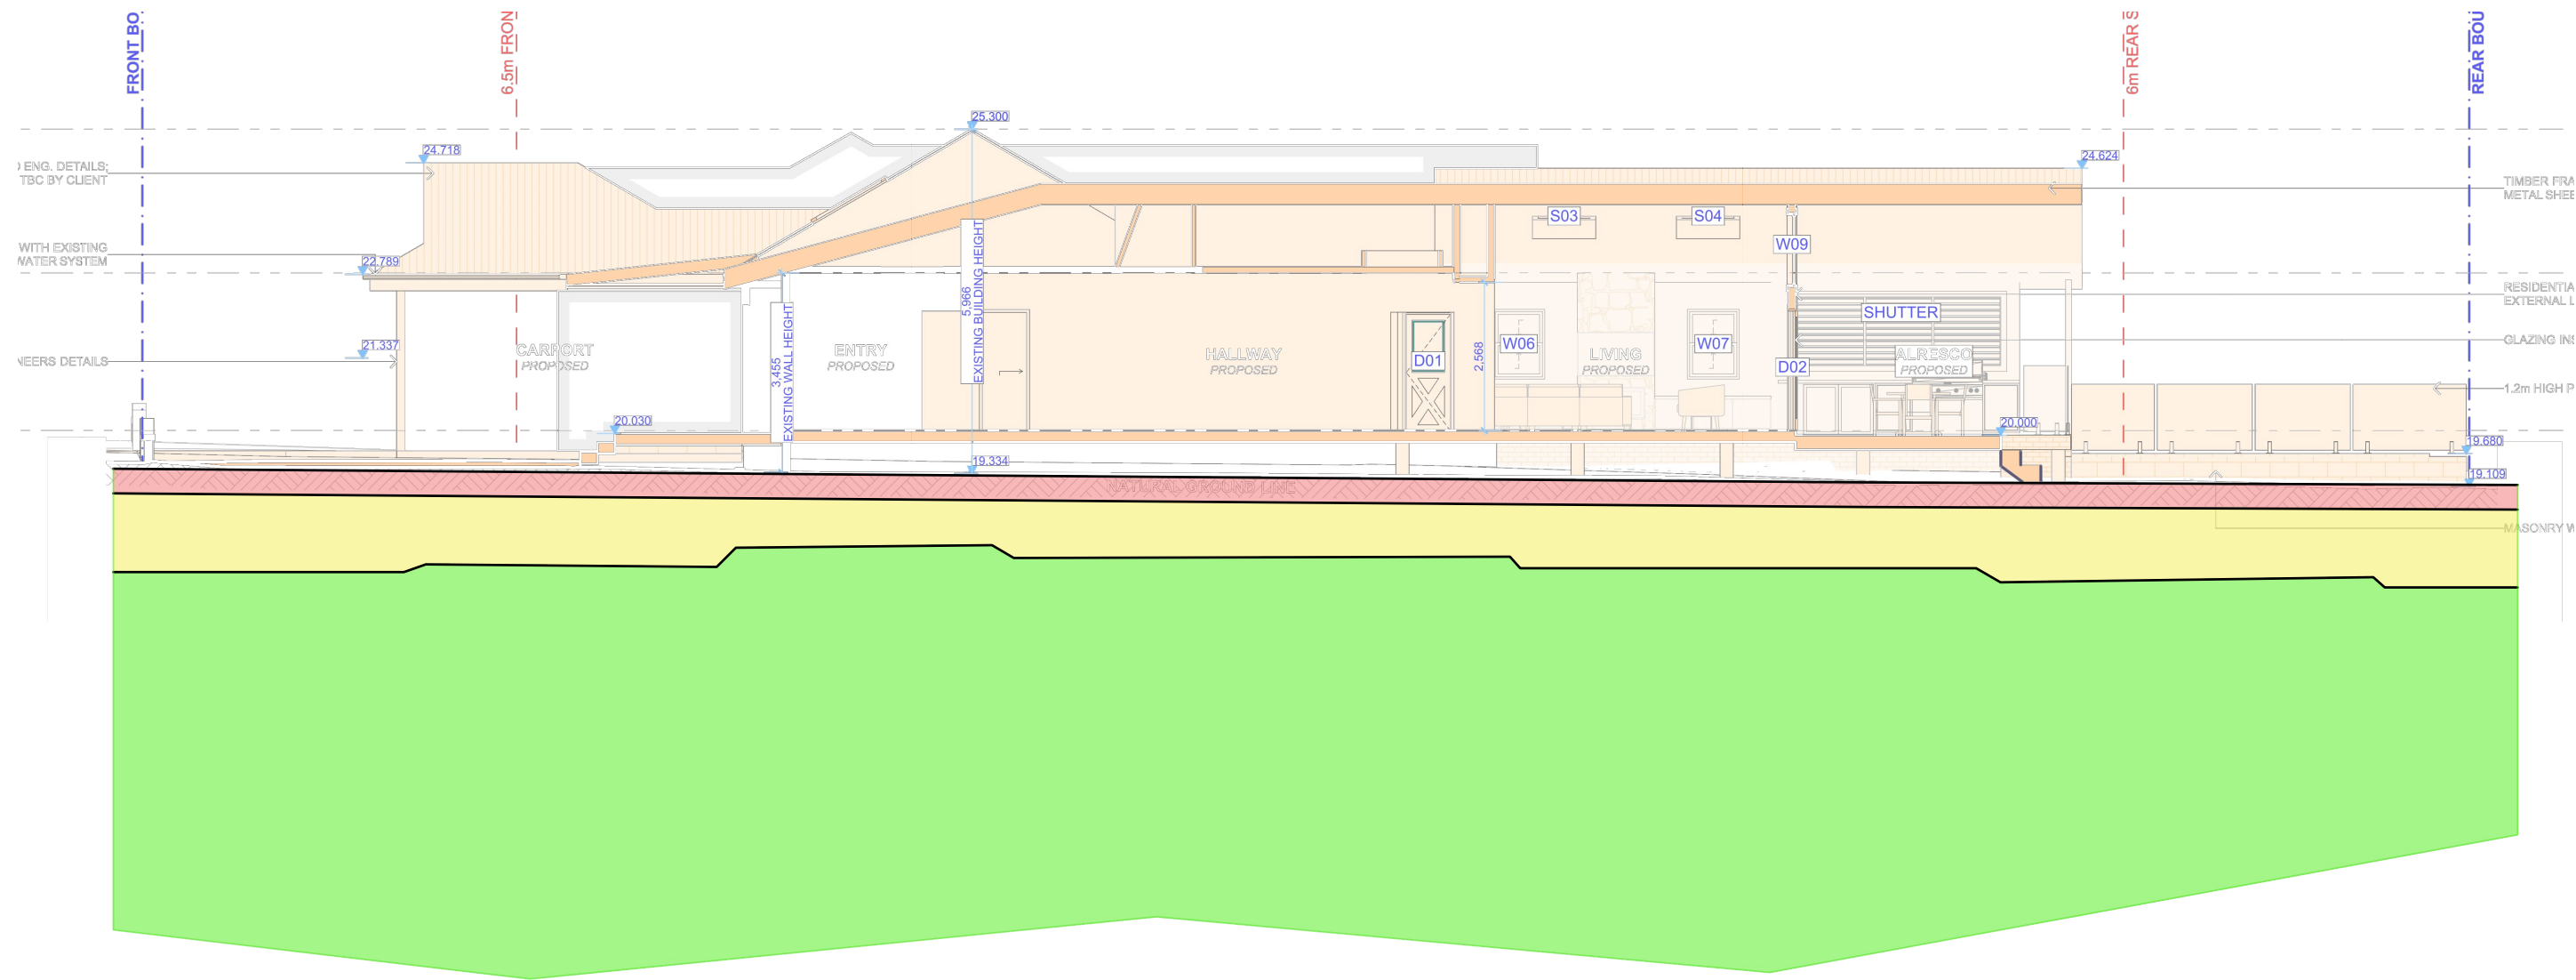
INFERRED GEOLOGICAL SECTION
SCALE NTS

Unit	Material	Comments
1	Silty Sand Topsoil	Sandy topsoil material. Unit 1 is inferred to be uncontrolled and poorly compacted.
2	Sand	Medium to coarse grained sand of the natural profile. Loose in the first ~1.0m depth before becoming well compacted and dense after ~1.0m depth.
3	Sandstone	Medium strength or greater sandstone bedrock (Class III+*) expected to be found below a low strength weathered crust (Class V*).

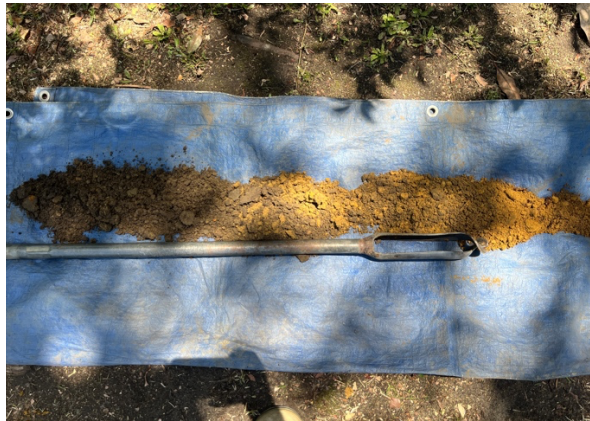
Photo 4: Sandy soil profile in excavated BH2

Fill Silty SAND SM: poorly compacted, dark brown, fine grained, moist.	PC	M	SM
				SAND SW: loose, orange light brown, medium to coarse grained, trace fine sized gravel, natural moist, tree root at 0.9m.	L		SW
2				BH2 refusal at 1.2m (Unable to progress auger in naturally compacted / cemented sand layer)
