Underground Services Report (USR)

Underground Services Report

| DBYD Details | | | | | | | | |
|--|---|--|--|---|---|---|---|--|
| Location | | | 43 Mariposa Rd Bilgola Plateau NSW 2107 | | | | | |

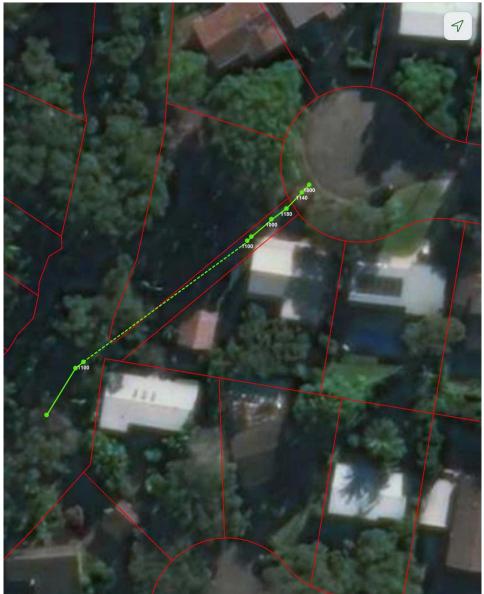
Figure 1 Work area overview

| Note | Details |
|---|--|
| 1 | The investigation has proven beyond reasonable doubt that the NBC alignment is outside the target property and does not fall into the easement over the property. |

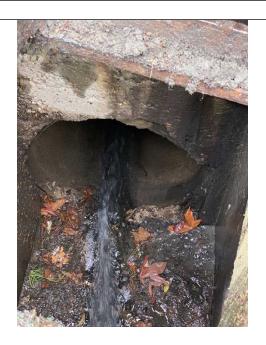
Inlet at kerb inlet pit

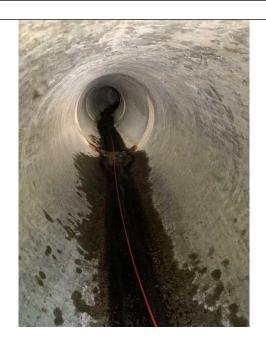
Outlet at creek up to a change of alignment

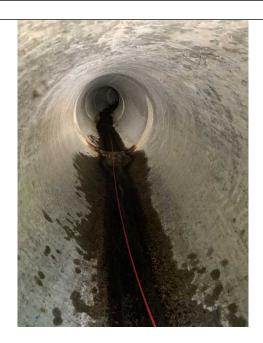
Outlet into creek

Pink is approximately what the NBC map shows as the
