J3291 31<sup>st</sup> March, 2021 Page 1.

#### **GEOTECHNICAL INVESTIGATION:**

New Pool at 170 McCarrs Creek Road, Church Point

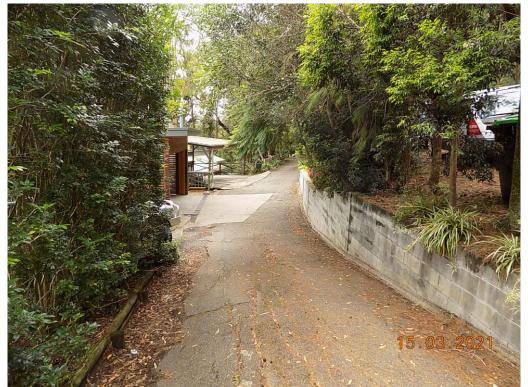
Photo 1

- 2.3 The property is accessed by a Right of Carriageway (ROW) off the downhill side of the road. The ROW is cut into the slope and is supported by a ~1.5m high concrete block retaining wall (Photo 1). A concrete driveway runs off the downhill side of the ROW to a stable timber carport and brick garage on the uphill side of the house (Photo 2). The cut for the driveway is supported by timber retaining walls reaching ~2.0m high (Photo 3). The fill for the driveway is supported by a timber crib retaining wall, reaching ~2.5m high (Photo 4). The part three-storey brick house is supported by on brick walls and brick piers. No significant signs of movement were observed in the supporting walls and the supporting piers stand vertical (Photo 5). A series of timber retaining walls ~1.0m high support a garden area that steps down the S side of the property (Photo 6). Several of the retaining walls are tilting 5-10° downslope but are being replaced as part of the proposed works. The slope below the house is terraced

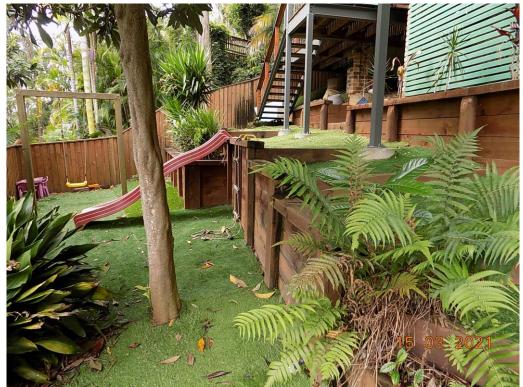
Photo 7

to the lower common boundary. The terraces are supported by a series of stable timber retaining walls (Photo 7).

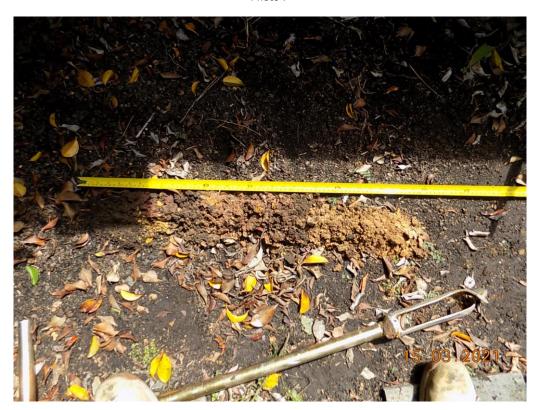
Photo 8

#### **AUGER HOLE 1** (~RL18.8) – AH1 (Photo 8)

Depth (m)	Material Encountered
0.0 to 0.1	<b>TOPSOIL</b> , dark brown, loose, damp, fine to medium grained with fine trace organic matter.
0.1 to 0.6	<b>FILL</b> , disturbed, mottled maroon, orange, yellow, and grey, damp, soft, fine to medium grained with small rock fragments.
0.6 to 0.8	<b>CLAY</b> , derived from weathered shale, mottled grey and yellow, stiff, dry, fine grained.

End of hole @ 0.8m in weathered shale. No water table encountered.

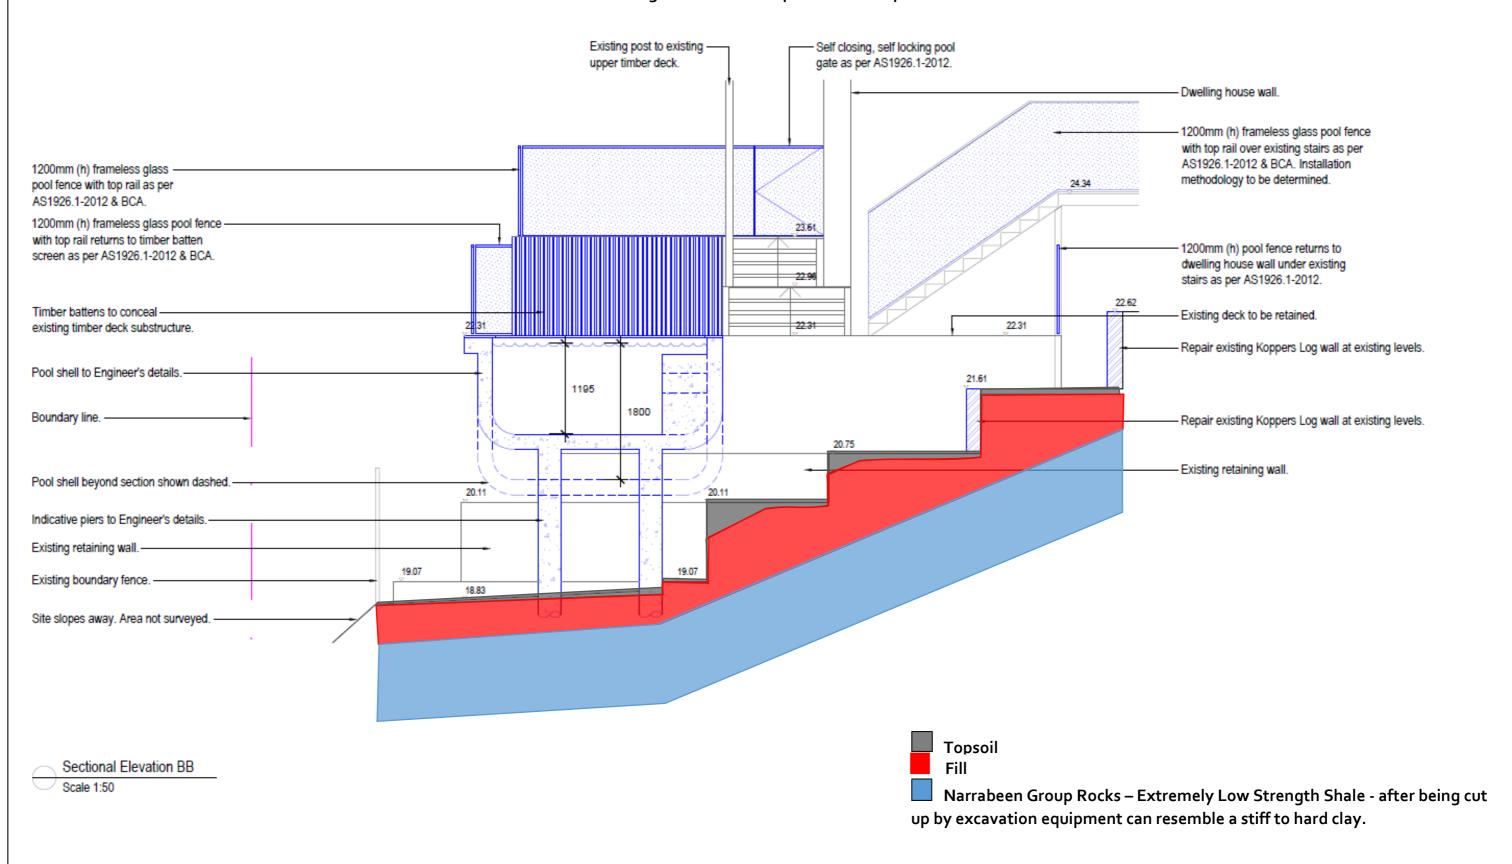
#### TYPE SECTION - Diagrammatical Interpretation of expected Ground Materials

The slope materials are colluvial at the near surface and residual at depth. In the test locations, the ground materials consist of sandy soils over stiff to very stiff sandy clays. Filling has been placed across the downhill side of the property to form the terraces. The clays merge into the underlying weathered rock at a depth of 0.6 to 2.1m below the current surface. The differing depth of rock is attributed to the presence of filling and a variable weathering profile. The weathered zone is interpreted to be Extremely Low Strength Shale. See Type Section attached for a diagrammatical representation of the expected ground materials.

Due to the steepness of the slope, the proposed pool is to be supported on piers taken to and embedded at least ~0.6m into Extremely Low Strength Shale. This ground material is expected at depths of between 0.6 to 2.6m below the current surface. Thus, the required depths of the piered foundations are expected to be a maximum of 1.2m to 3.2m below the current surface taken from the downhill side of the pier hole. See Type Section appended.
