# DILAPIDATION REPORT

**Lorikeet Grove, Warriewood**

This report is intended to be a record of the council assets at Lorikeet Grove, Warriewood at the time of the inspection.

The inspection was carried out on 11 November 2024.

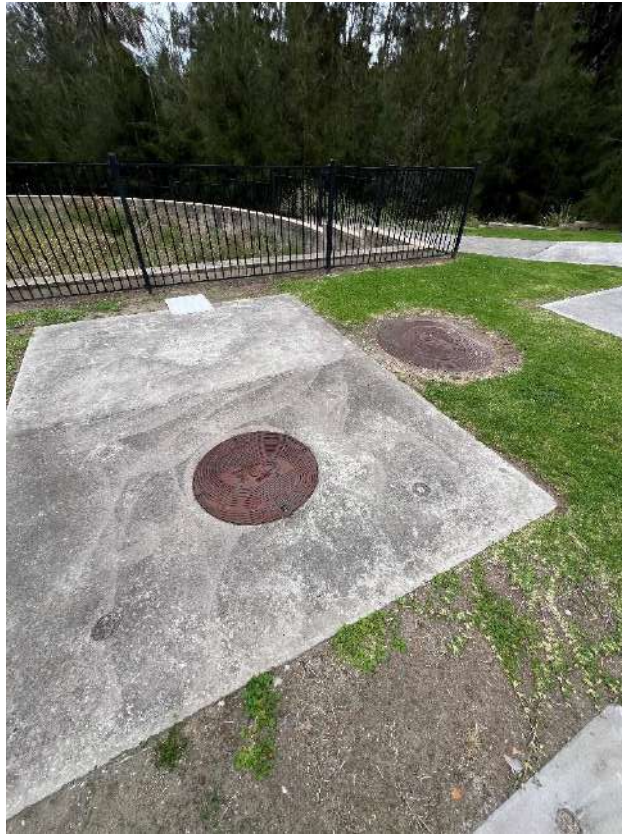
*Figure 1 – General condition of the pit.*

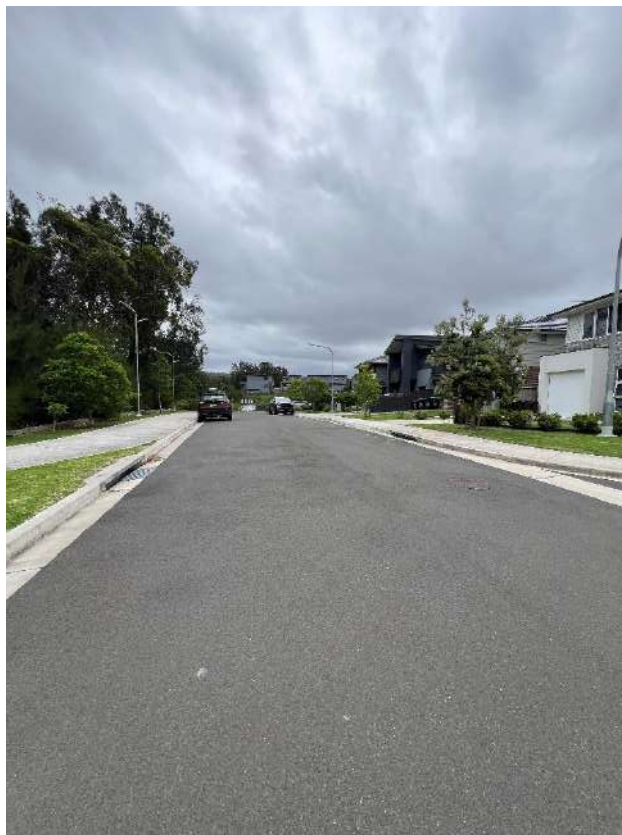
*Figure 2 – General condition of the road.*

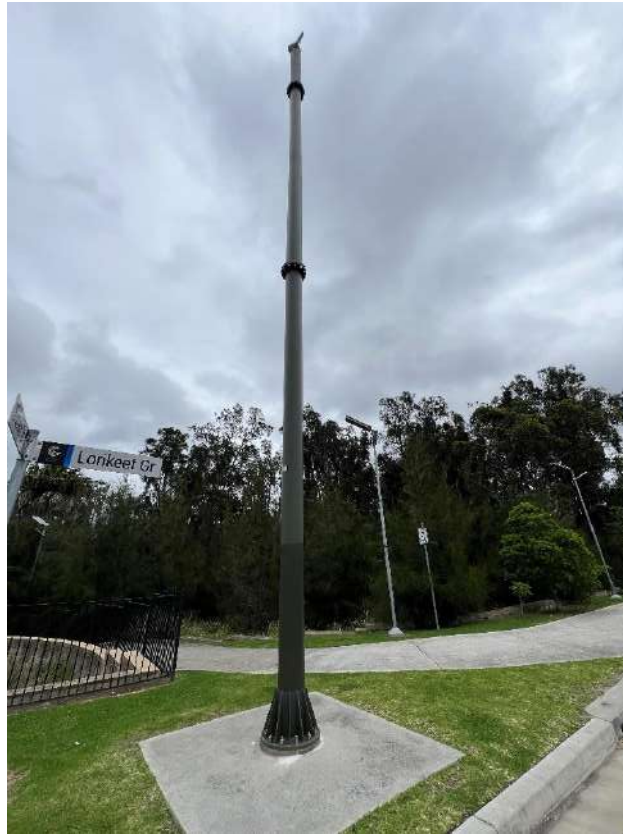
*Figure 3 – General condition of the pole.*

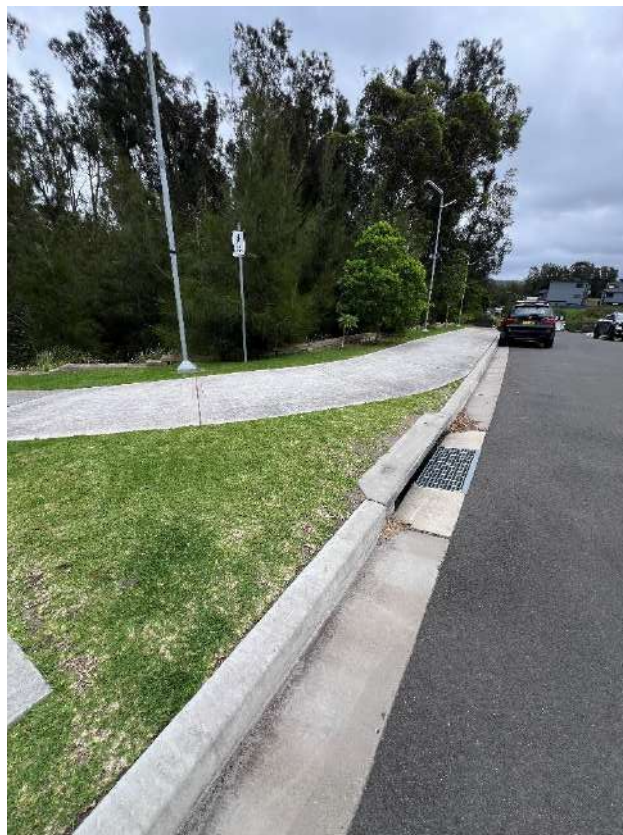
*Figure 4 – General condition of the kerb.*

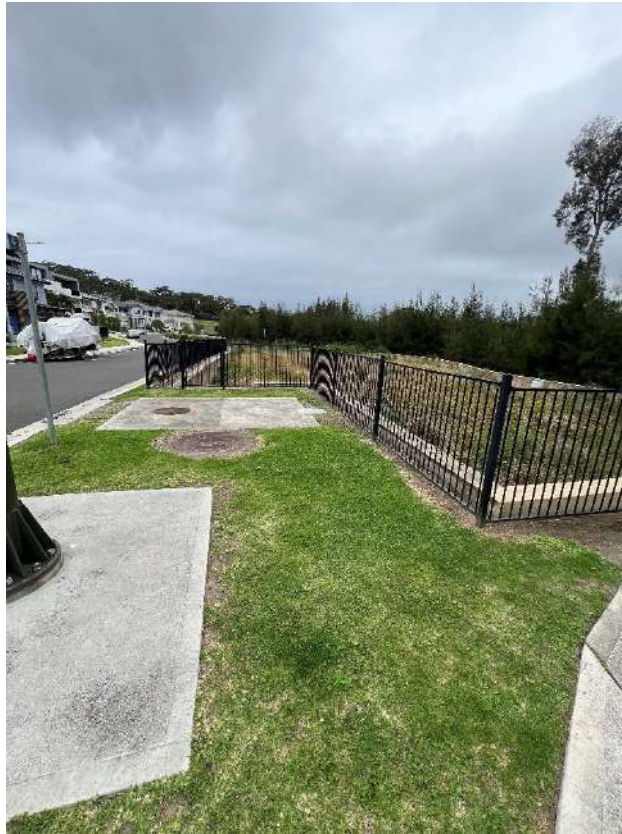
*Figure 5 – General condition of the nature strip.*

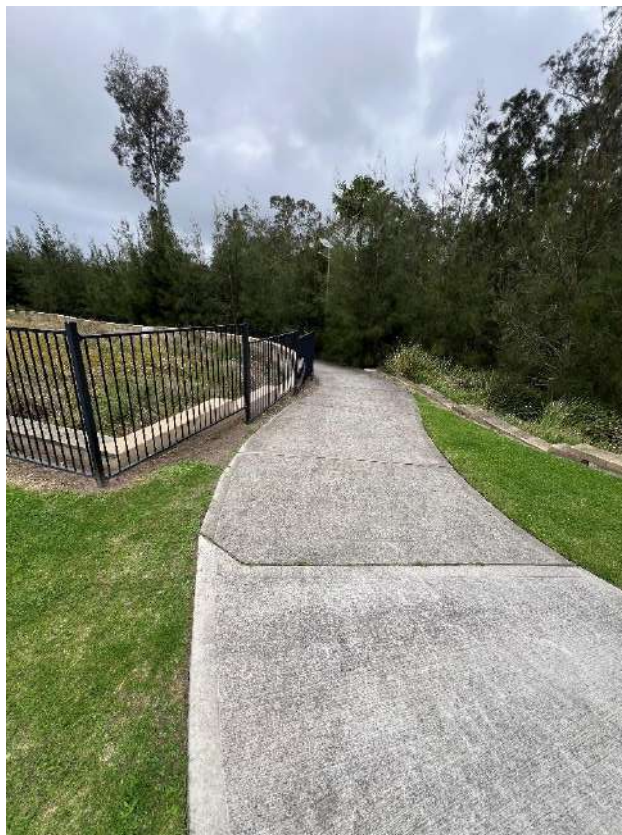
*Figure 6 – General condition of the footpath.*

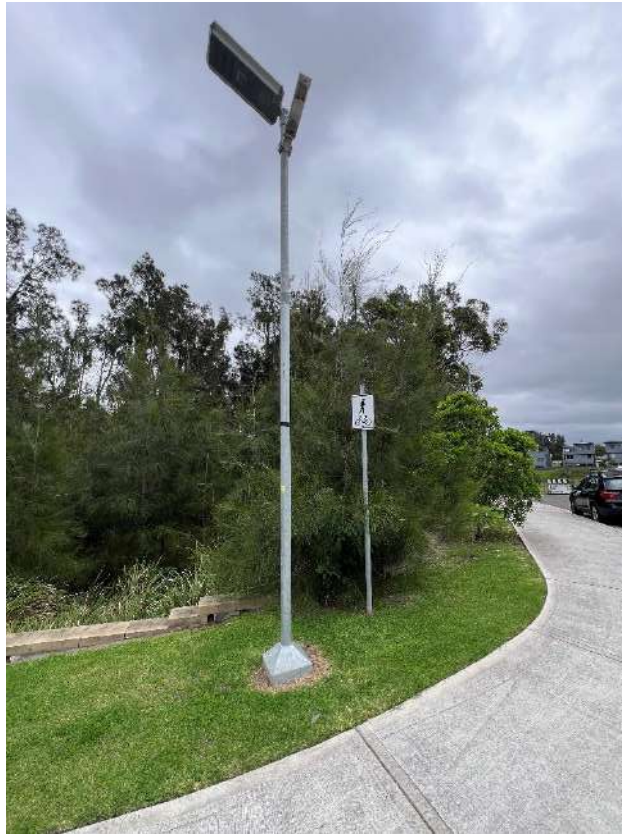
*Figure 7 – General condition of the street/traffic post.*

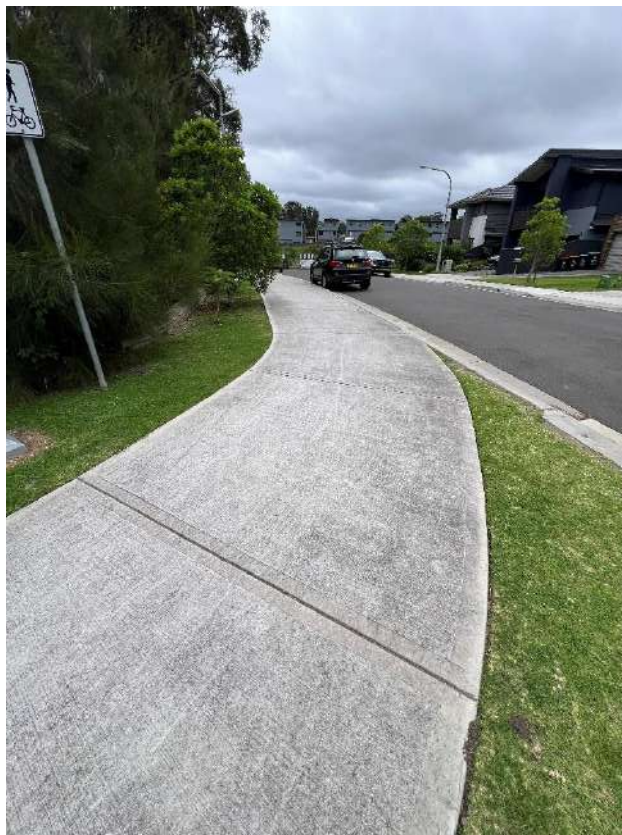
*Figure 8 – General condition of the footpath.*

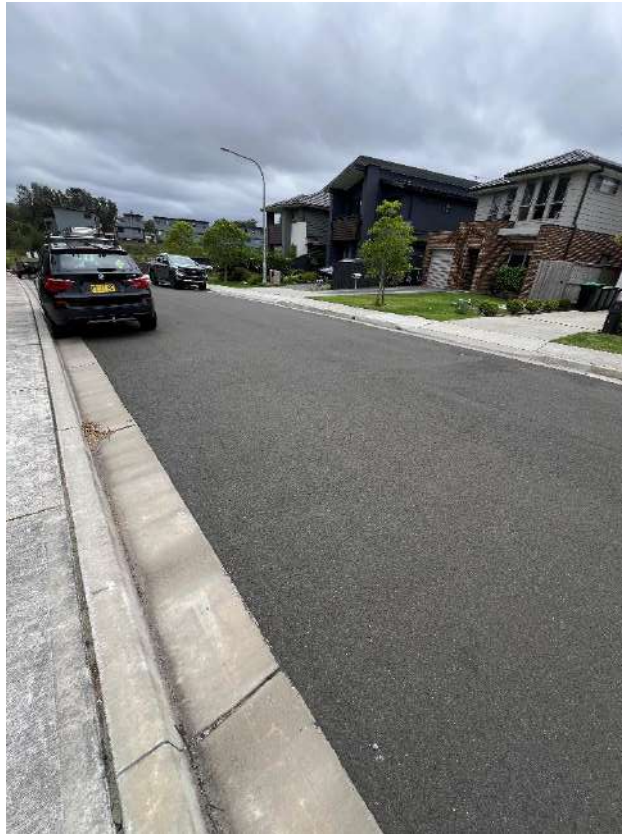
*Figure 9 – General condition of the kerb/road.*

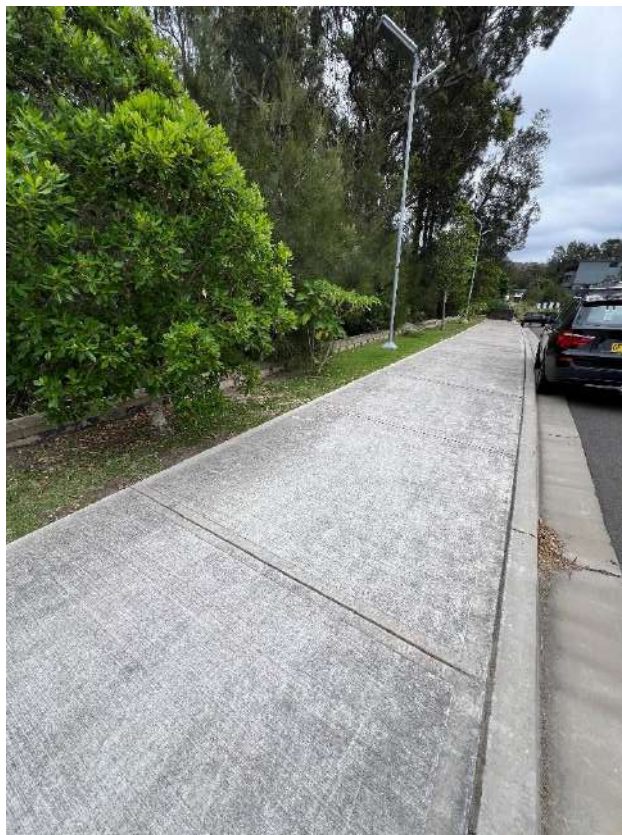
*Figure 10 – General condition of the footpath.*

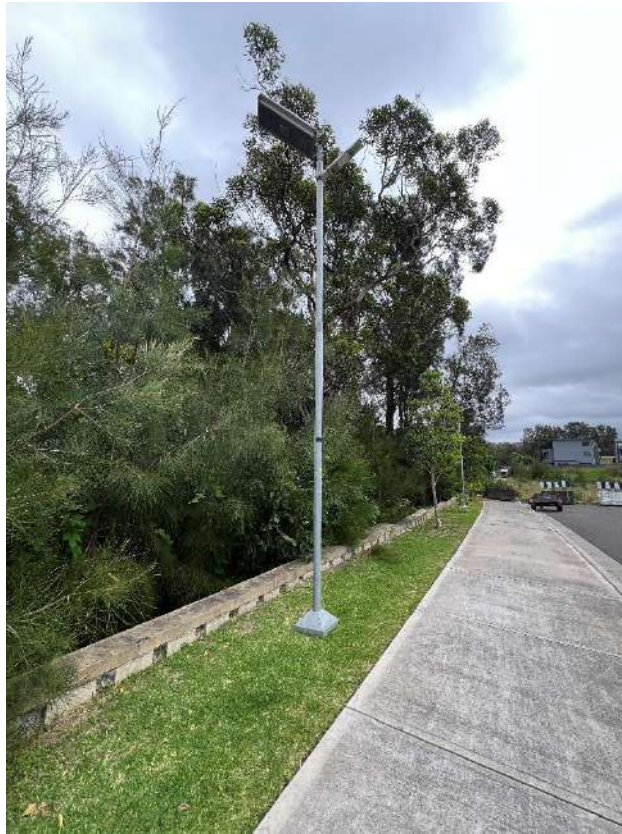
*Figure 11 – General condition of the street light.*

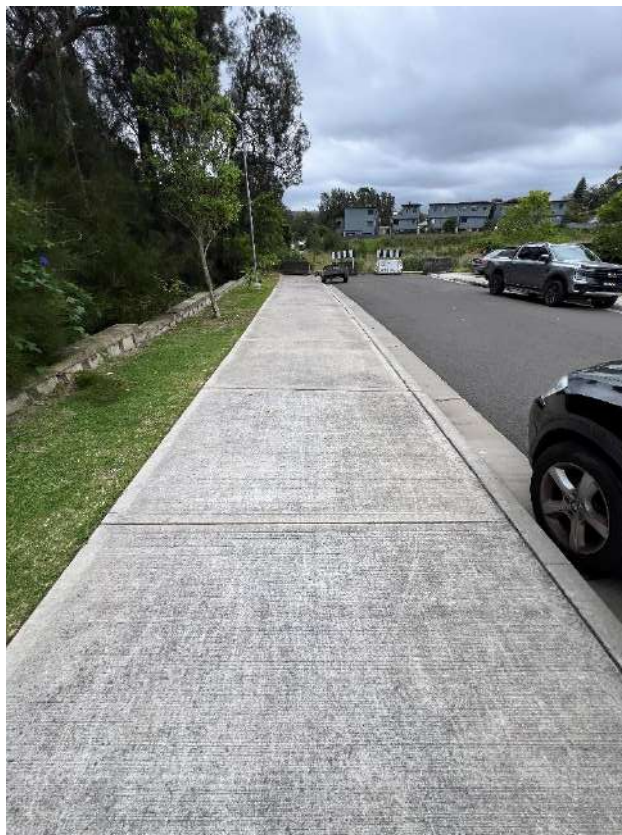
*Figure 12 – General condition of the footpath.*

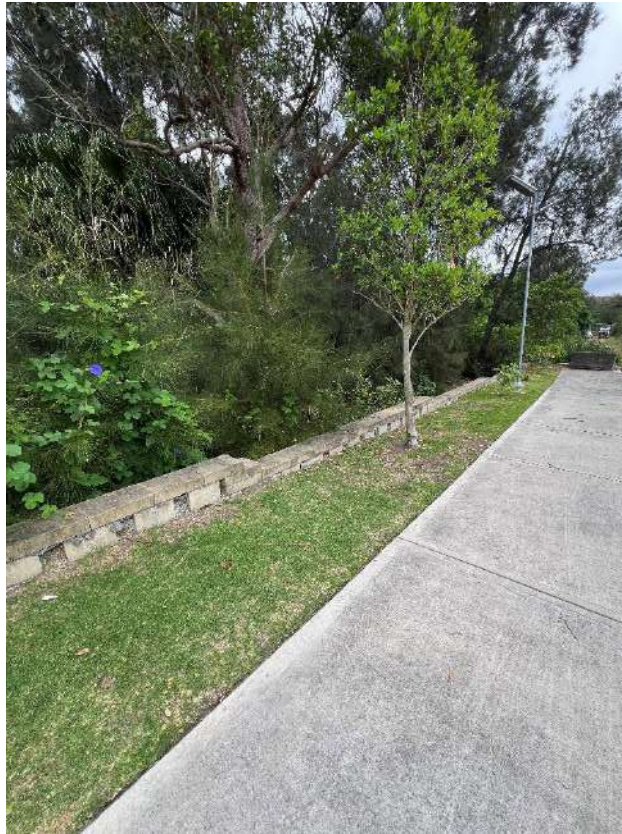
*Figure 13 – General condition of the retaining wall/nature strip.*

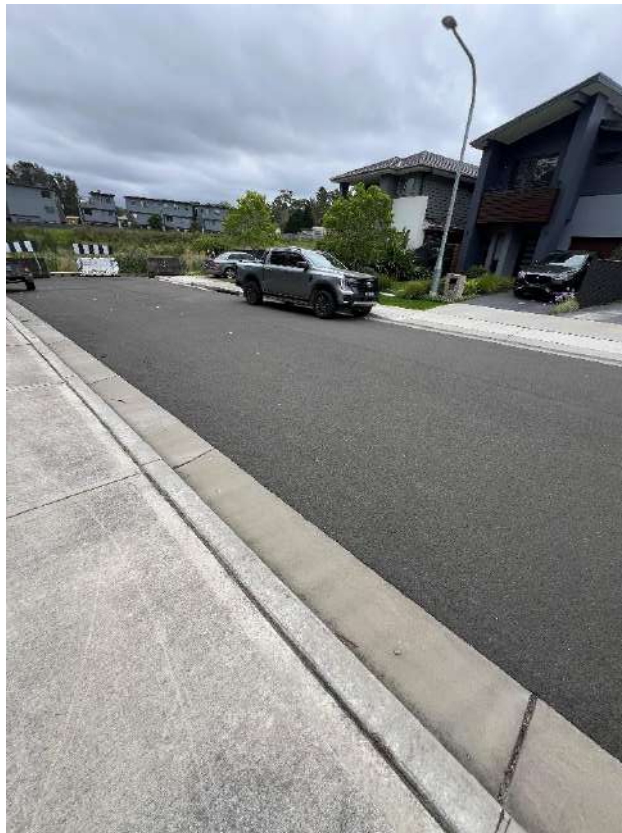
*Figure 14 – General condition of the kerb/road.*

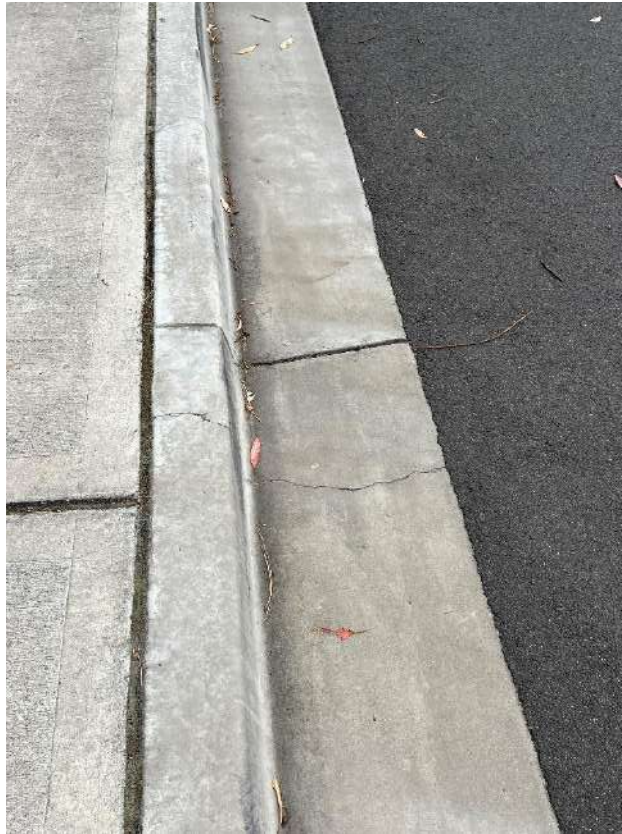
*Figure 15 – Crack is evident to the kerb at the opposite side of 57 Lorikeet Grove, Warriewood.*

The council assets were found to be in a fair condition with evidence of crack to the driveway, kerb and footpath.

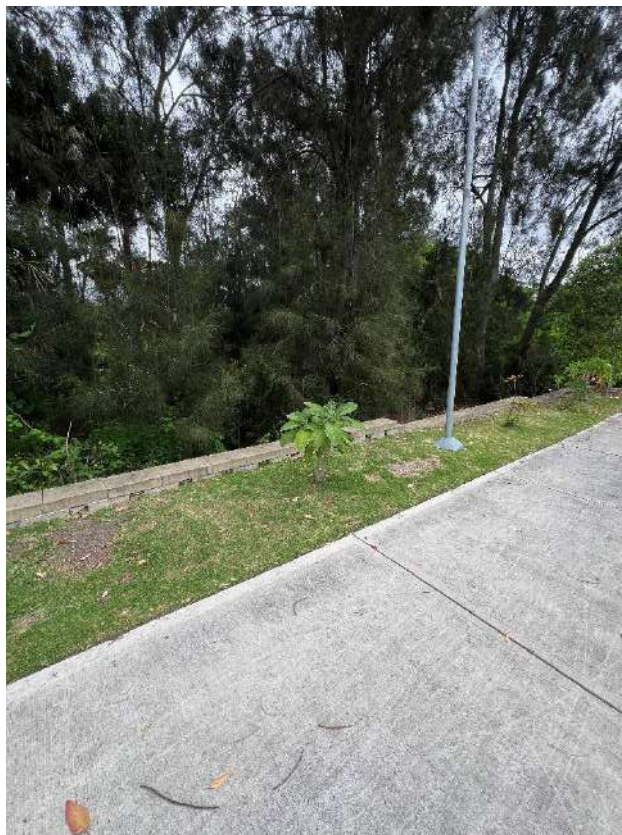
*Figure 16 – General condition of the footpath/nature strip.*

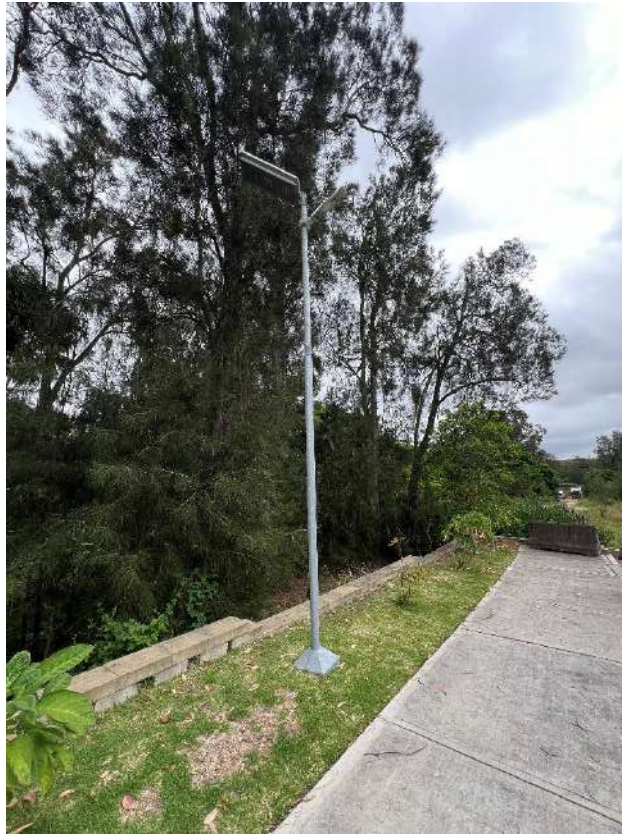
*Figure 17 – General condition of the street light.*

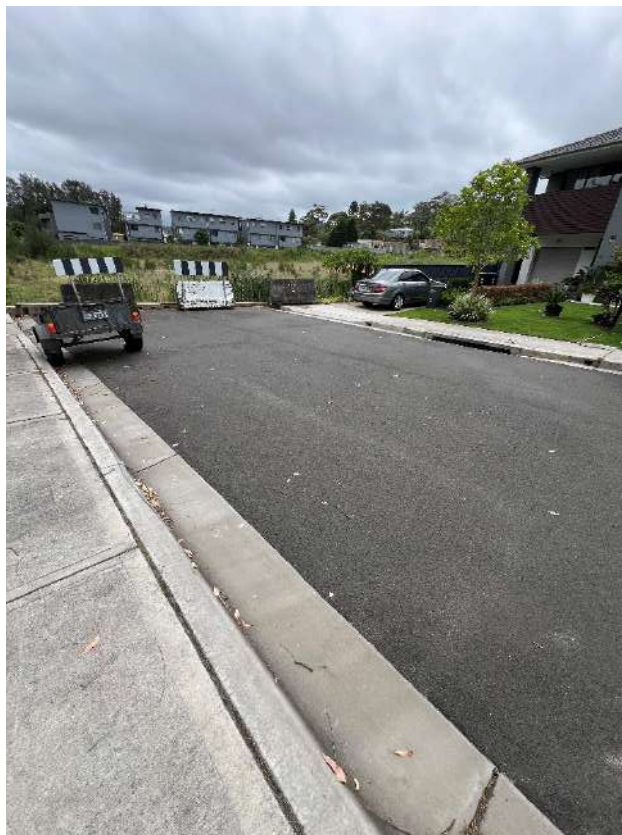
*Figure 18 – General condition of the kerb/road.*

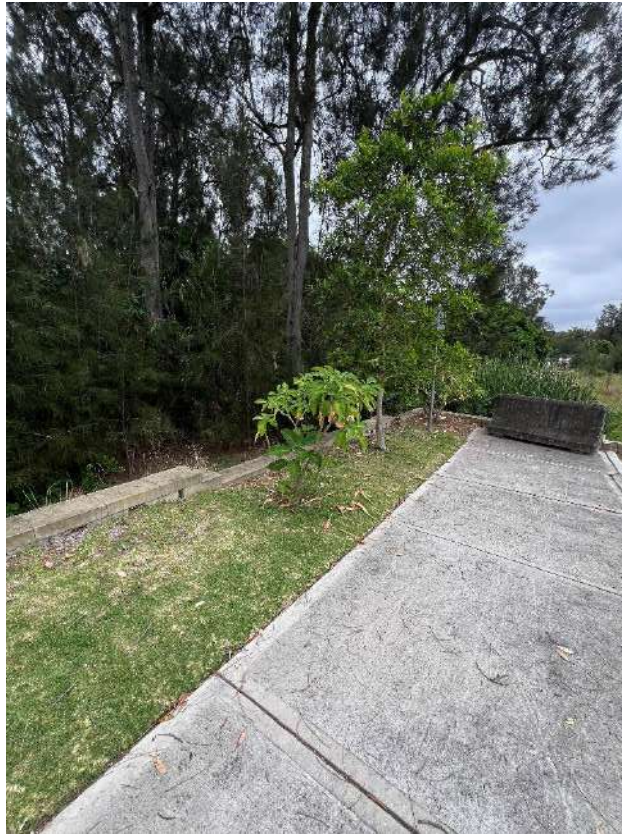
*Figure 19 – General condition of the footpath.*

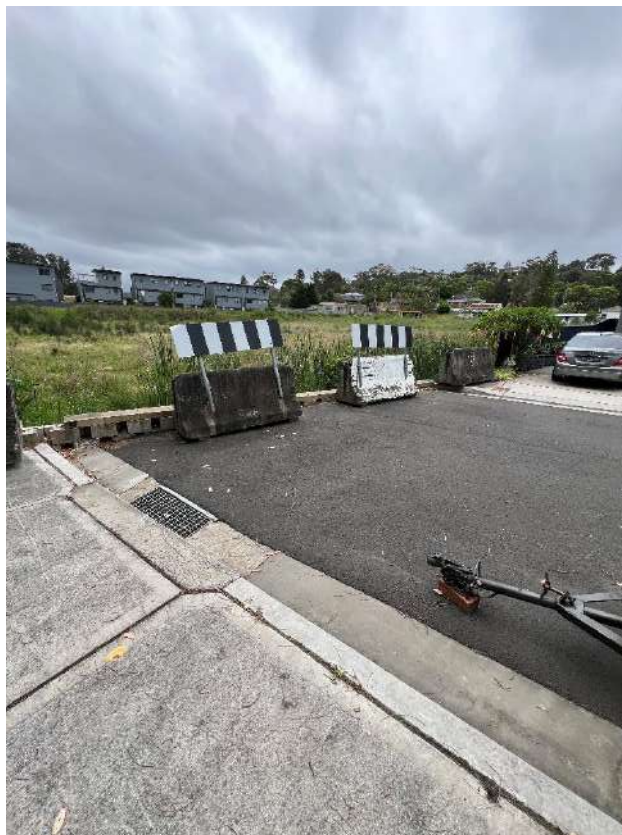
*Figure 20 – General condition of the kerb/pit.*

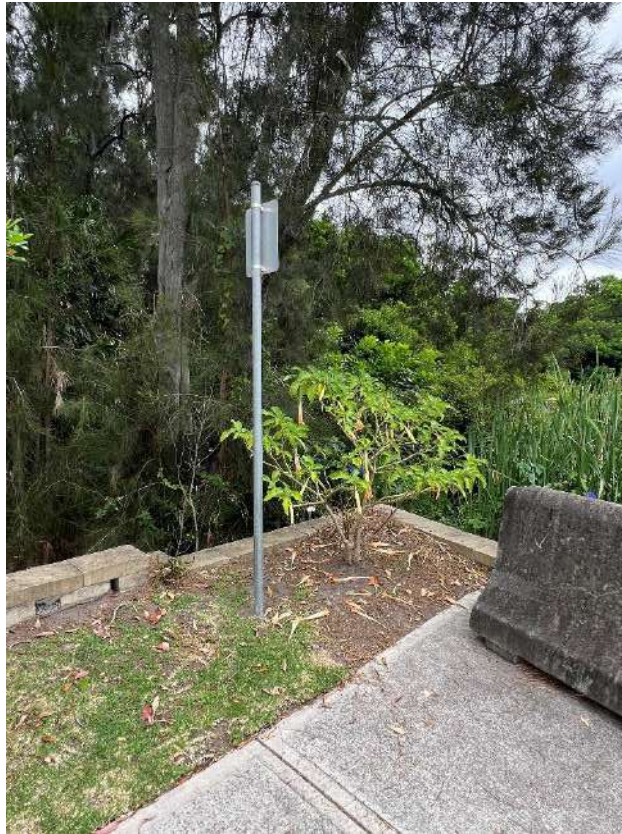
*Figure 21 – General condition of the street signpost.*

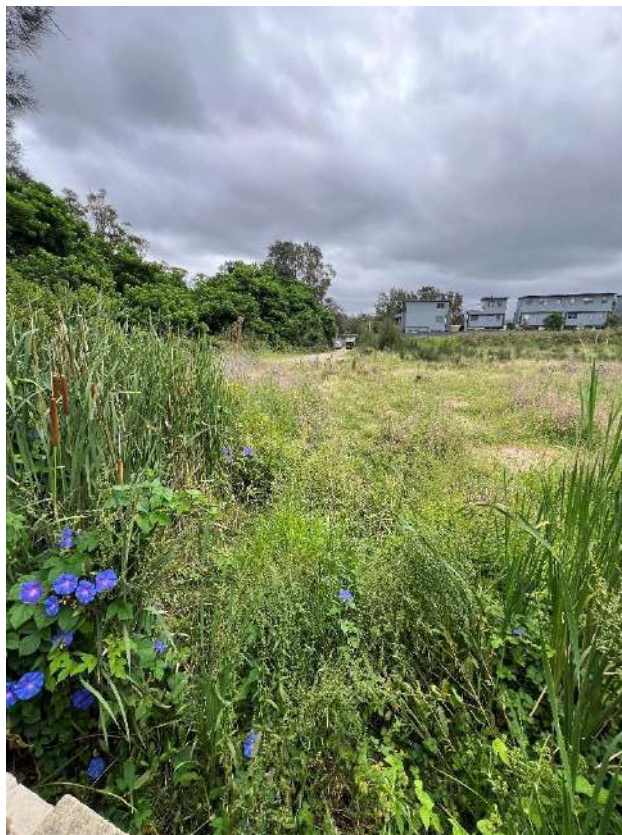
*Figure 22 – General condition of the ground area.*

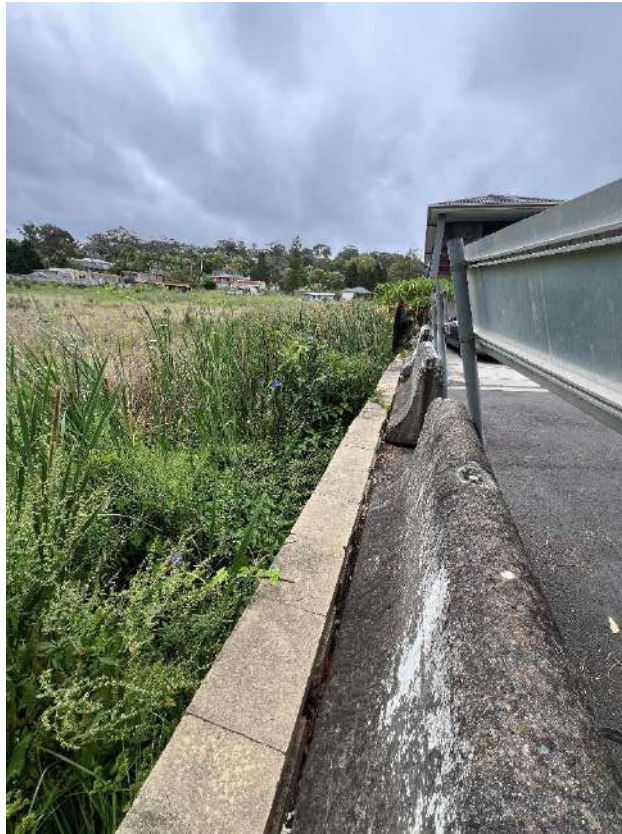
*Figure 23 – General condition of the concrete barrier.*

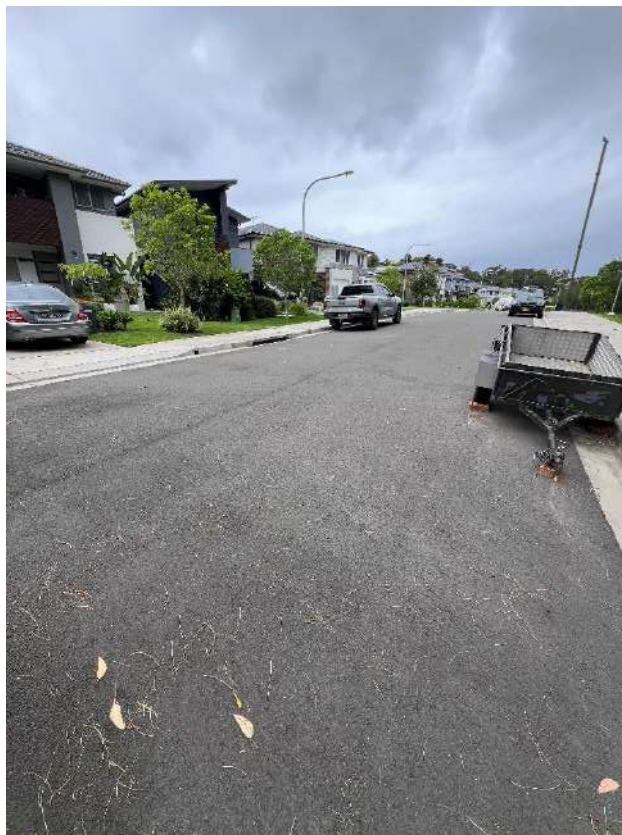
*Figure 24 – General condition of the road.*

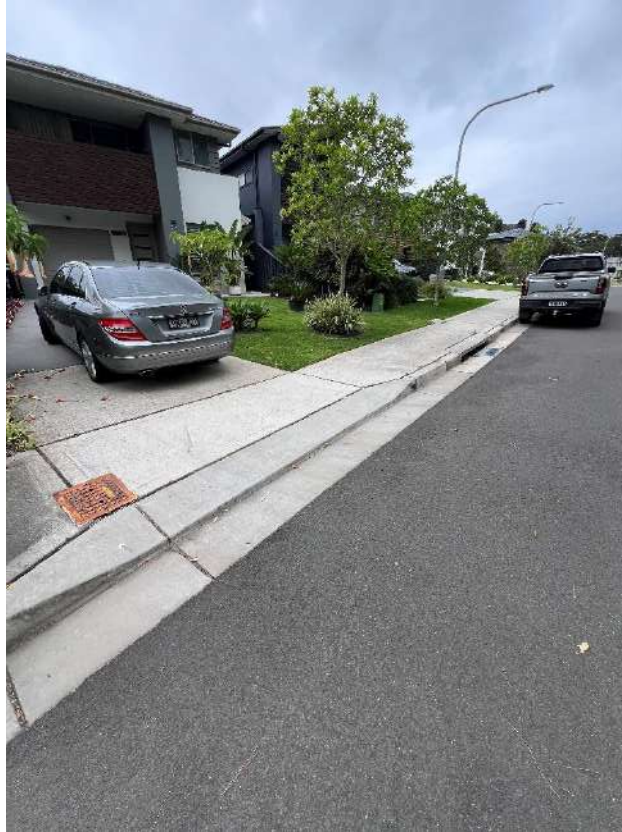
*Figure 25 – General condition of the driveway.*

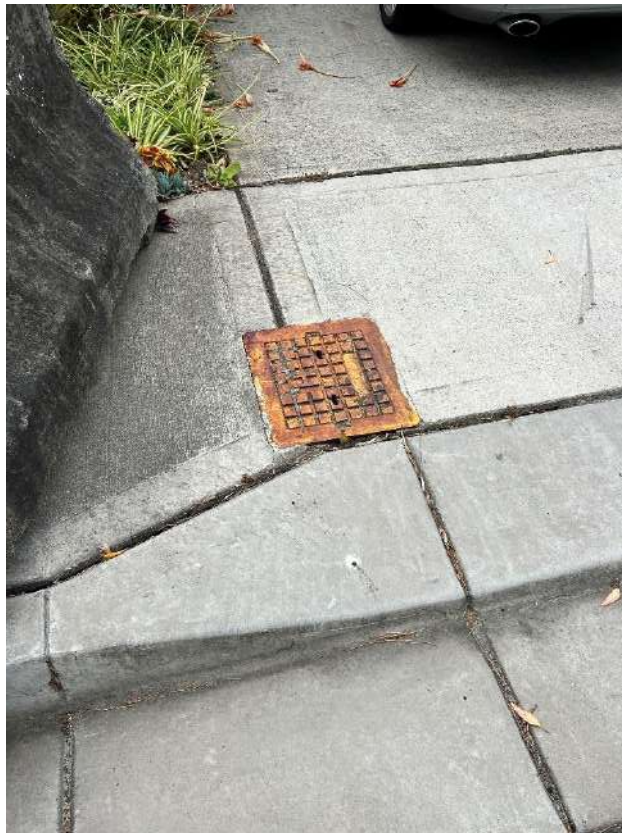
*Figure 26 – General condition of the inspection point.*

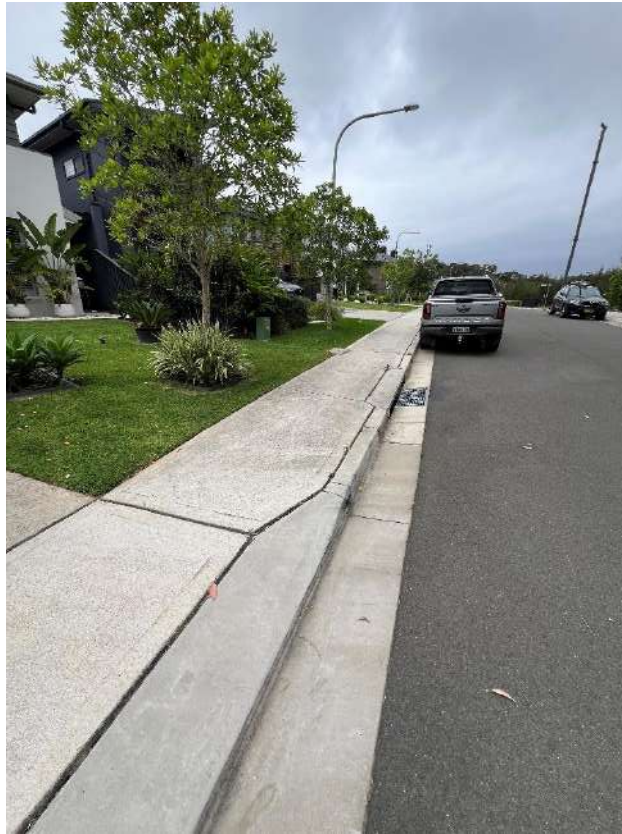
*Figure 27 – General condition of the footpath/kerb.*

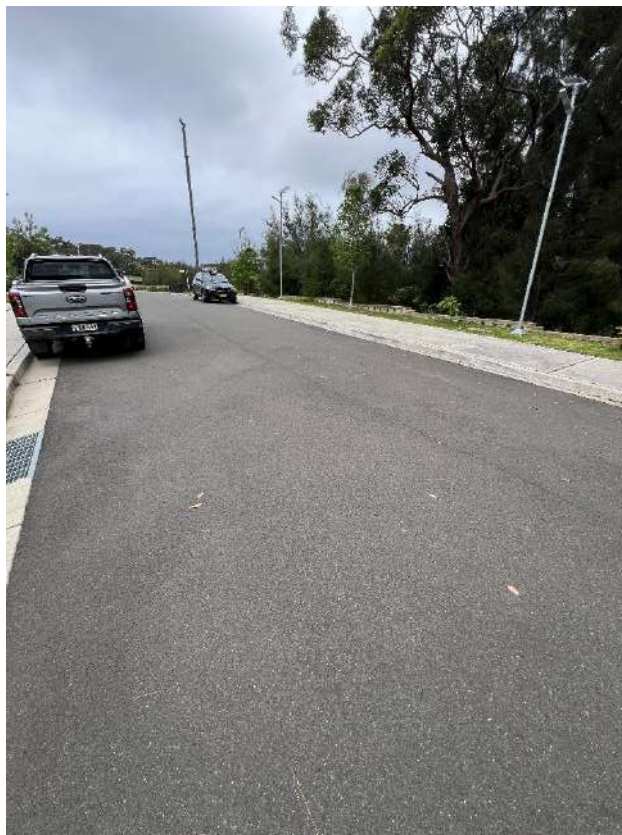
*Figure 28 – General condition of the road.*

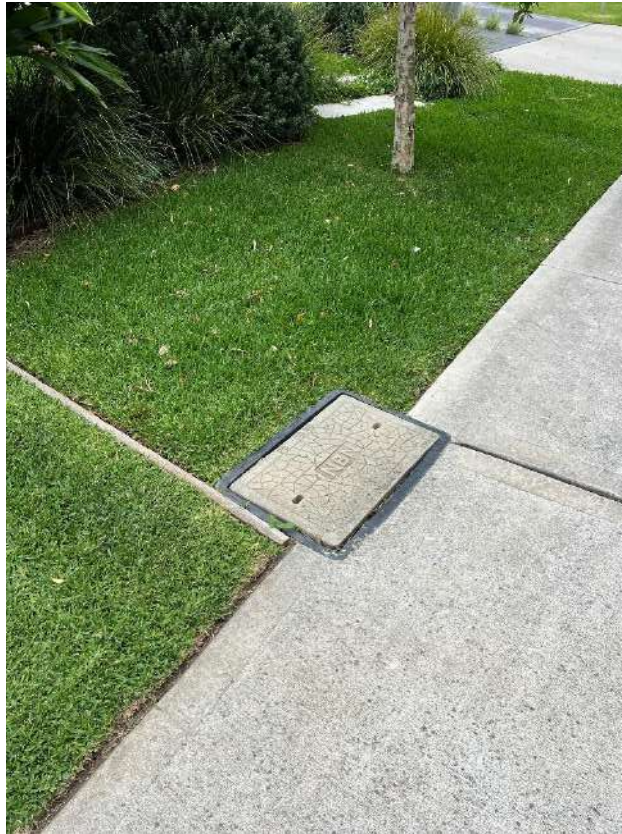
*Figure 29 – General condition of the utility lid.*

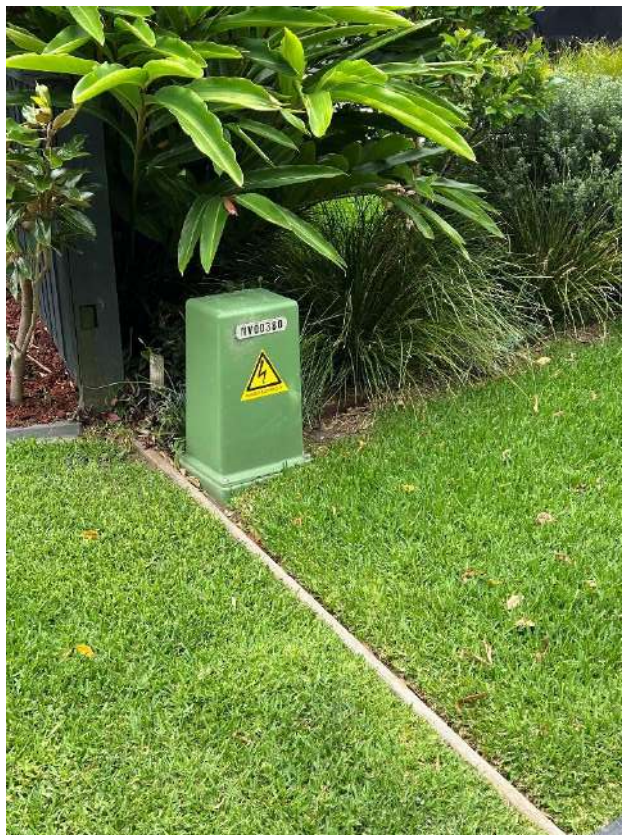
*Figure 30 – General condition of the transformer box.*

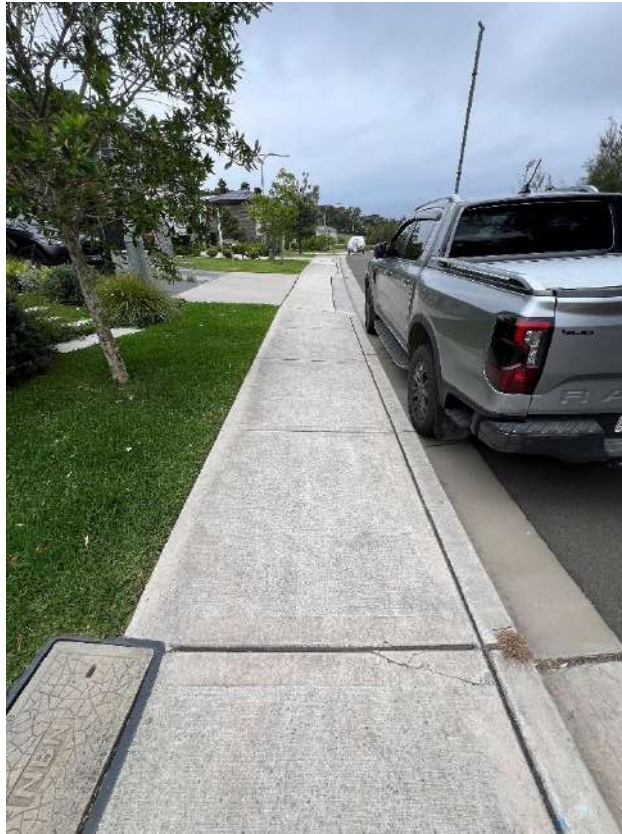
*Figure 31 – Crack is evident to the footpath outside of 59 Lorikeet Grove Warriewood*

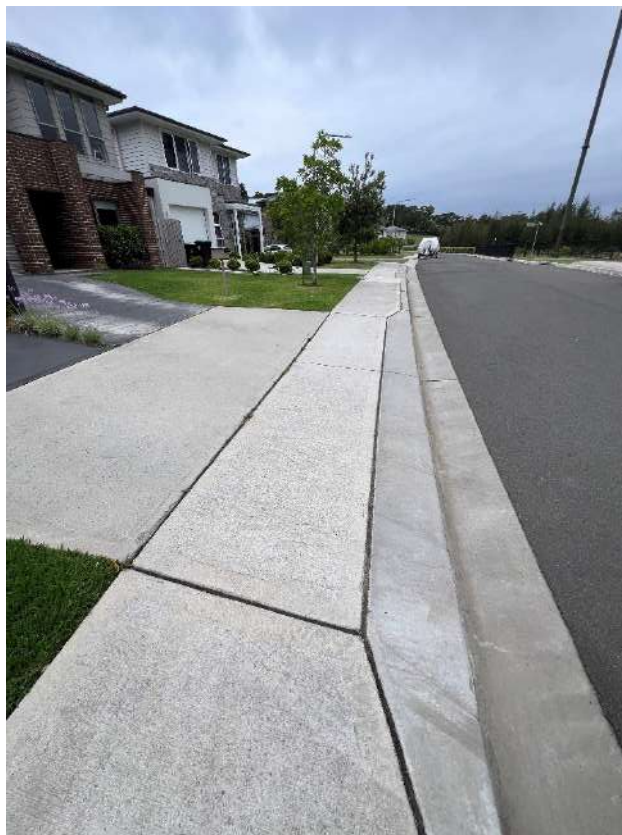
*Figure 32 – General condition of the driveway.*

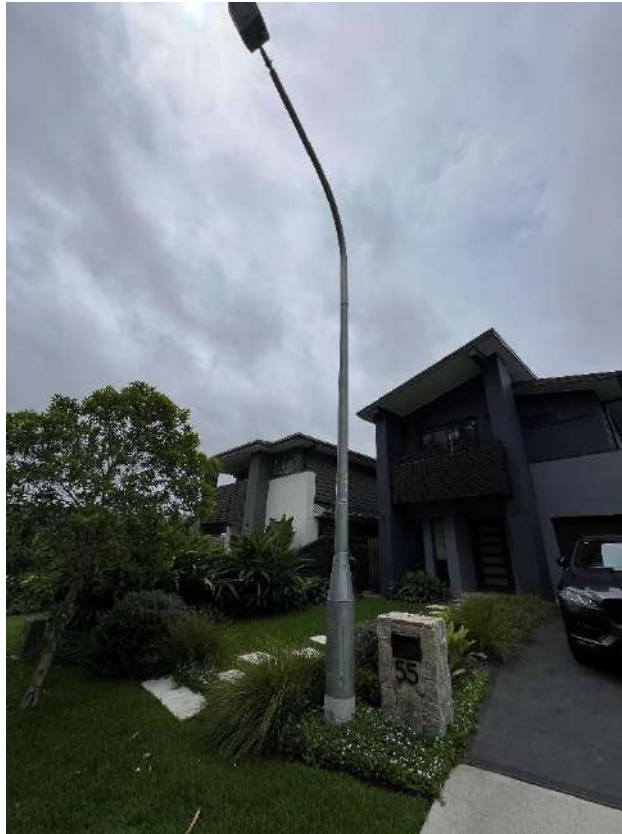
*Figure 33 – General condition of the street light.*

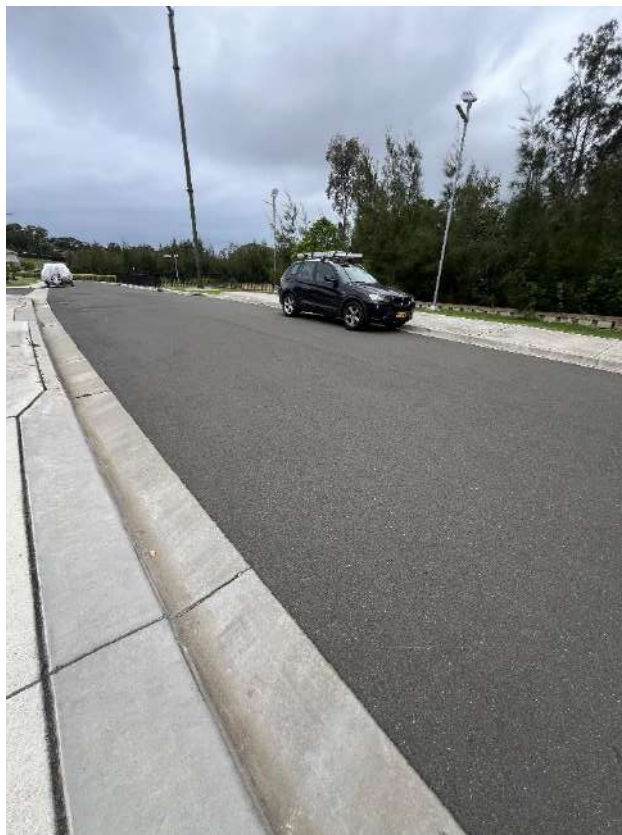
*Figure 34 – General condition of the kerb/road.*

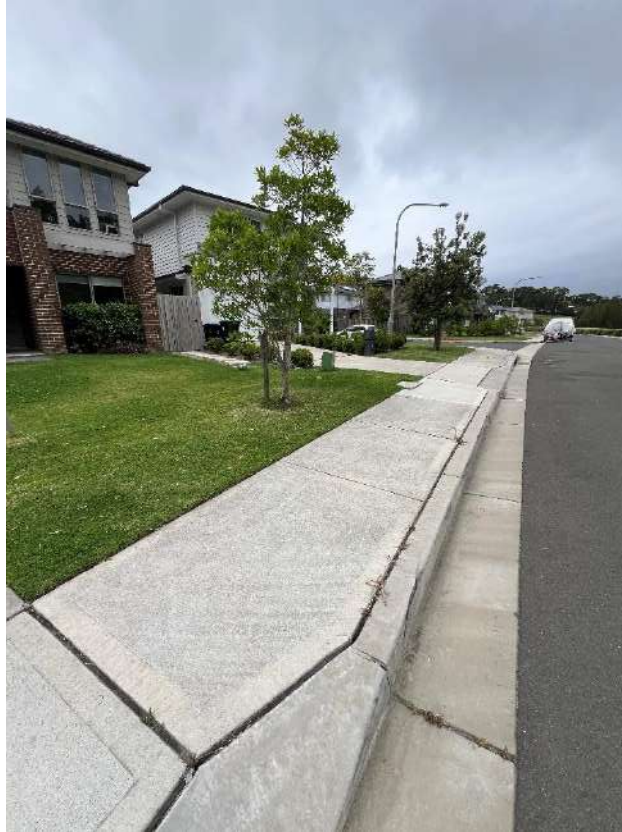
*Figure 35 – General condition of the footpath.*

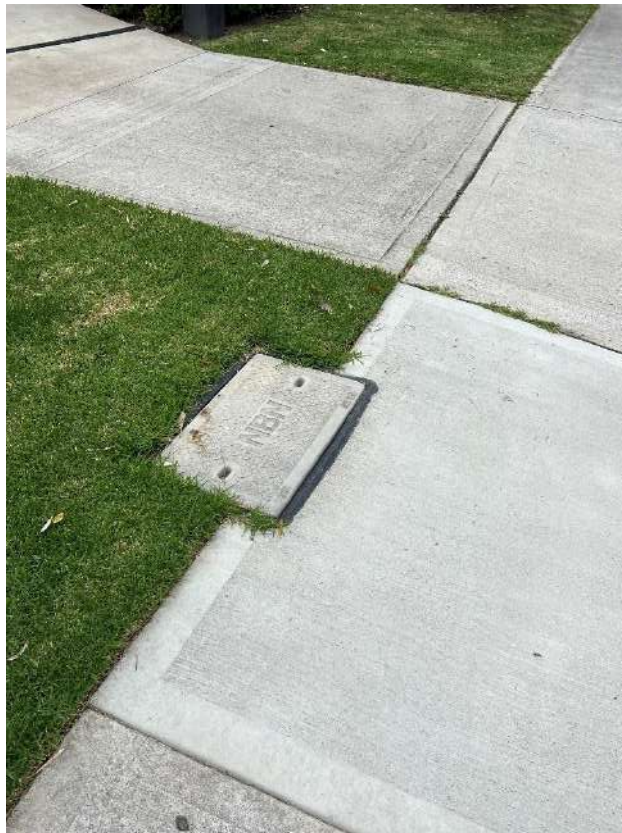
*Figure 36 – General condition of the utility lid.*

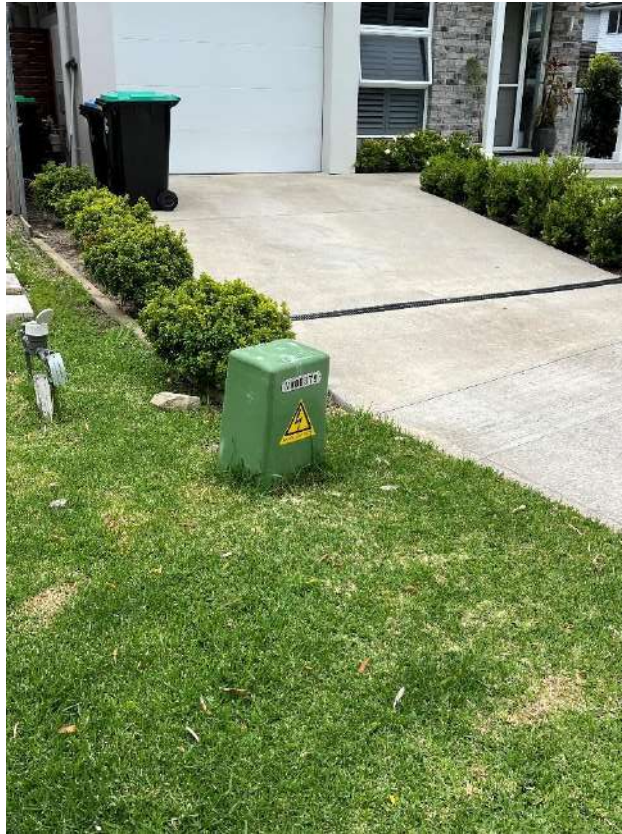
*Figure 37 – General condition of the transformer box.*

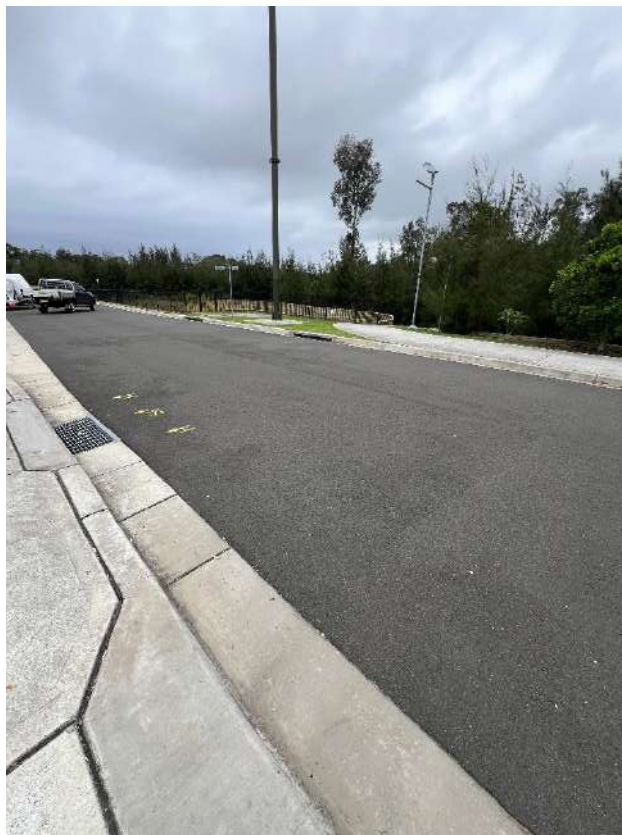
*Figure 38 – General condition of the road.*

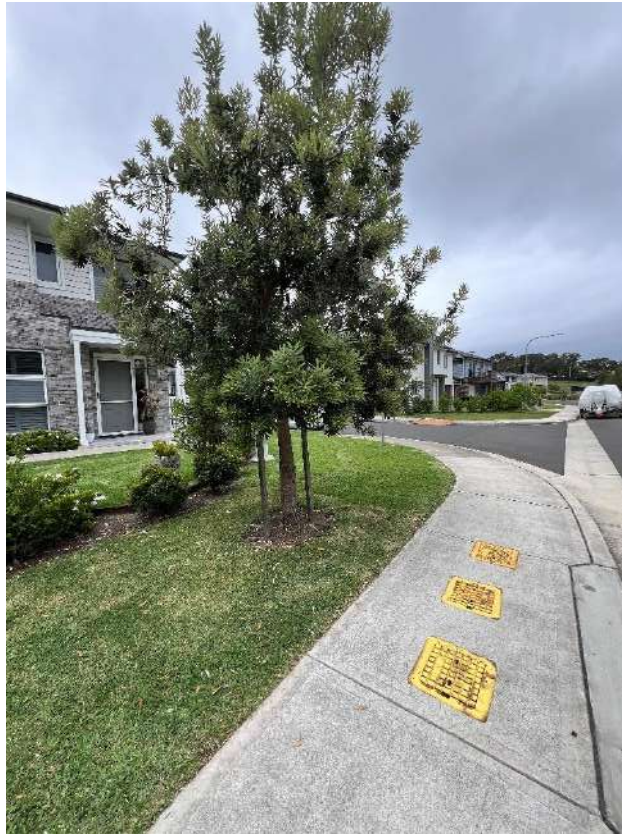
*Figure 39 – General condition of the tree.*

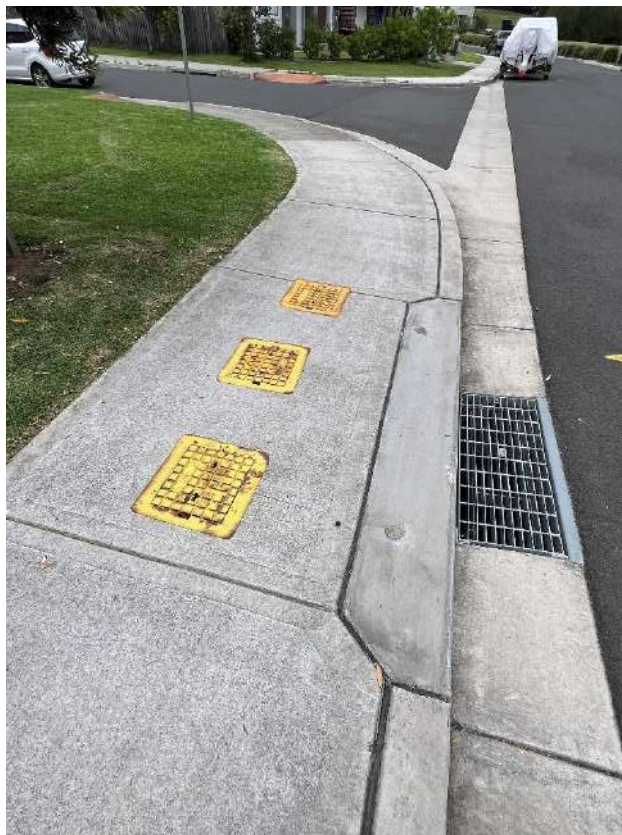
*Figure 40 – General condition of the footpath/utility lid.*

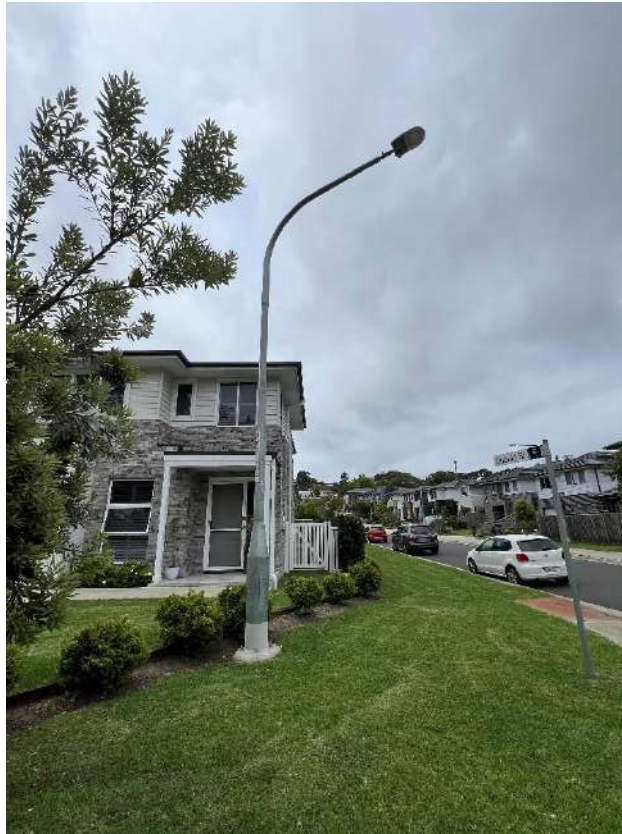
*Figure 41 – General condition of the street light.*

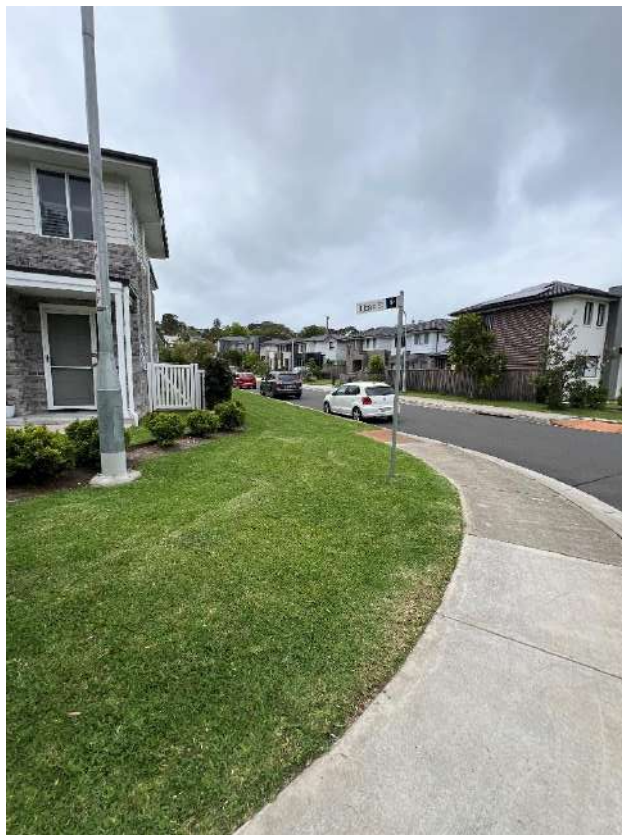
*Figure 42 – General condition of the footpath/nature strip.*

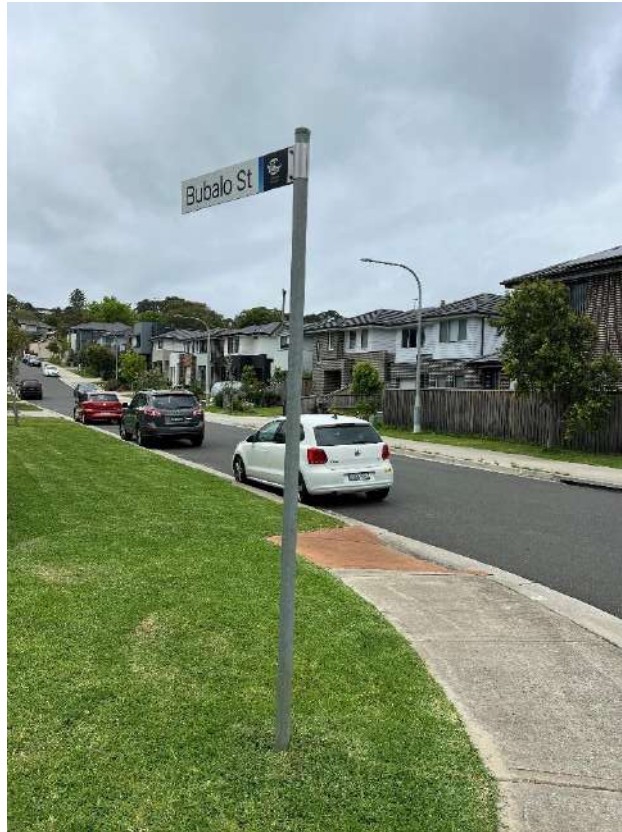
*Figure 43 – General condition of the street signpost.*
