# DILAPIDATION REPORT

**Lorikeet Grove, Warriewood**

This report is intended to be a record of the council assets at Lorikeet Grove, Warriewood at the time of the inspection.

The inspection was carried out on 11 November 2024.

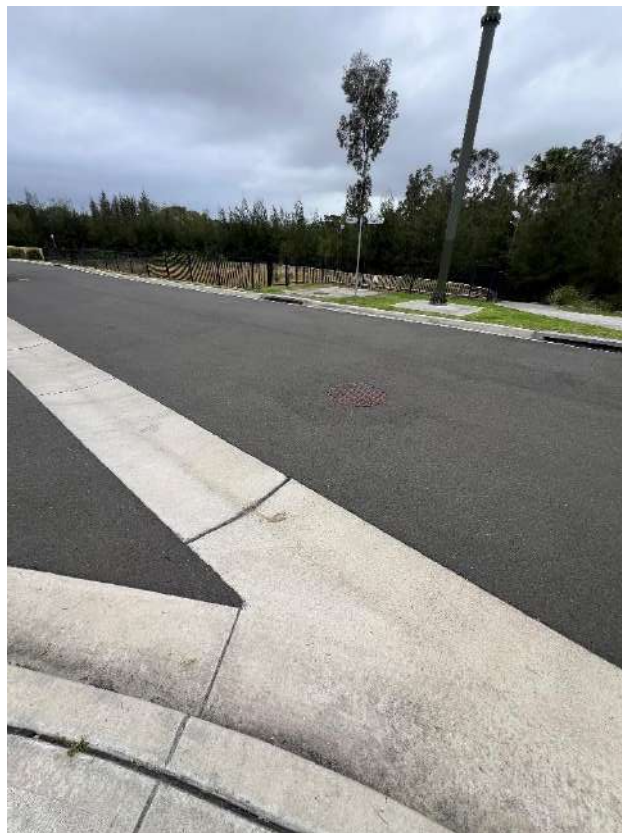
*Figure 44 – General condition of the kerb/road.*

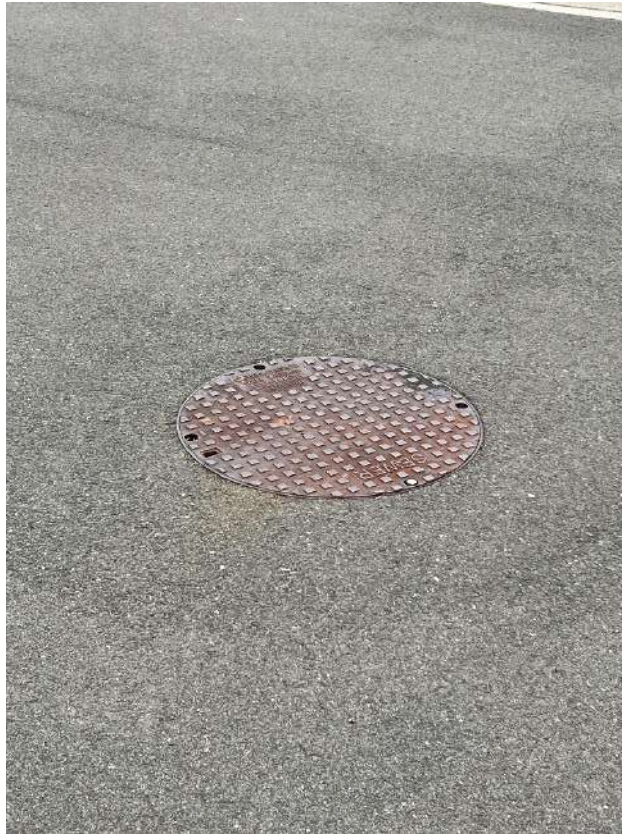
*Figure 45 – General condition of the pit.*

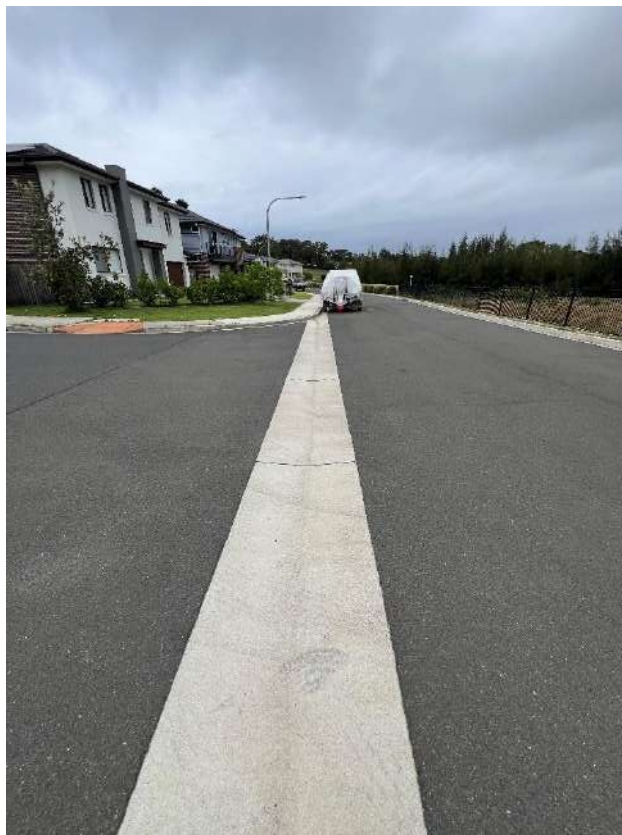
*Figure 46 – General condition of the road.*

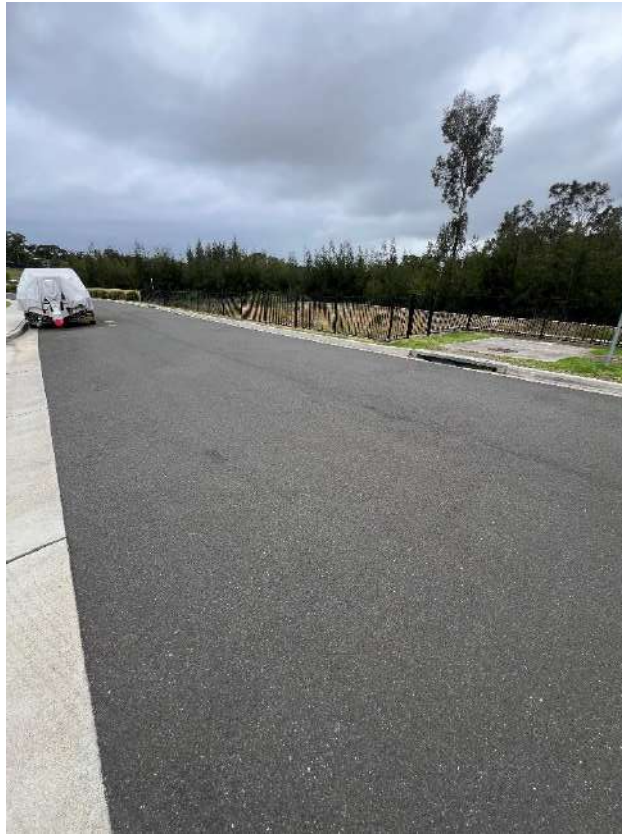
*Figure 47 – General condition of the road.*

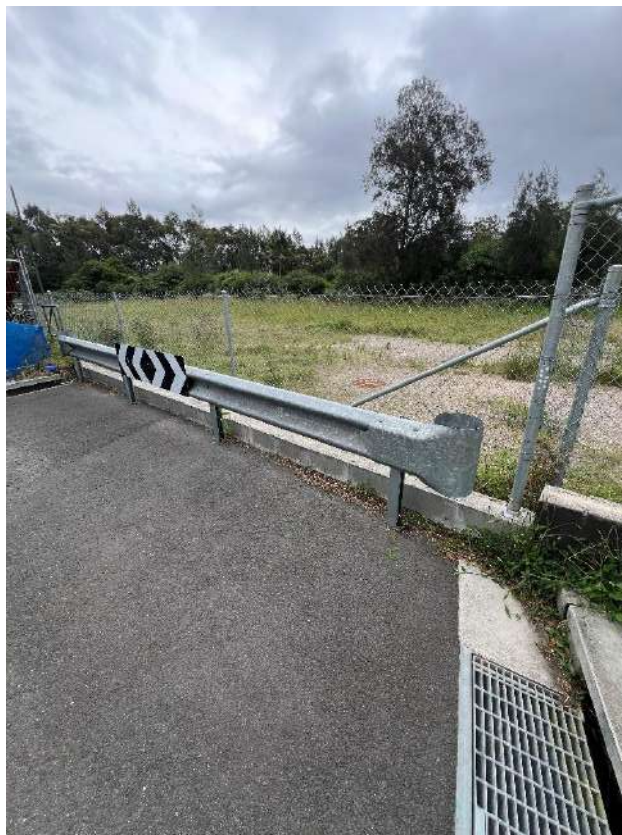
*Figure 48 – General condition of the railings.*

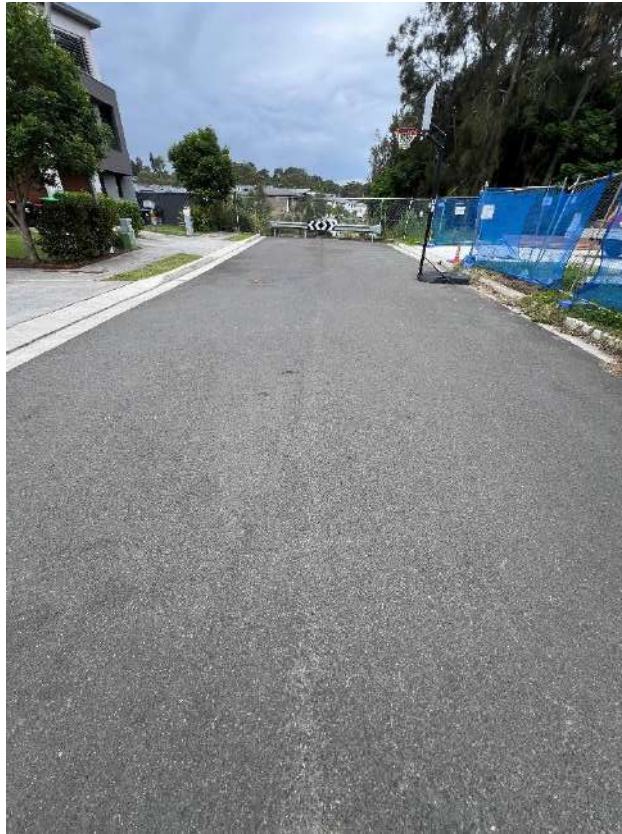
*Figure 49 – General condition of the road.*

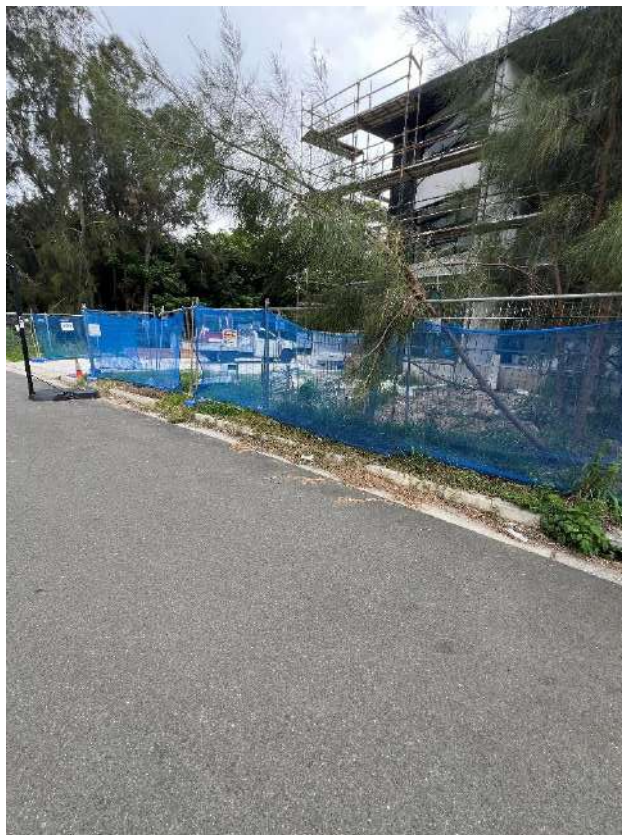
*Figure 50 – General condition of the road/kerb.*

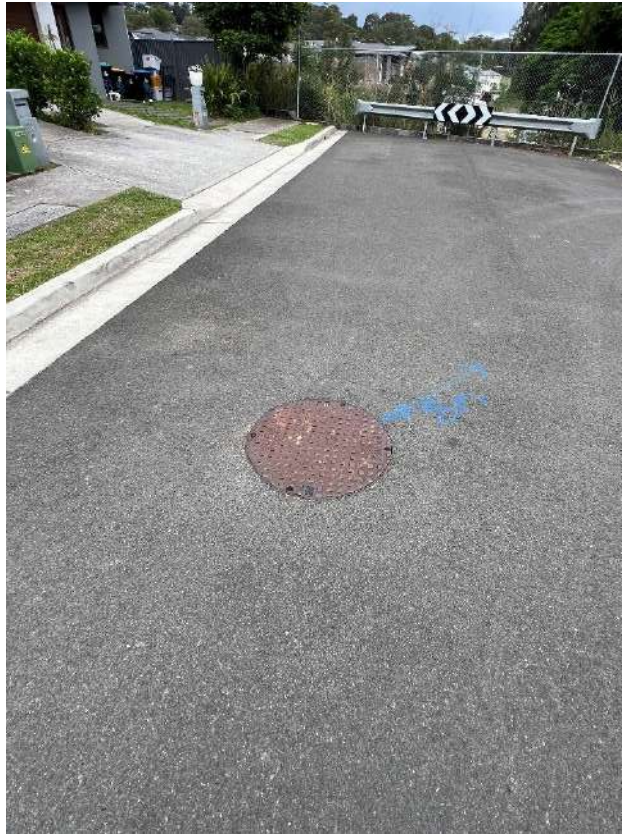
*Figure 51 – General condition of the utility lid.*

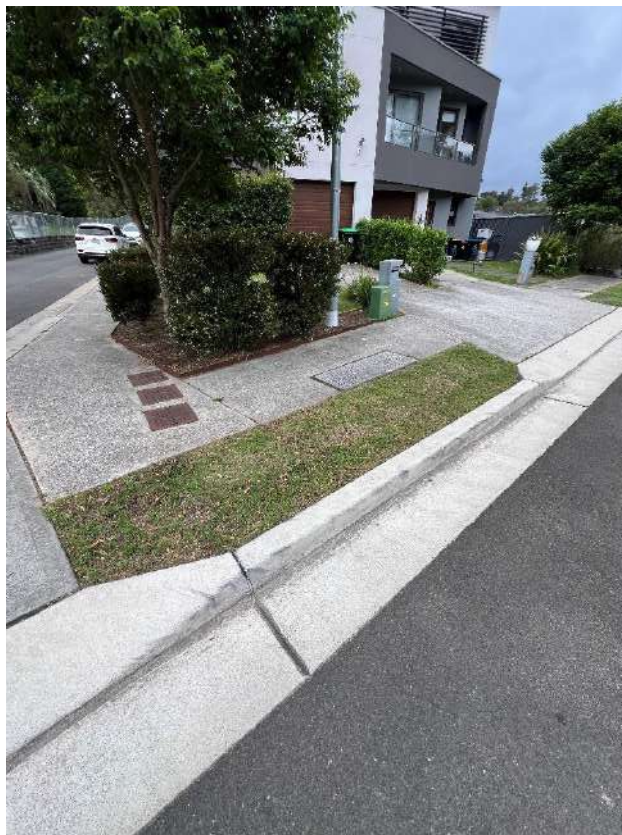
*Figure 52 – General condition of the kerb.*

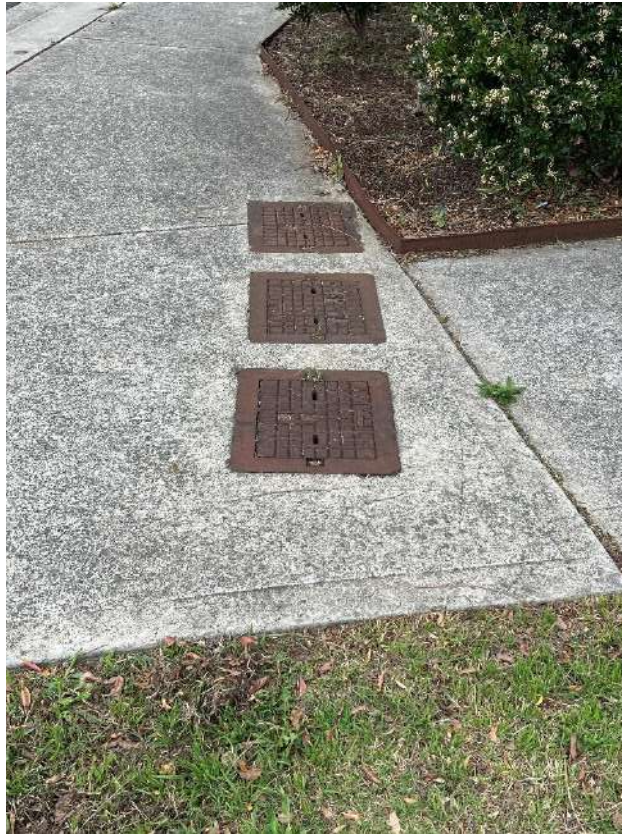
*Figure 53 – General condition of the inspection points.*

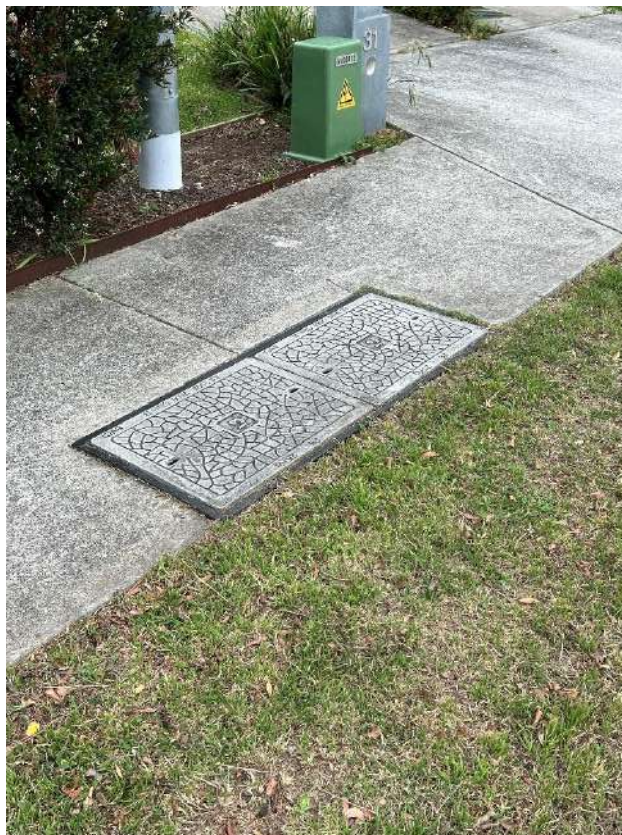
*Figure 54 – General condition of the utility lid.*

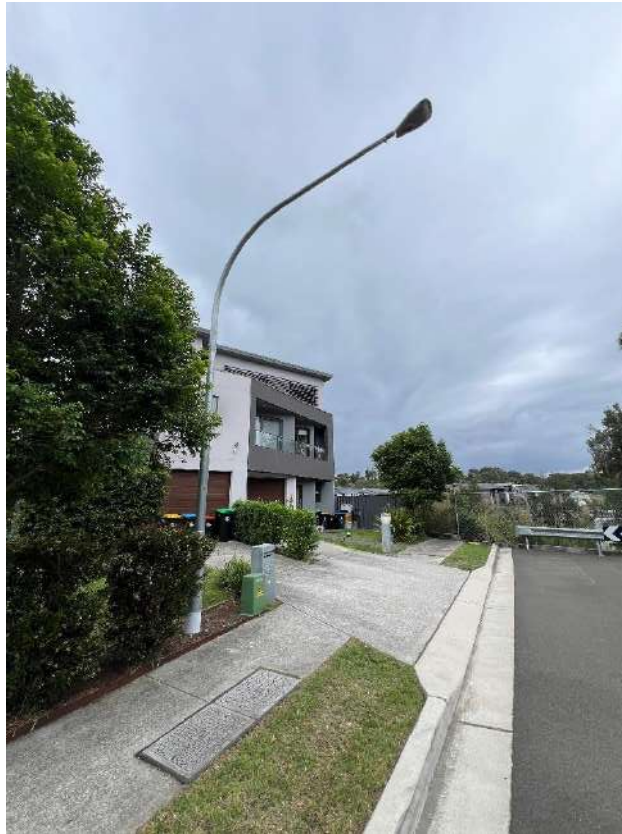
*Figure 55 – General condition of the street light.*

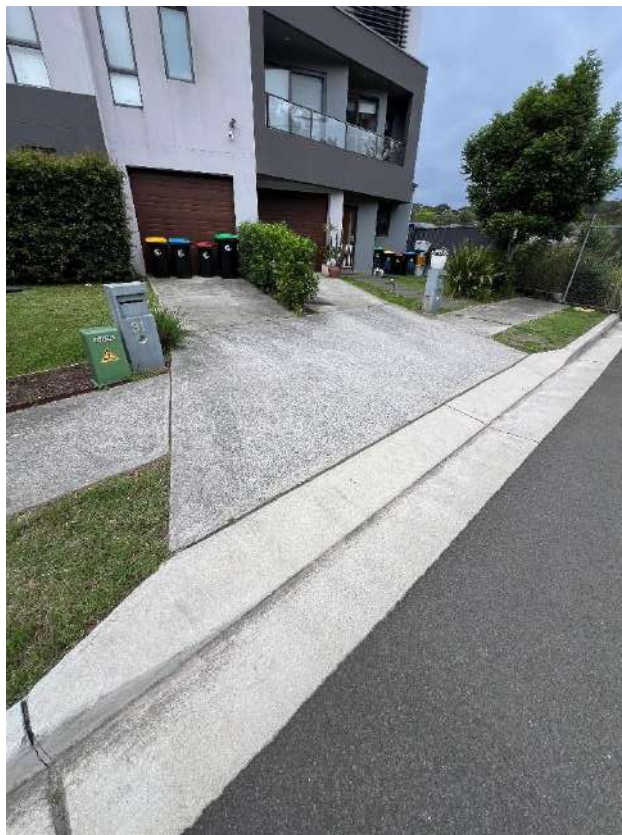
*Figure 56 – General condition of the driveway.*

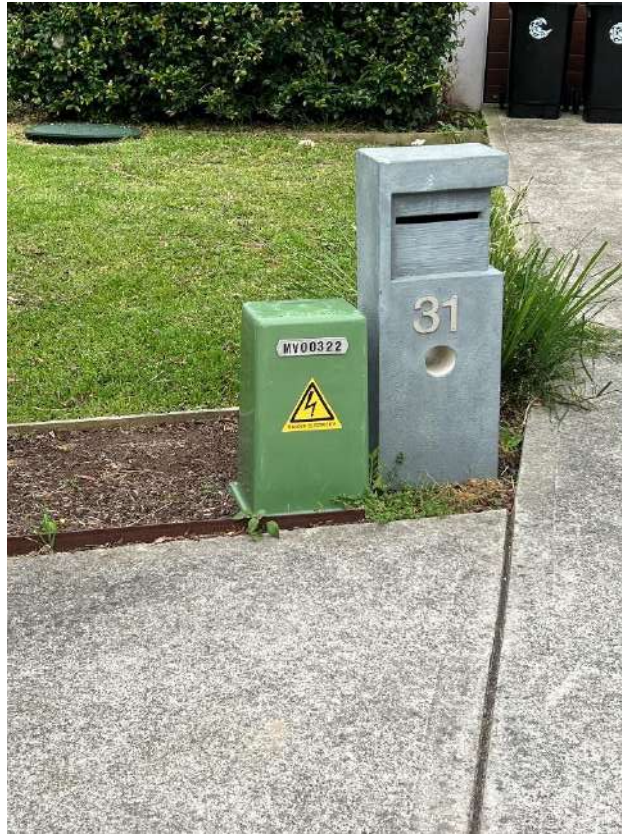
*Figure 57 – General condition of the transformer box.*

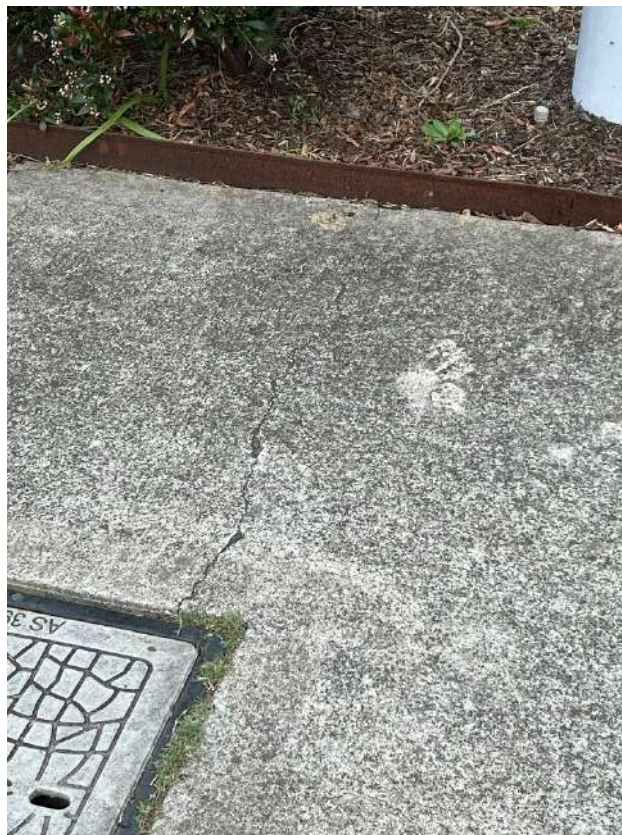
*Figure 58 – Crack is evident to the footpath outside of 31 Lorikeet Grove, Warriewood*

The council assets were found to be in a fair condition with evidence of crack to the driveway, kerb and footpath.

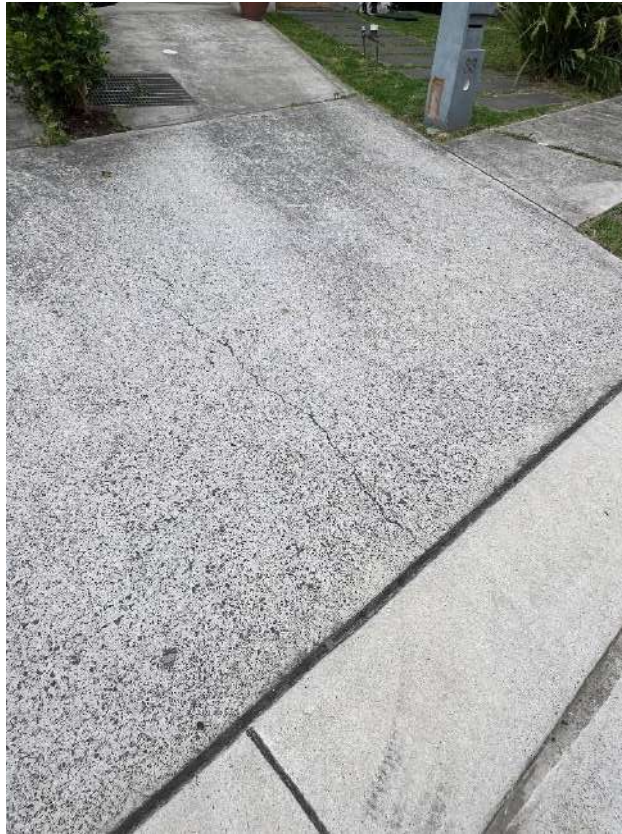
*Figure 59 – Crack is evident to the driveway outside of 33 Lorikeet Grove, Warriewood*

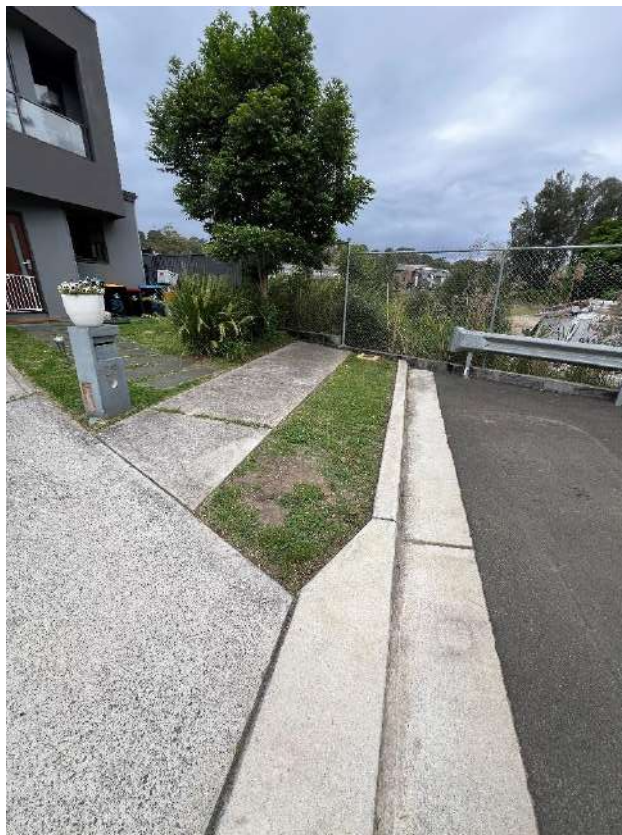
*Figure 60 – General condition of the nature strip.*

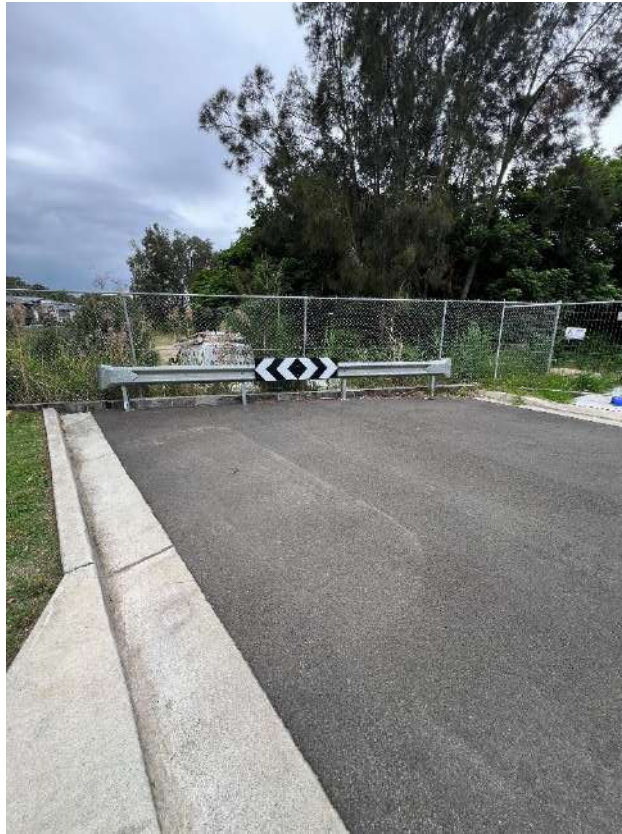
*Figure 61 – General condition of the road.*

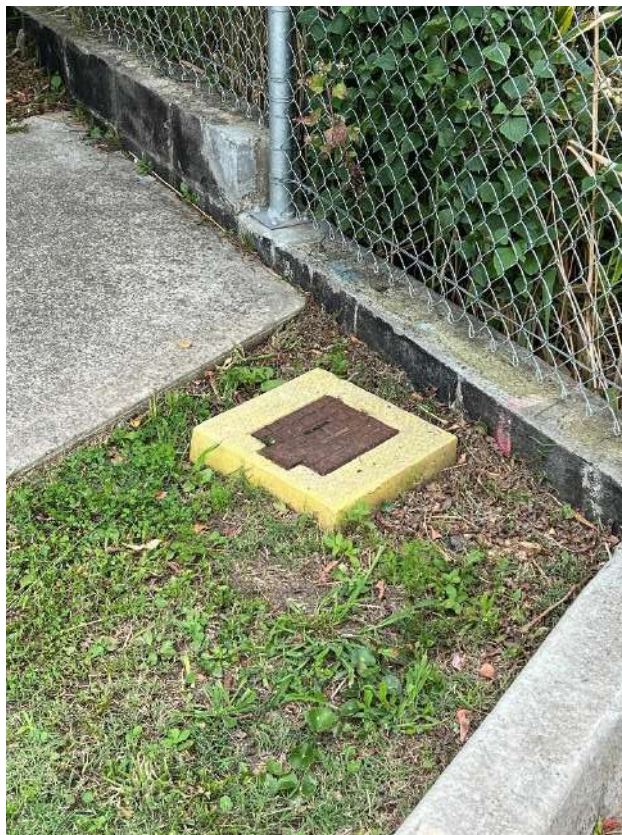
*Figure 62 – General condition of the utility lid.*

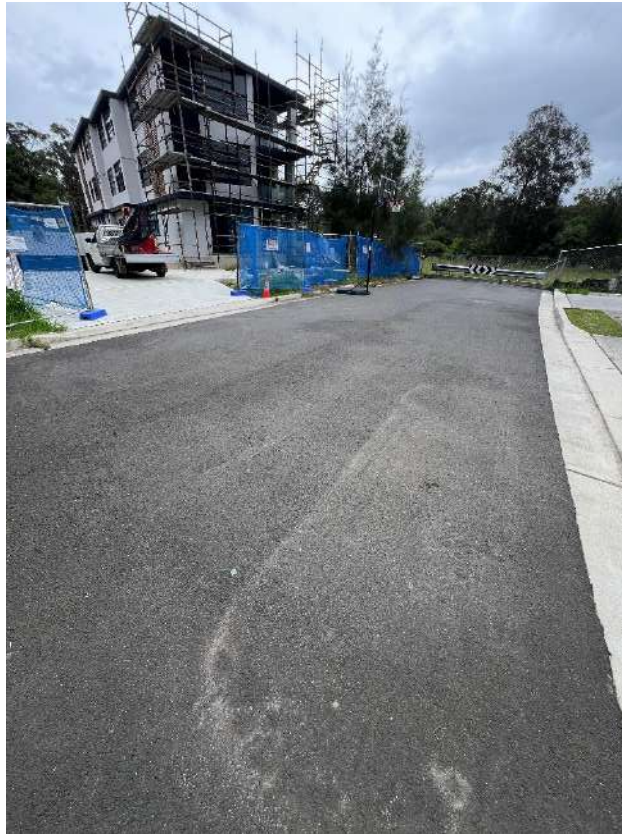
*Figure 63 – General condition of the road.*

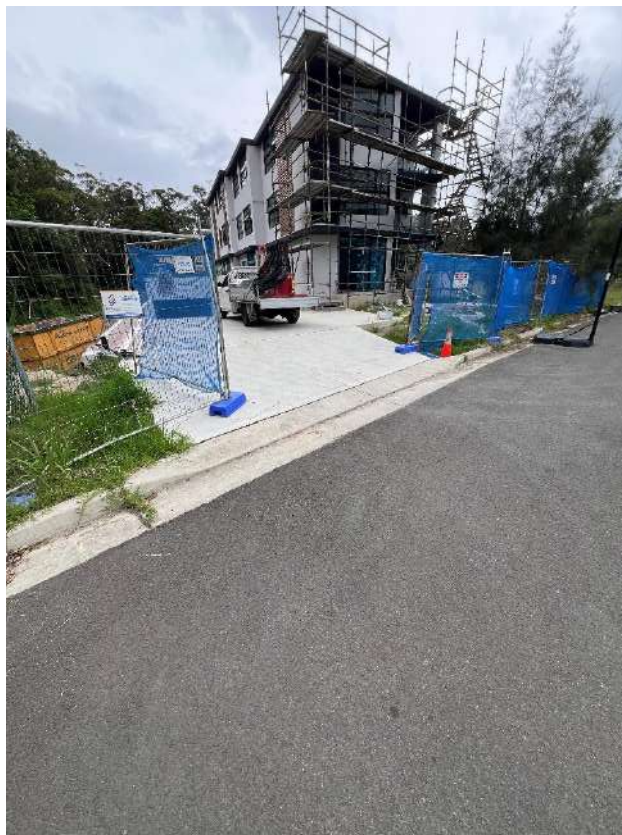
*Figure 64 – General condition of the driveway.*
