J1441A 19th November, 2021 Page 1.

GEOTECHNICAL INVESTIGATION:

New House at 122 Riverview Road, Avalon (AKA 55 Trappers Way)

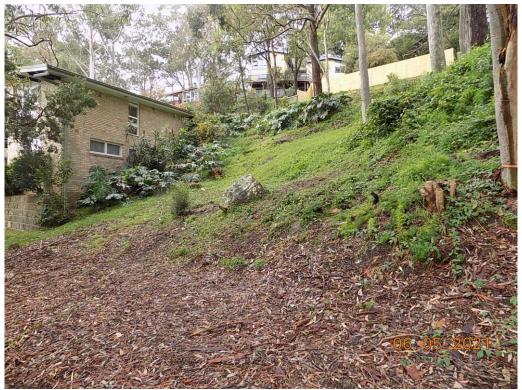
Photo 1

- 2.3 The vacant lot rises from the road frontage to Riverview Road to the downhill side of Trappers Way (Photo 1). The lot continues above Trappers Way to the upper common boundary (Photo 2). The slope between Riverview Road and Trappers Way has been slightly levelled (Photo 3). The cut and fill batters for the levelled area are battered to stable angles. The fill for Trappers Way is also battered to stable angles

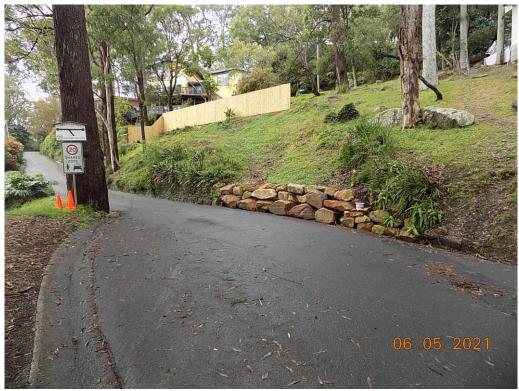
Photo 2

(Photo 4). The steep slope that rises above Trappers Way to the upper common boundary appears stable (Photo 2).

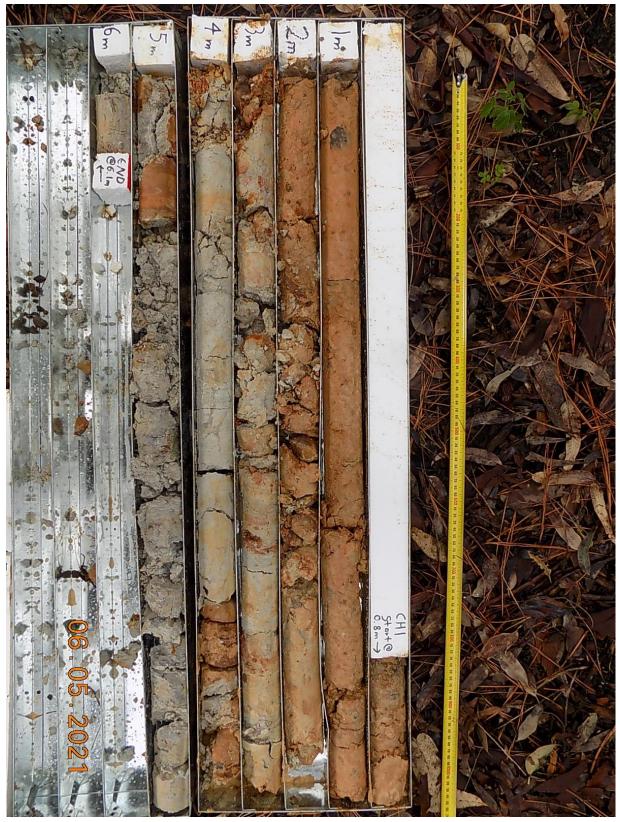
Photo 5: CH1

CORE HOLE 1 (~RL46.5) – CH1 (Photo 5)

| Depth (m) | Material Encountered |
|---|---|
| 1.1 to 2.4 | EXTREMELY LOW STRENGTH SHALE, orange and mottled maroon, dry, |

End of hole @ 6.1m in Extremely Low Strength Shale. No water table encountered.

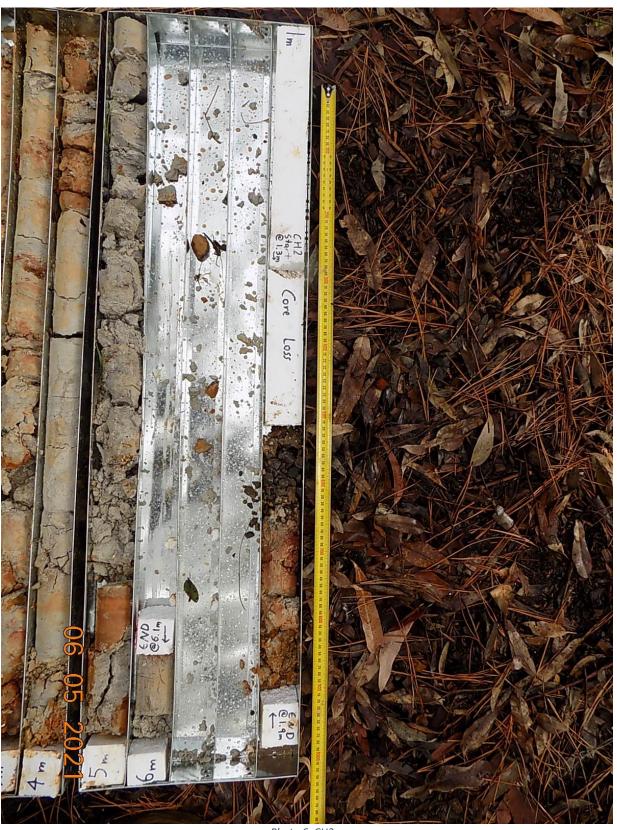
Photo 6: CH2

CORE HOLE 2 (~RL47.0) – CH2 (Photo 6)

| 1.3 to 1.5 | CORE LOSS. |
| 1.5 to 1.65 | GRAVEL, most likely fill or due to drilling process. |
| 1.65 to 1.9 | EXTREMELY LOW STRENGTH SHALE, orange and mottled grey and |

End of hole @ 1.9m in Extremely Low Strength Shale. No water table encountered.
