Geotechnical Assessment

Project: Waterfront Improvements
158A McCarrs Creek Road, Church Point NSW

Ref: AG 24408
2 October 2024

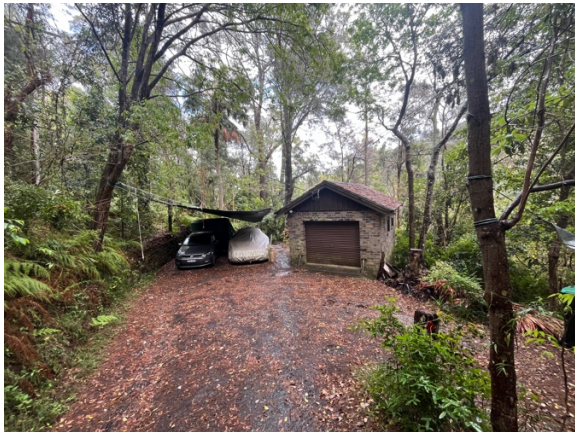
Photo 1: Garage and parking areas near street frontage.

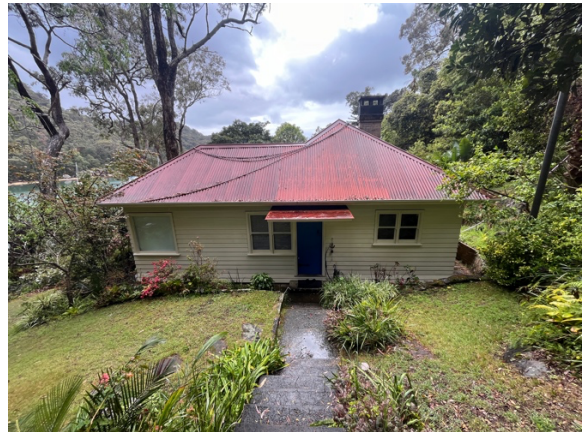
Photo 2: Dwelling, southern side.

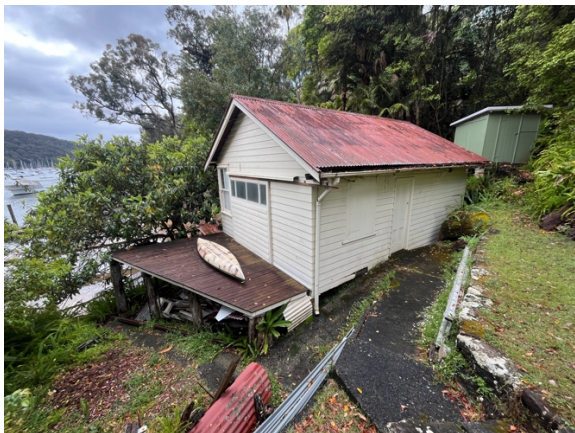
Photo 3: Boat shed.

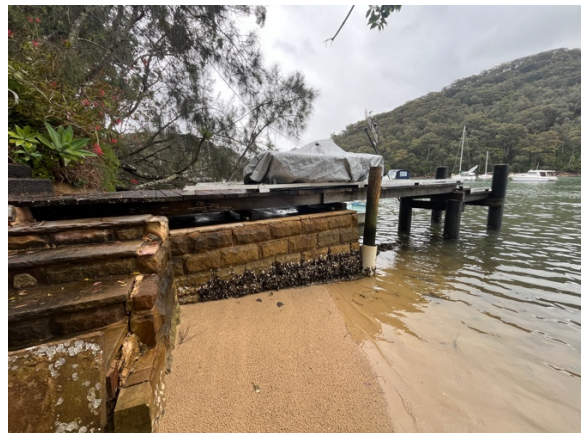
Photo 4: Jetty and area of the proposed waterfront improvements
