PRELIMINARY GEOTECHNICAL ASSESSMENT:

34 Mary Street, Beacon Hill

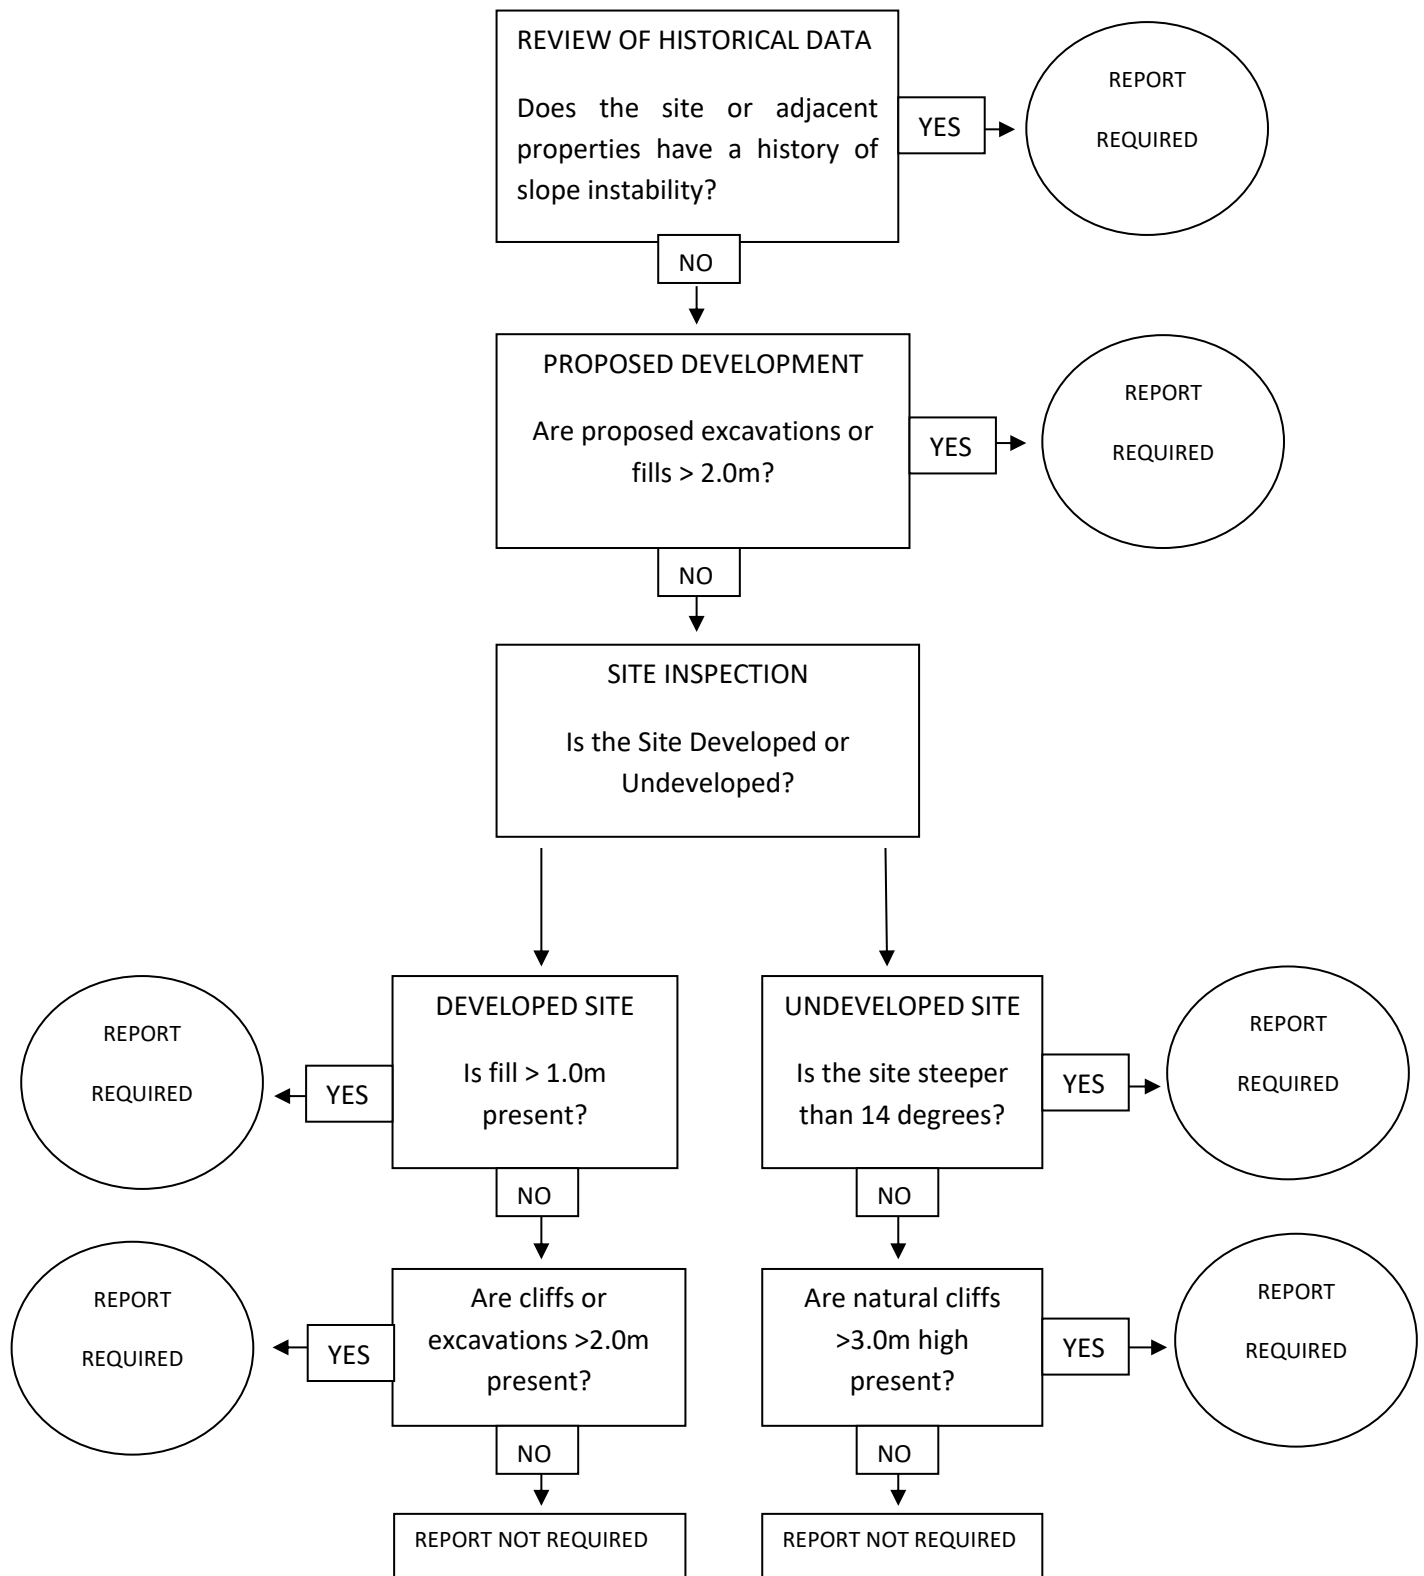
Preliminary Assessment Flow Chart – Northern Beaches Council (Warringah)

The proposed development and site conditions were considered and applied to the Council Flow Chart.

Provided good engineering and building practice are followed, no further Geotechnical assessment is recommended for the proposed development.
