AS2870-2011 SITE CLASSIFICATION

SITE ADDRESS: Lot 13, No 15 Pitt Road Manly Vale NSW

Our REF: AWT 81795

Class P

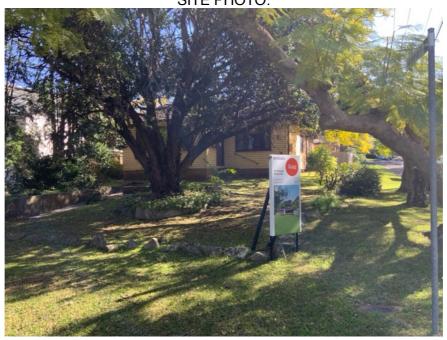
SITE PHOTO:

Site Features: Existing Dwelling with grass & trees
