Report Title: Geotechnical Report 77, 77A, & 81 Myola Road, Newport

GEOTECHNICAL INVESTIGATION:

New Right of Carriageway at 77, 77A, & 81 Myola Road, Newport

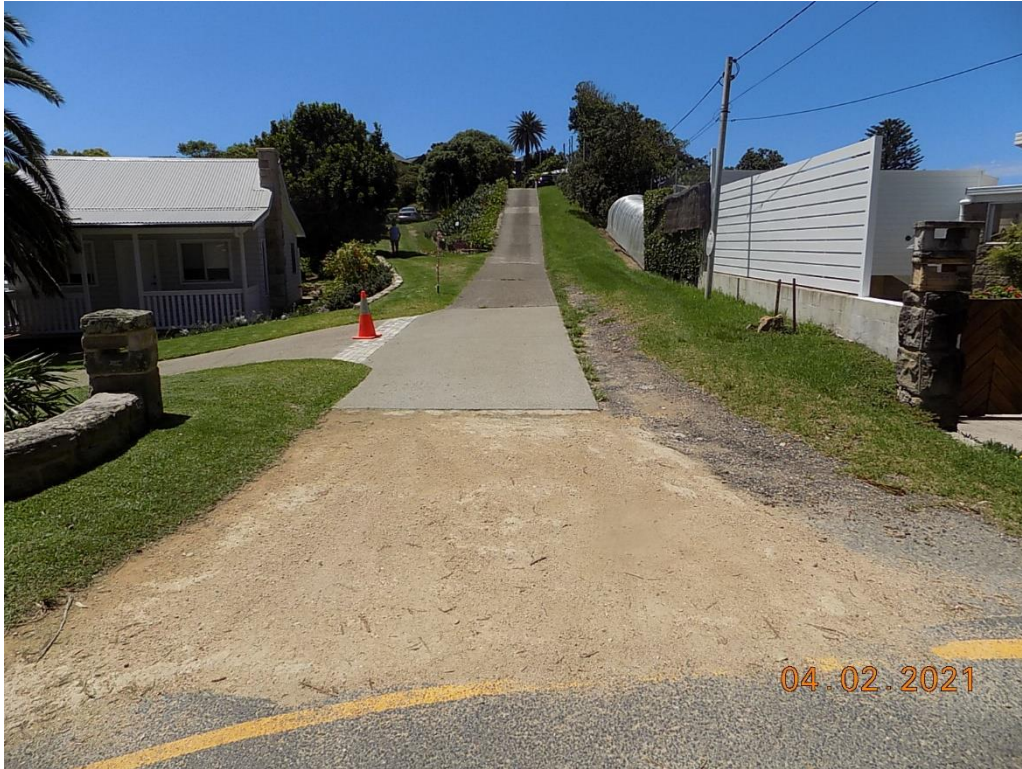
Photo 1

- 2.3 **77 Myola Road** – At the road frontage, a long concrete ROW runs past the S side of the property (Photo 1). Competent Medium Strength Sandstone outcrops through the N side of the slope that drops away from the ROW (Photo 2). A concrete driveway diverts off the ROW to a parking area near the road frontage (Photo 3). A stable steel and timber framed and clad granny flat has been constructed beside the parking area (Photo 4). The slope between the granny flat and the main house has been terraced with three stable sandstone block retaining walls and a series of stable garden slopes (Photos 5, 6, & 7). The old single-storey split level sandstone block house is supported on brick and sandstone block walls (Photo 8). Some stepped cracking was observed through the mortar of the sandstone blocks on the lower E side of the house (Photo 9). This type of cracking is typical in houses of this age and construction. No

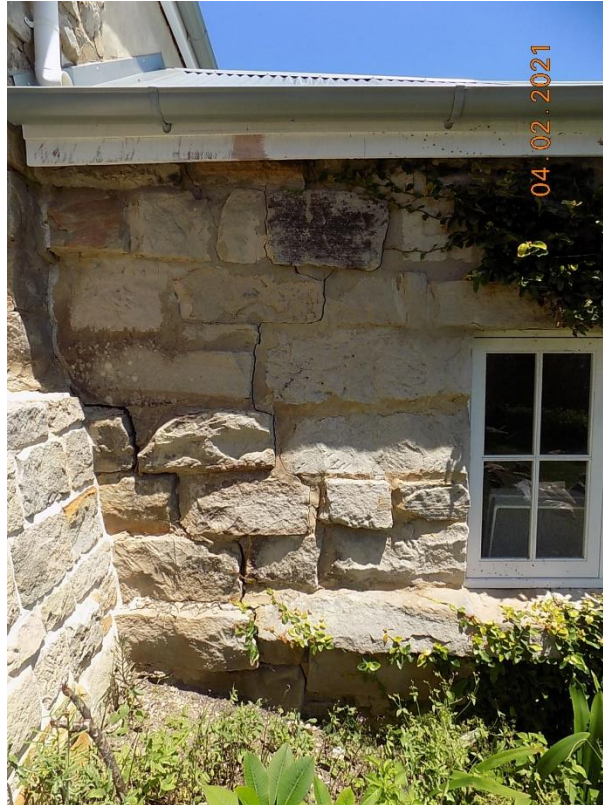
Photo 9

other significant signs of movement were observed in the supporting walls. The house has been partially excavated directly into the outcropping sandstone (Photo 10). A gently sloping lawn extends above the house to the upper common boundary (Photo 11).

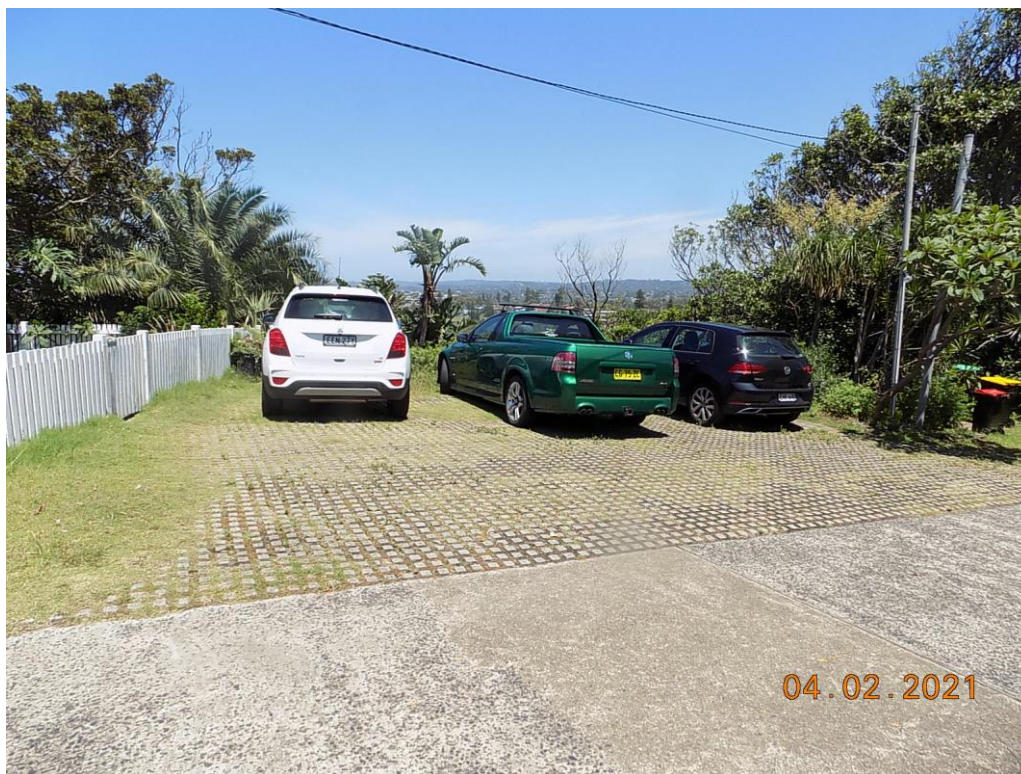
Photo 12

2.4 77A Myola Road – At the road frontage, a concrete ROW runs up the slope along the ridgeline to a concrete parking area on the W side of the property (Photo 12). Between the parking area and the house is a near-level lawn covered fill (Photo 13). The fill for this lawn and for the parking area is supported by an old timber crib retaining wall that will be demolished as part of a separate DA (Photo 14). The fill for the lawn is also supported by a stable mortared stack rock retaining wall ~1.0m high in the foundation space of the house (Photo 15). No significant signs of movement were observed in the supporting brick piers and sandstone block walls of the old, single-storey sandstone block and timber framed and clad house (Photo 16). A cut has been made in the slope to provide a level platform for the house. The cut is supported by a stable ~1.6m high concrete block retaining wall (Photo 17). The wall appears to have been tied back with steel rods and displays no significant signs of movement. Along the base of the wall is a low flagging wall that displays some movement.

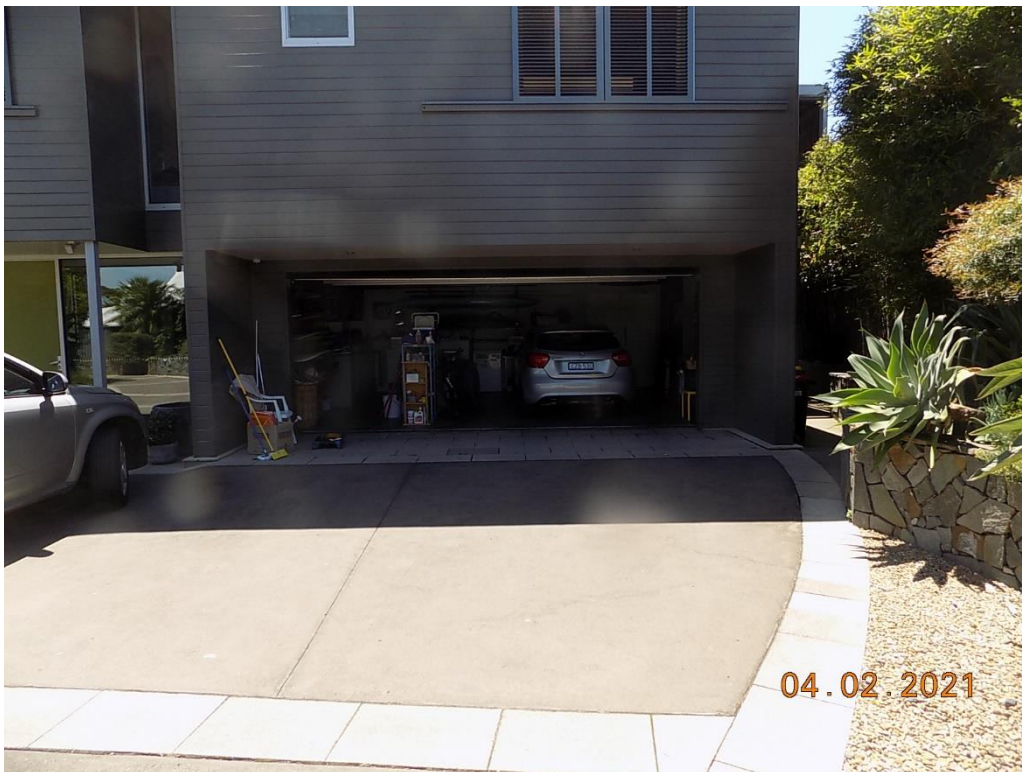
Photo 18

2.5 81 Myola Road – At the road frontage, a concrete ROW runs up the slope along the ridgeline to a garage on the ground floor of the house and to a carport with studio above on the S side of the property (Photos 18 & 19). An excavation has been made in the slope to level the slope surface for the driveway and house. The cut is supported by a stable retaining wall reaching ~2.3m high that has been mostly dressed in stone (Photos 20 & 21). The two-storey clad house is in good condition (Photo 22). A gently sloping lawn and garden area extends off the N and W sides of the house (Photo 23). An above-ground pool has been constructed in the NE corner of the property (Photo 24). The water level of the pool indicates no ground movement has occurred in the shell of the pool since its construction.
