GEOTECHNICAL INVESTIGATION:

New Pool and Landscaping at 292 Hudson Parade, Clareville

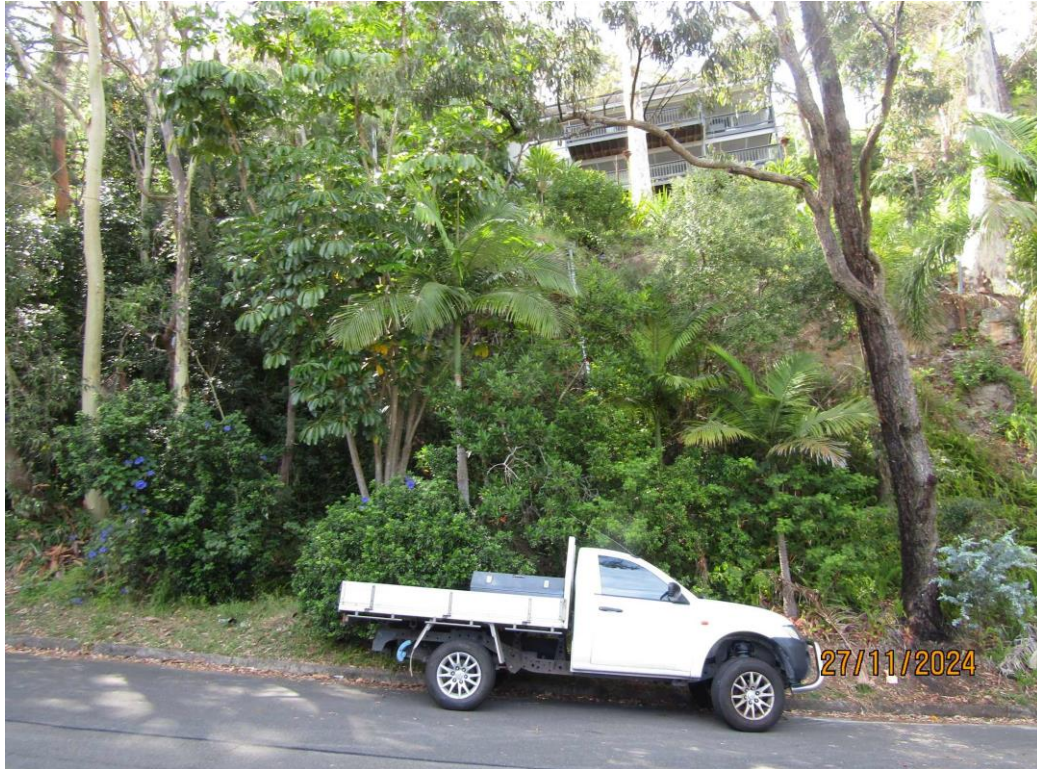
Photo 1

- 2.1** The site was inspected on the 27th November, 2024.
- 2.2** This residential property is on the low side of the road and has a NW aspect. It is located on the steeply graded lower reaches of a hillslope. The natural slope falls across the property at an average angle of ~20°. The slope below the property continues at similar steep angles for some 16m before reaching Pittwater. The slope above the property increases in grade and continues at steep angles for some 100m before decreasing in grade.
- 2.3** The slope at the uphill side of the road and opposite of the subject property rises at very steep angles (Photo 1). Sandstone bedrock outcrops midway up the slope. The slope is densely vegetated where rock is not exposed. At the road frontage, a concrete driveway runs to a double garage at the uphill side of the house (Photo 2).

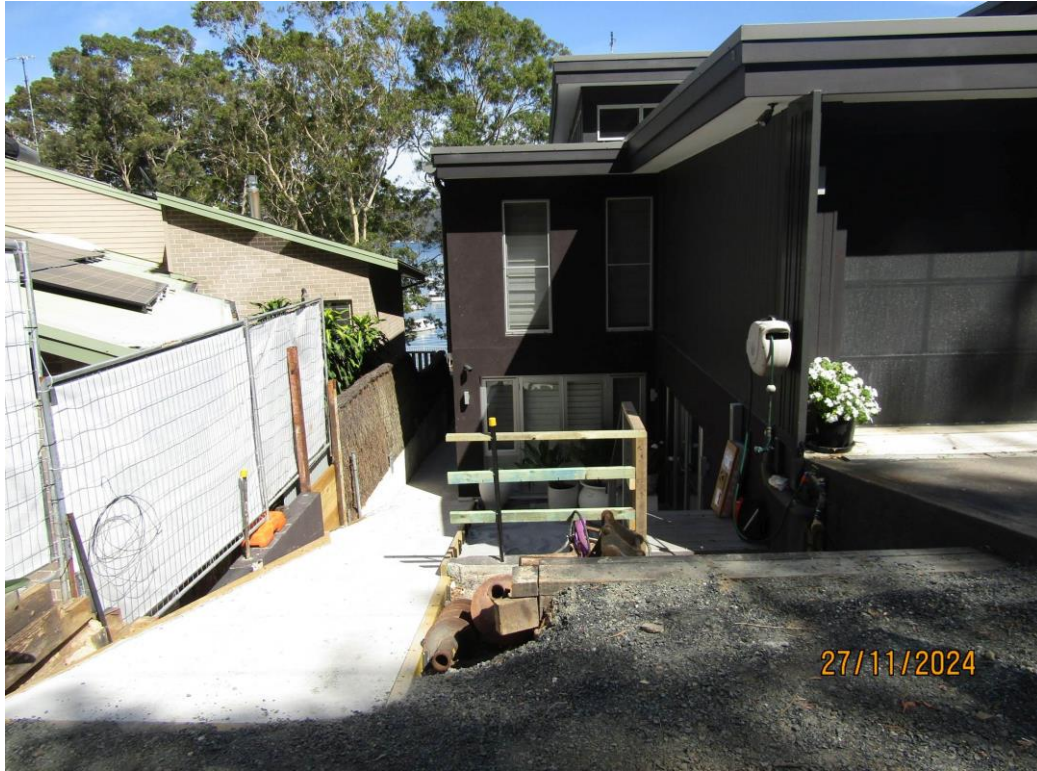
Photo 3

The part three storey house is supported on masonry walls (Photos 3 & 4). The external supporting walls show no significant signs of movement.

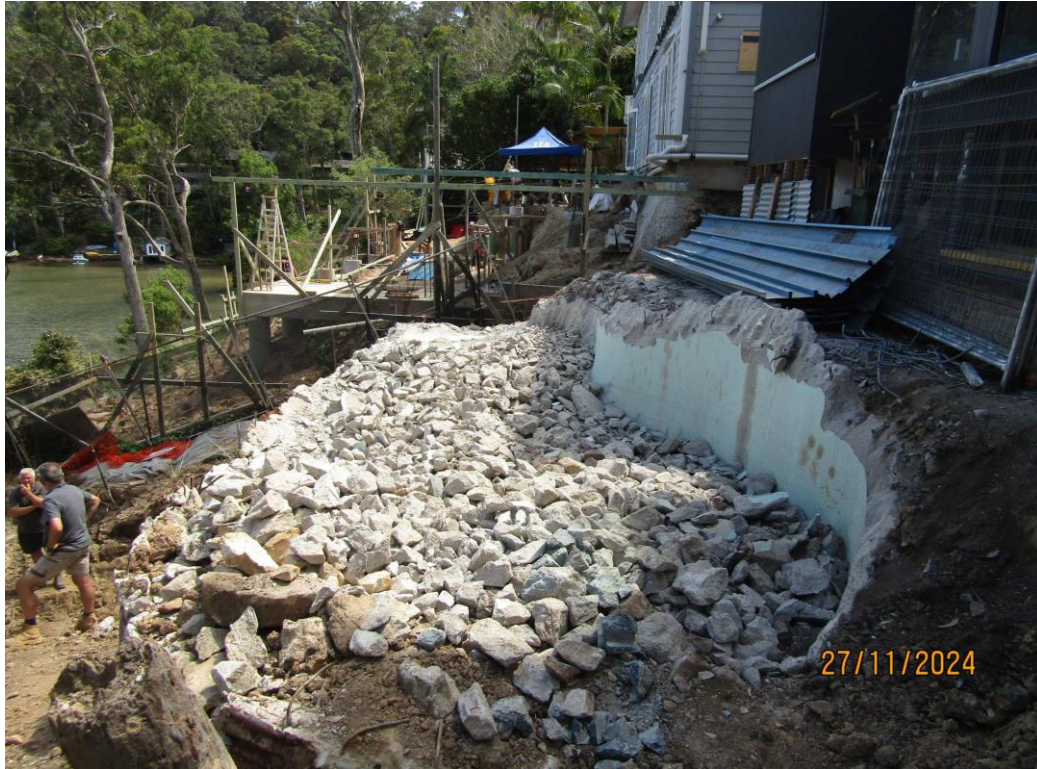
Photo 5

Construction/demolition works are ongoing at the downhill side of the house (Photos 5 & 6). An extreme heavy and prolonged rainfall event occurred during March, 2022. This resulted in movement of the deep fill that had been placed across the downhill side of the property during its development. The posts supporting a timber deck at the downhill side of the existing pool tilted and settled. Severe cracking and deflection occurred in a mortared stack rock retaining wall up to ~3.5m, that supported a fill immediately downslope of the pool. The base of the existing pool is undercut at the downhill side, although piers support this side of the pool (Photo 7). The deck, retaining wall and pool have been demolished or partially demolished (Photos 5 & 6). Structural landscaping retaining walls with counterfort returns will be constructed across the downhill side of the property as part of the proposed works to stabilise the slope.

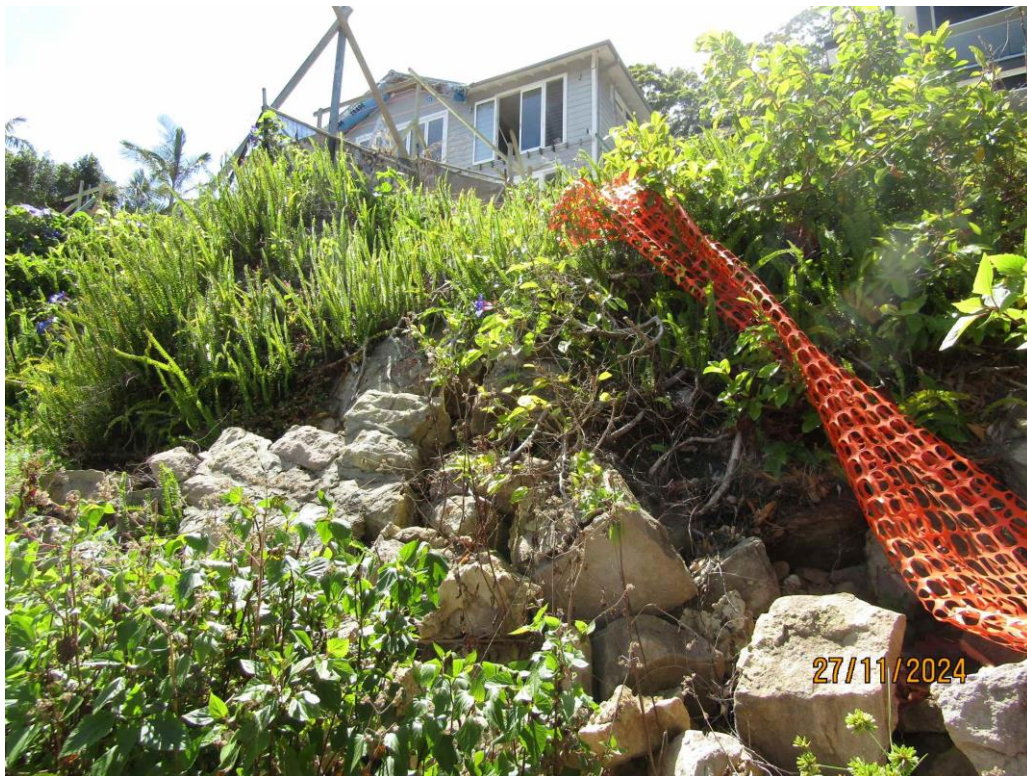
Photo 8

The steep slope below the property is densely vegetated with some rubble from the slope movement (Photos 8 to 10). Detached sandstone joint blocks are scattered across the toe of the slope (Photo 10). A tree has toppled and fallen down the slope in this location (Photo 11). Landslide material is also present at the toe of the slope (Photo 12). It is interpreted that the toppled tree and landslide rubble are the result of the slope movement initiated by the extreme rainfall event in March, 2022, and that was ongoing for some 6 months after.

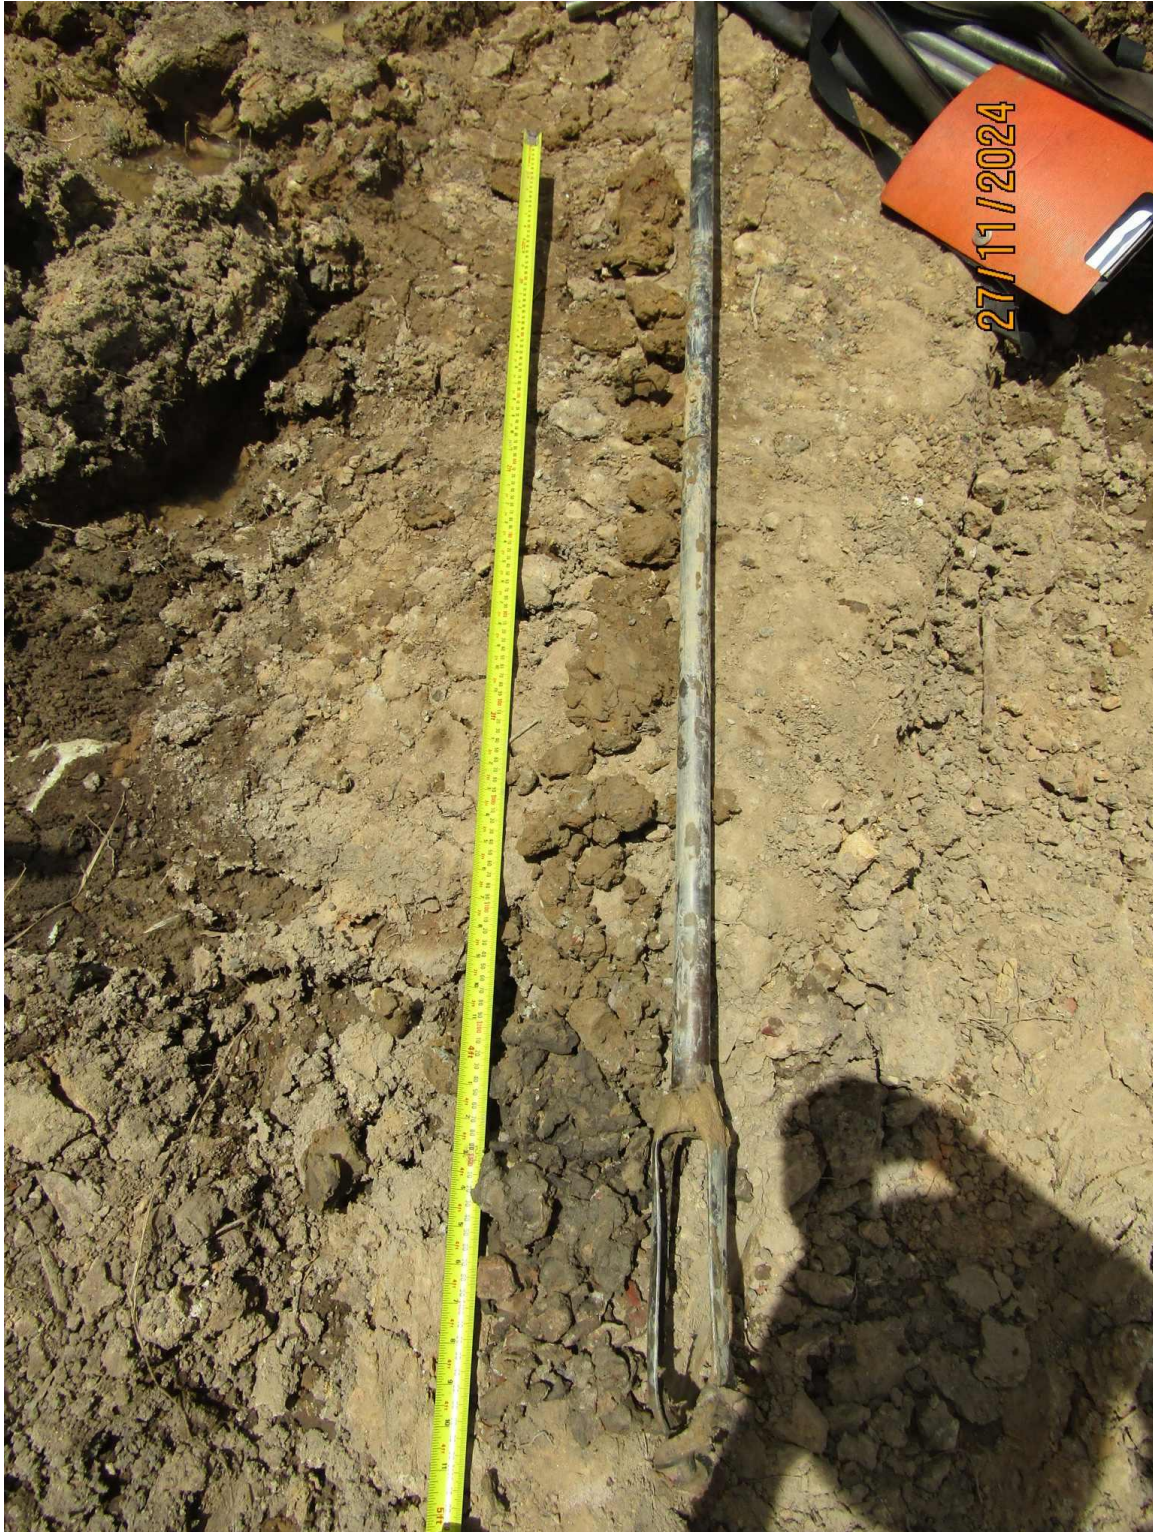
Depth (m)	Material Encountered
0.0 to 1.2	FILL , clay, clayey soil, with some rock fragments, brown, moist to damp, fine to coarse grained.
1.2 to 1.4	SILTY SAND , dark brown/grey, damp to wet, fine to medium grained.
1.4 to 1.5	SANDY CLAY , grey and maroon, mottled, stiff, damp.

Refusal @ 1.5m, auger grinding on weathered rock. No water table encountered.

Photo 13: AH1 – Downhole is from top to bottom.

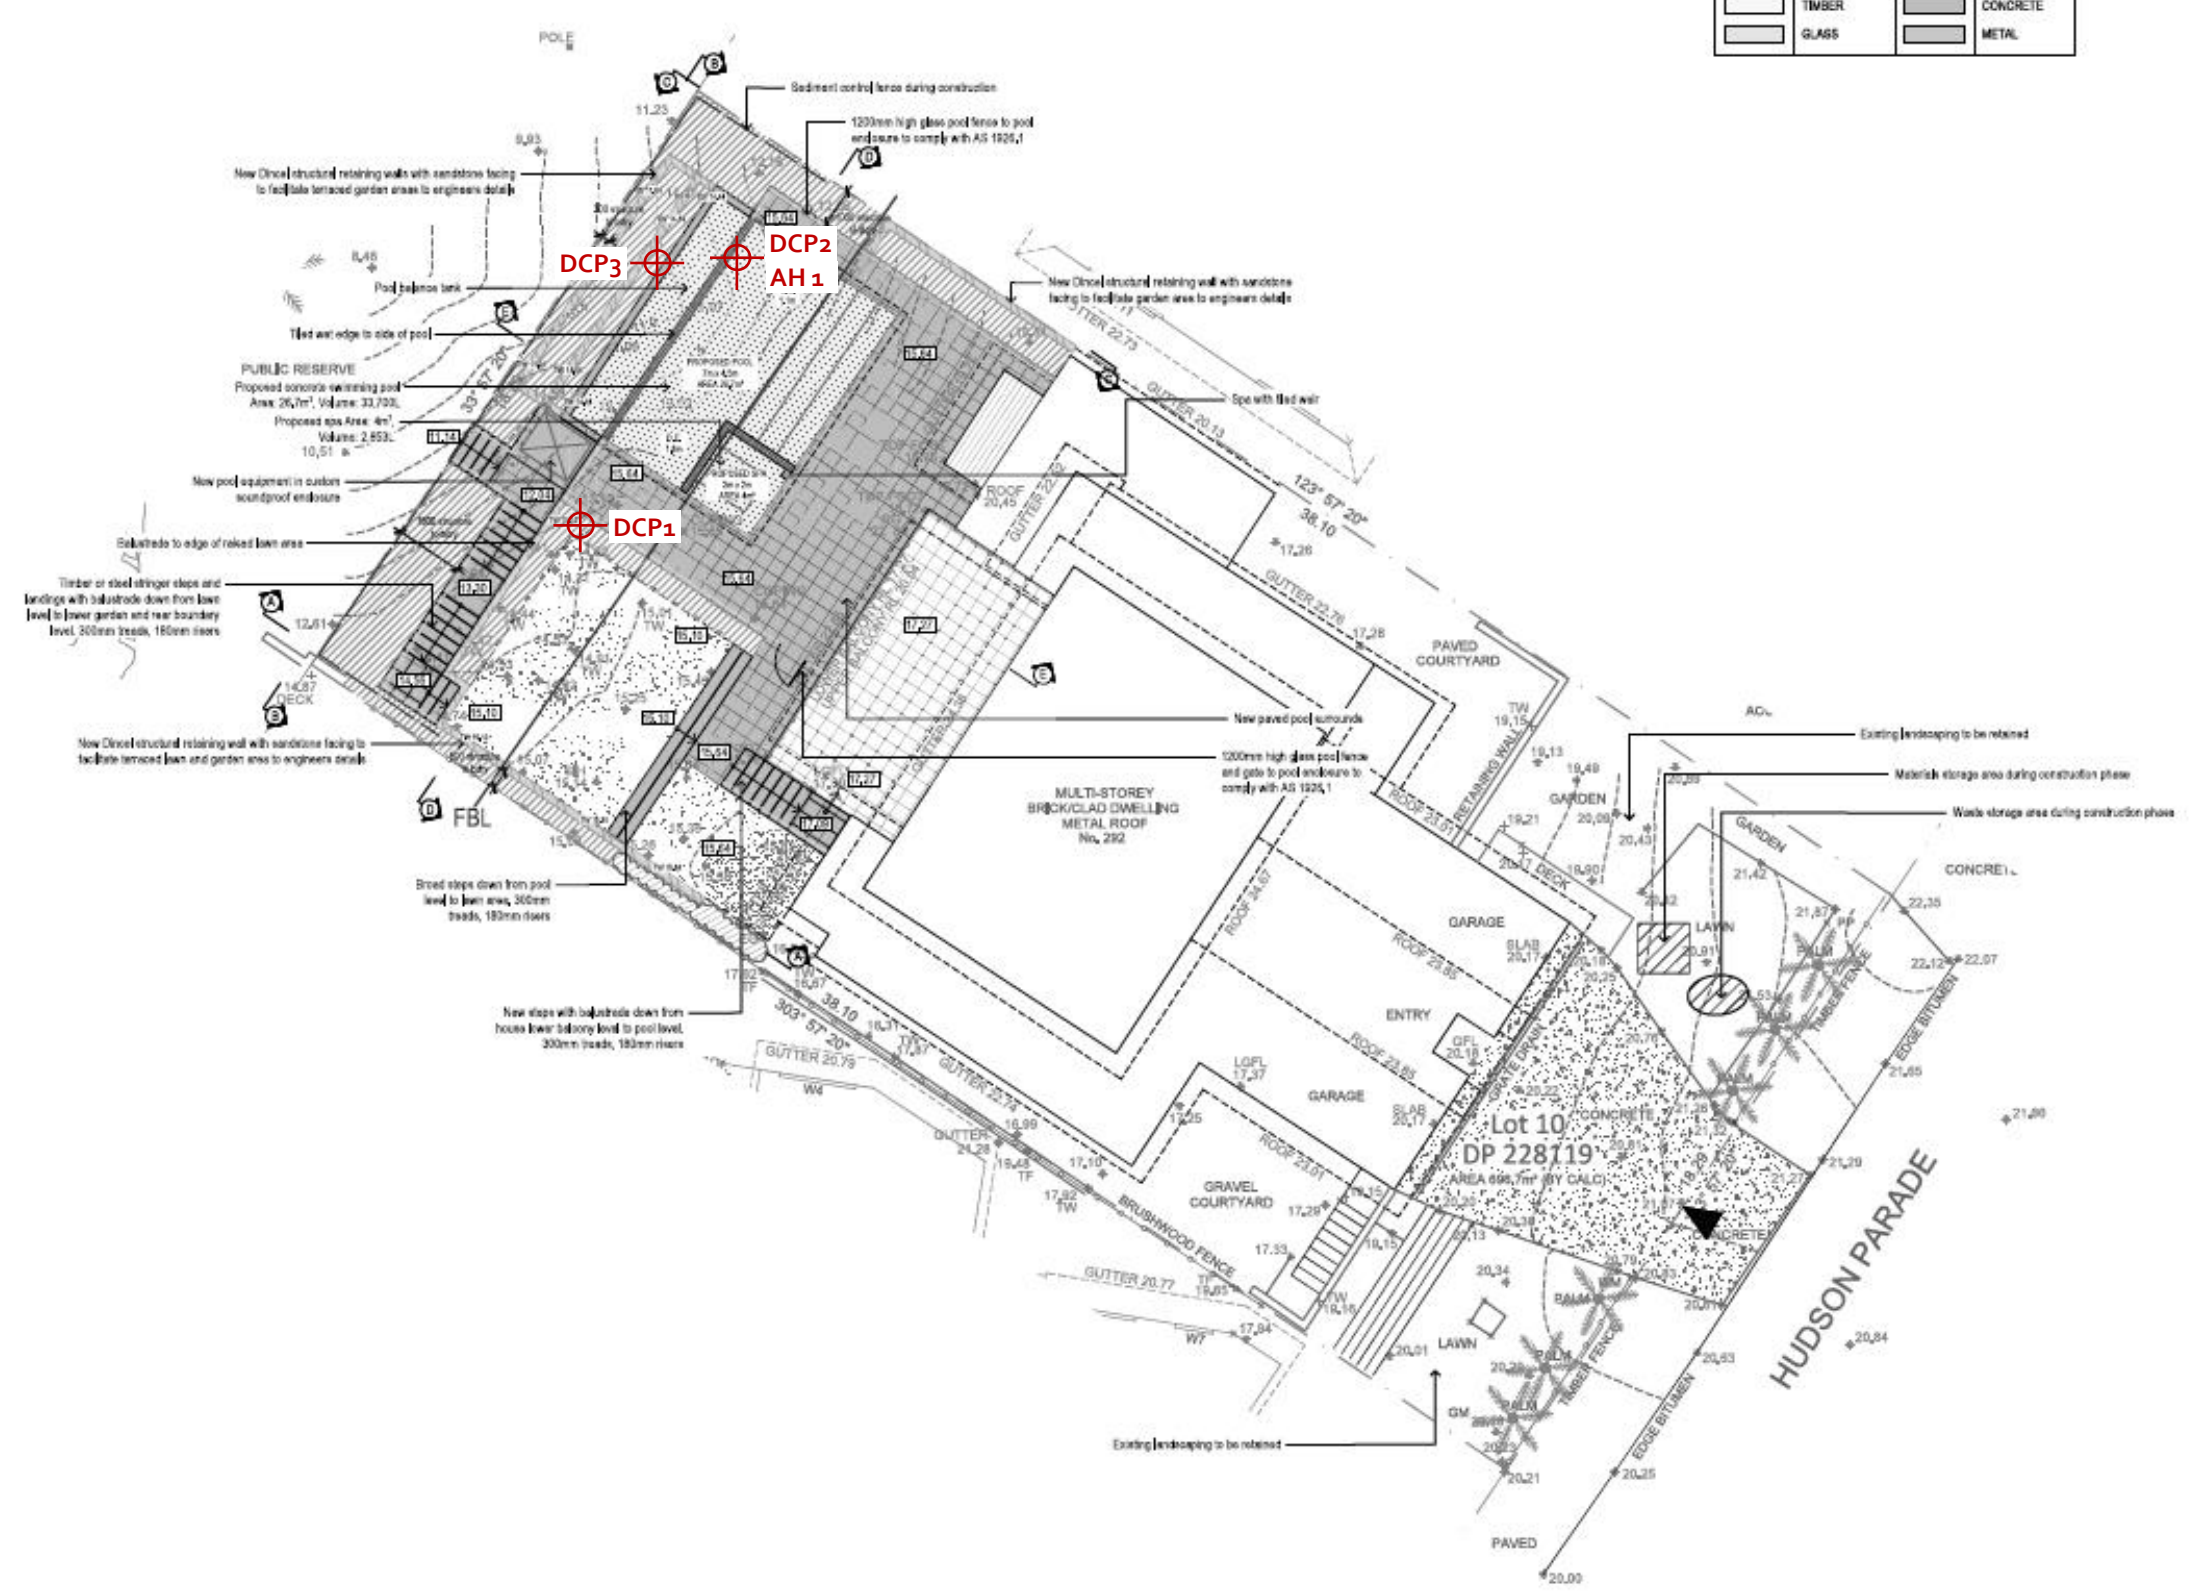
SITE PLAN – showing test locations

One hand Auger Hole (AH) was put down to identify the soil materials. Three Dynamic Cone Penetrometer (DCP) tests were put down to determine the relative density of the overlying soil and the depth to weathered rock. The locations of the tests are shown on the site plan attached. It should be noted that a level of caution should be applied when interpreting DCP test results. The test will not pass through hard buried objects so in some instances it can be difficult to determine whether refusal has occurred on an obstruction in the profile or on the natural rock surface. This is not expected to have been an issue for this site. But due to the possibility that the actual ground conditions vary from our interpretation there should be allowances in the excavation and foundation budget to account for this. We refer to the appended "Important Information about Your Report" to further clarify. The results are as follows:

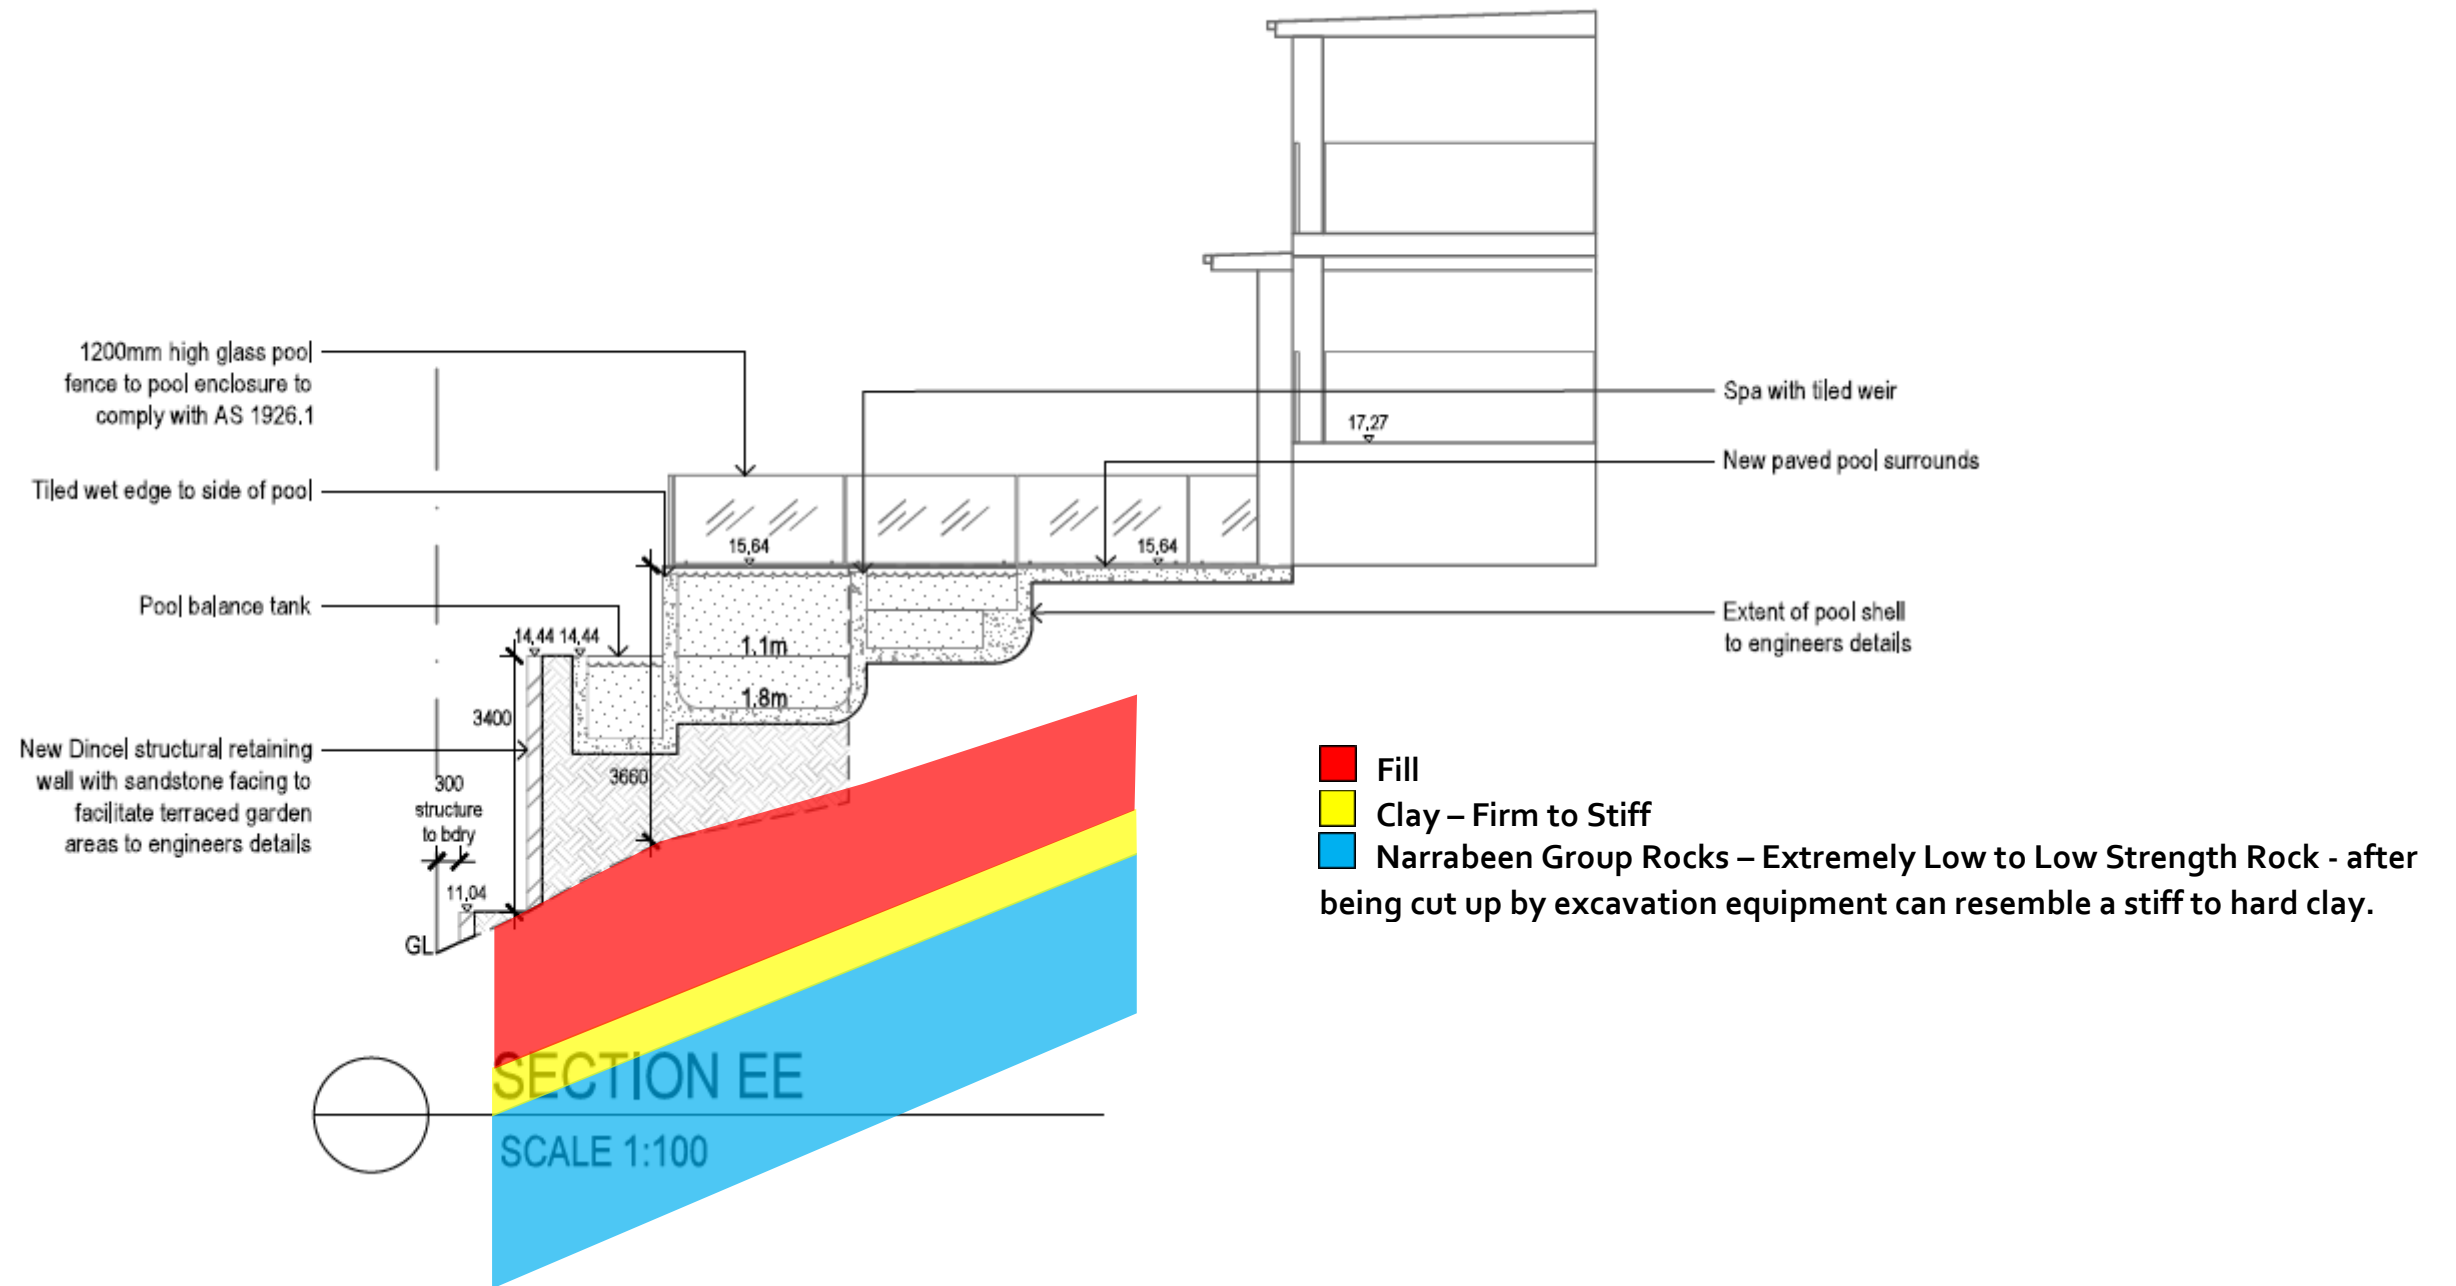
TYPE SECTION – Diagrammatical Interpretation of expected Ground Materials

The slope materials are colluvial at the near surface and residual at depth. In the test locations, the ground materials consist of fill and silty sand over firm to stiff clays. Fill to an estimated maximum depth of ~3.5m has been placed across the downhill side of the property. In the test locations, the clays merge into the weathered zone of the underlying rock at depths

of between ~1.5m to ~3.3m below the current surface, being deeper where the fill is deeper. The DCP tests bounced off the rock surface in all three tests. In this instance this does not provide a definitive answer on rock strength as the shale profile is known to have thin sandstone beds through the otherwise 'clay like' rock profile. Until the rock is excavated on site it is assumed the weathered zone of the underlying rock is Extremely Low to Low Strength Rock. It is to be noted that this material is a soft rock and can appear as a mottled stiff clay when it is cut up by excavation equipment. See Type Section attached for a diagrammatical representation of the expected ground materials.
