# Estuarine Risk Management Report for “Yamba”, 23 & 25-33 Robertson Road, Scotland Island, NSW 2105

<b>Authors:</b>	Dr David Wainwright
<b>Prepared For</b>	Sam Crawford Architects
<b>Version</b>	FINAL
<b>Date</b>	26/02/2020

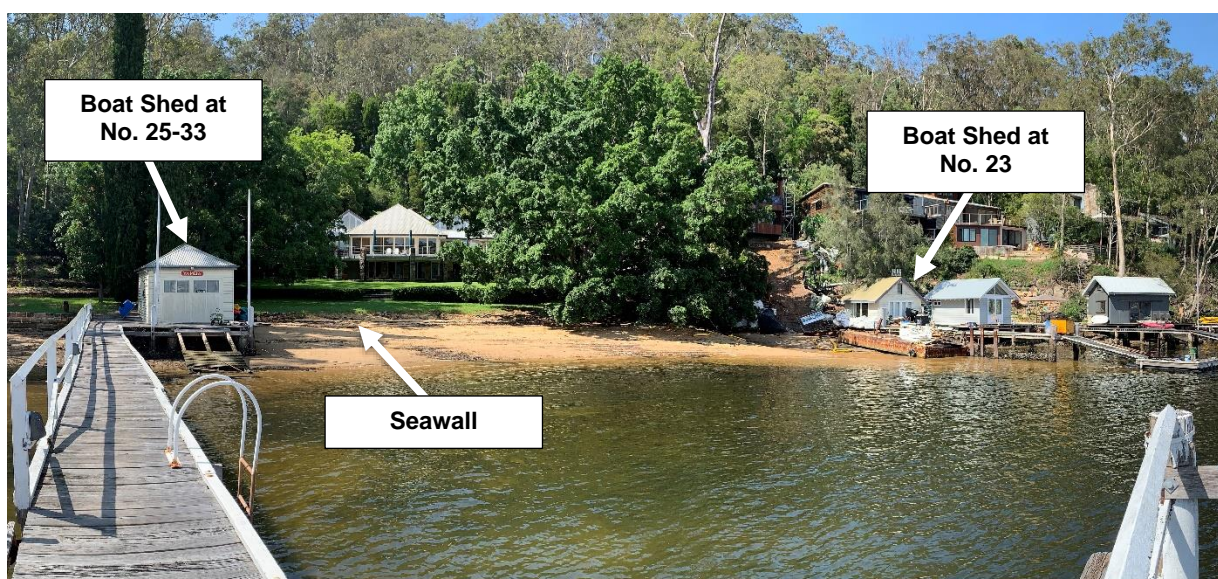
**Figure 4** Foreshore at "Yamba", 10:30am, 16 February 2020

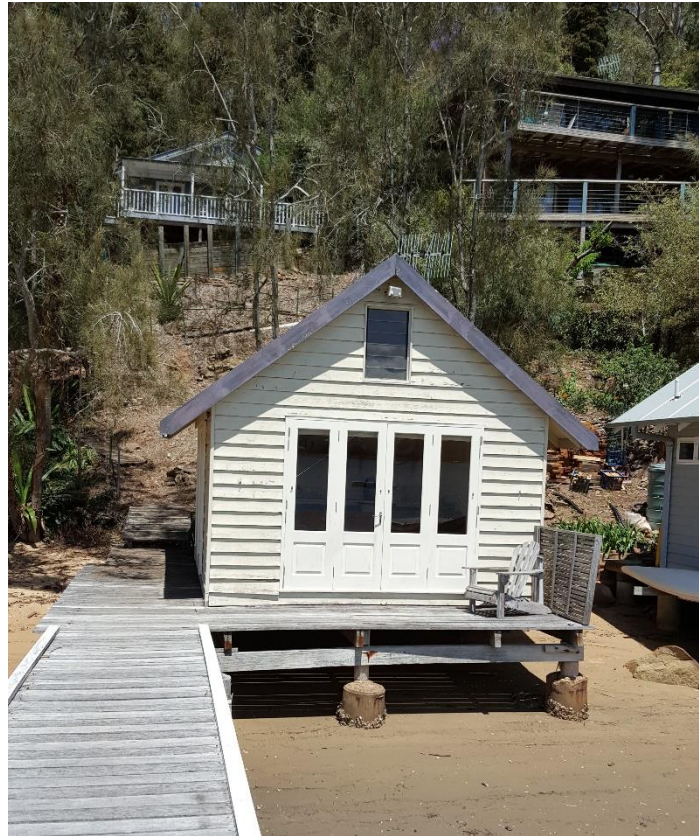
The boat shed at No. 23 (Figure 5 and Figure 6) is of weatherboard construction with a corrugated steel roof. Twin bifold doors are present at the front of the structure and sliding glass doors along its eastern side. The superstructure appears to be in reasonable condition, however, close inspection of the structure on 16<sup>th</sup> February 2020 was impeded by ongoing construction at the site. The substructure is of typical timber construction, comprising piers, headstocks, girders and planks. The timbers, particularly the decking planks, are weathered but appear serviceable. Most of the jetty and boat shed's piers have been encased in concrete and are heavily encrusted with oysters within the intertidal zone. The concrete encasement is likely provided to protect against deterioration caused by marine borers. Chainwire mesh has been attached to the eastern edges of the boat shed substructure, and along the eastern edge of the jetty, between the deck and the bed. The purpose of the chainwire is unclear, although it is encrusted with oyster shells in the intertidal zone and would reduce

wave energy and debris being carried across into the beach between the two boat sheds.

**Figure 5 View from Jetty, Onshore to Boat Shed, No. 23 Robertson Rd, Scotland Island, 31 October 2017**

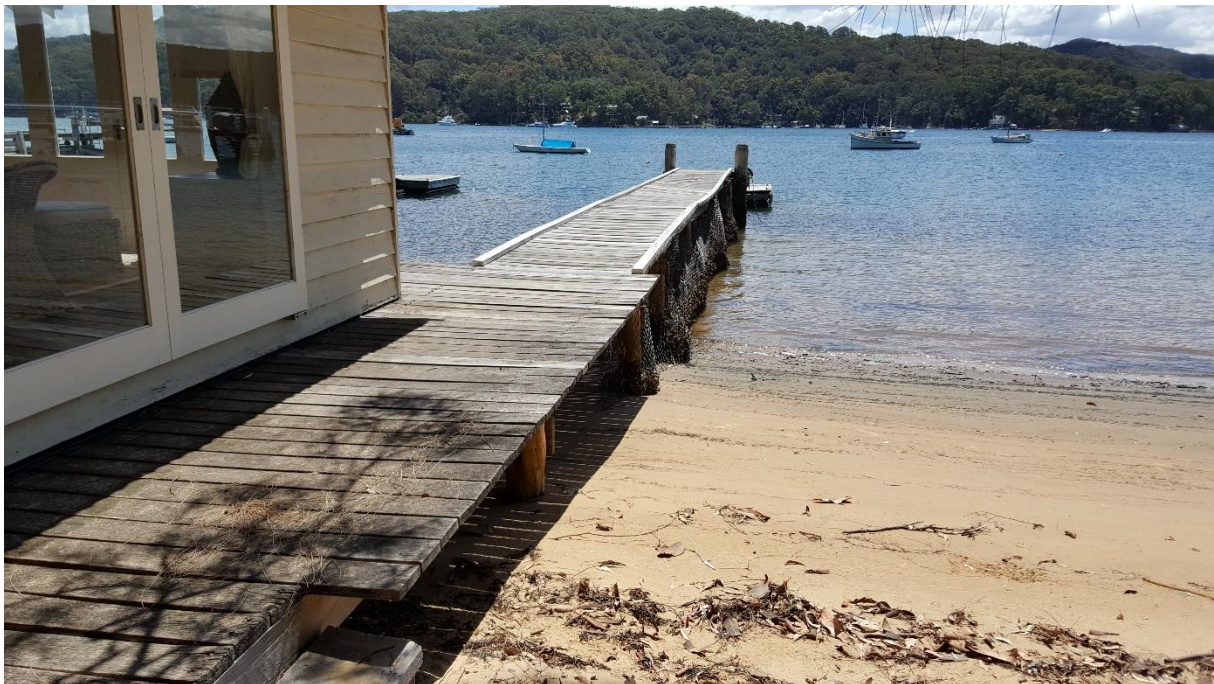
**Figure 6 View Offshore along eastern edge of Jetty, No. 23 Robertson Rd, Scotland Island, 31 October 2017**

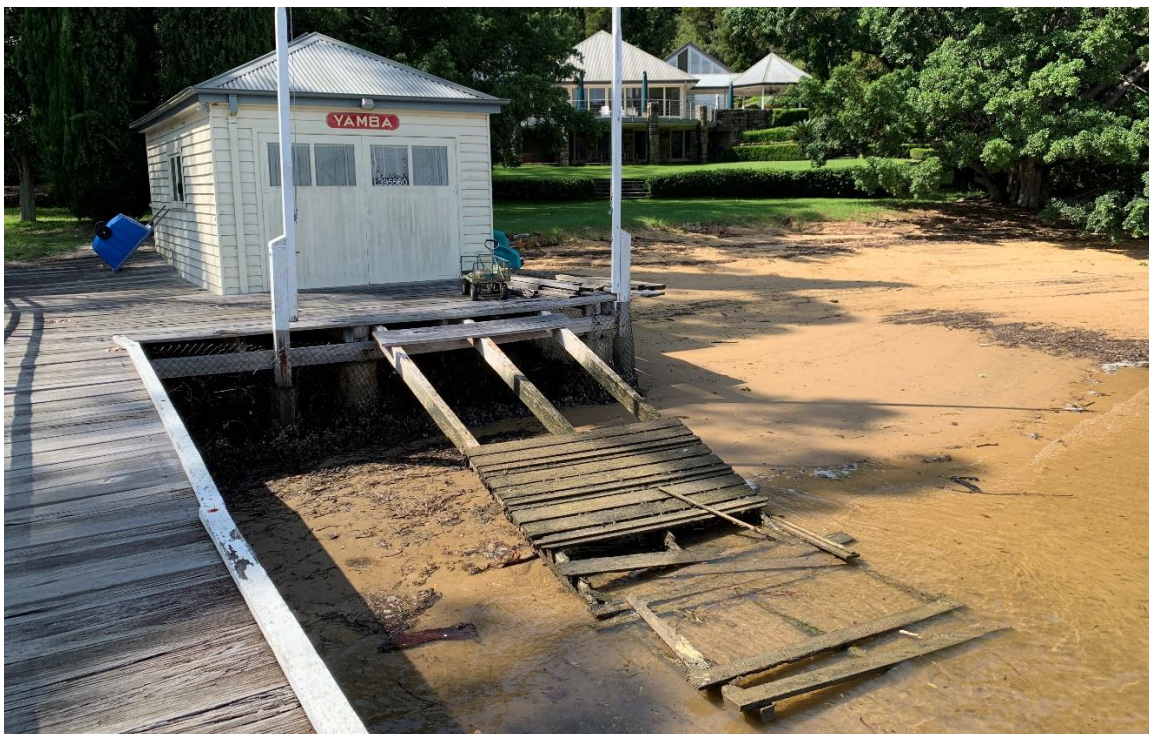
The boat shed fronting No. 25-33 (Figure 7 and Figure 8) is of weatherboard construction with a corrugated steel roof. Twin bifold doors are present at the front of the structure, along with a small window and shade sail along its eastern side. It appears that rainwater is collected from the roof of the structure and power is available through external weatherproof power points on the eastern wall. The interior of the structure was not inspected and, therefore, we are not able to provide comment on the existing provision of services and their appropriateness. The superstructure appears to be in reasonable condition. The substructure is of typical timber construction, comprising piers, headstocks, girders and planks. The timbers, particularly the decking planks, are weathered, and several planks are broken and/or loose. Most of the jetty and boat shed's piers have been encased in concrete within the intertidal zone and are heavily encrusted with oysters. The concrete encasement is likely provided to protect against deterioration caused by marine borers. A dilapidated timber boat skid is provided at the front of the walkway on the seaward edge of the boat shed. Most of the planks are missing from the skid and the piers holding the seaward end seem to have settled noticeably. Chainwire mesh has been attached to the western and northern edges of the boat shed substructure and along the western edge of the jetty, however, the mesh has become detached from the northern half of the jetty. The purpose of the chainwire is unclear, although it is encrusted with oyster shells in the intertidal zone and would reduce wave energy and debris being carried across into the beach between the two boat sheds.

**Figure 7 View from Jetty, Onshore to Boat Shed, No. 25-33 Robertson Rd, Scotland Island, 16 February 2020**

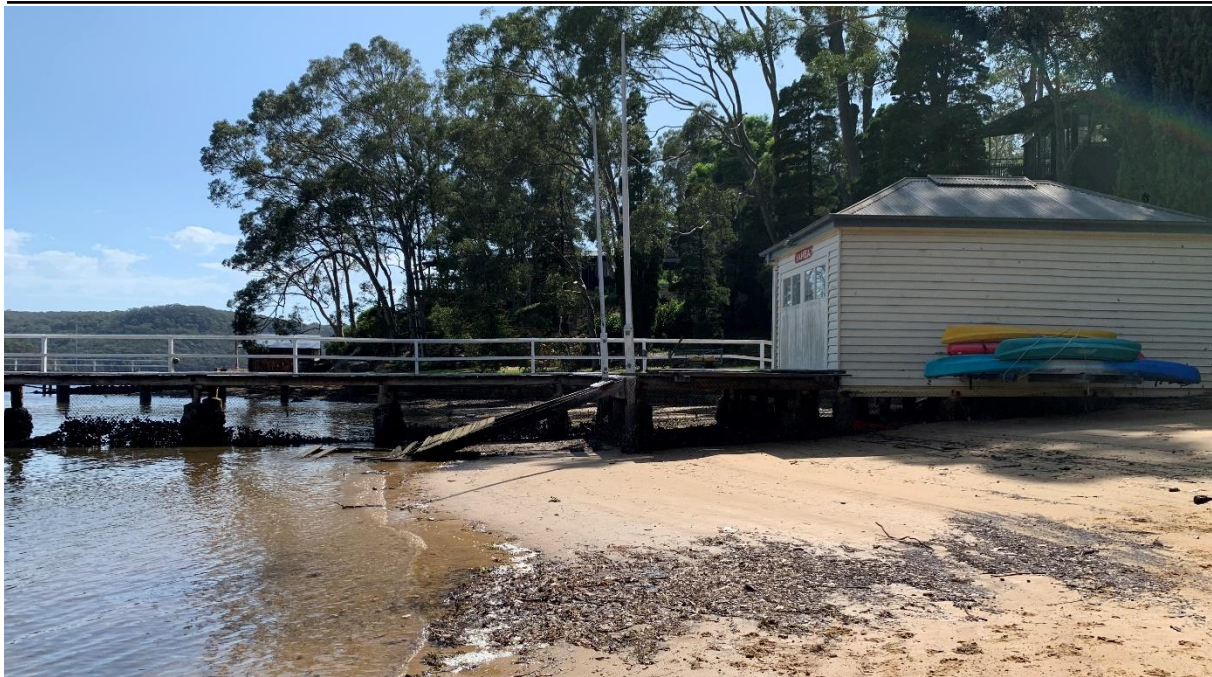
**Figure 8 Western side of Boat Shed, No 25-33 Robertson Rd, Scotland Island, 16 February 2020**

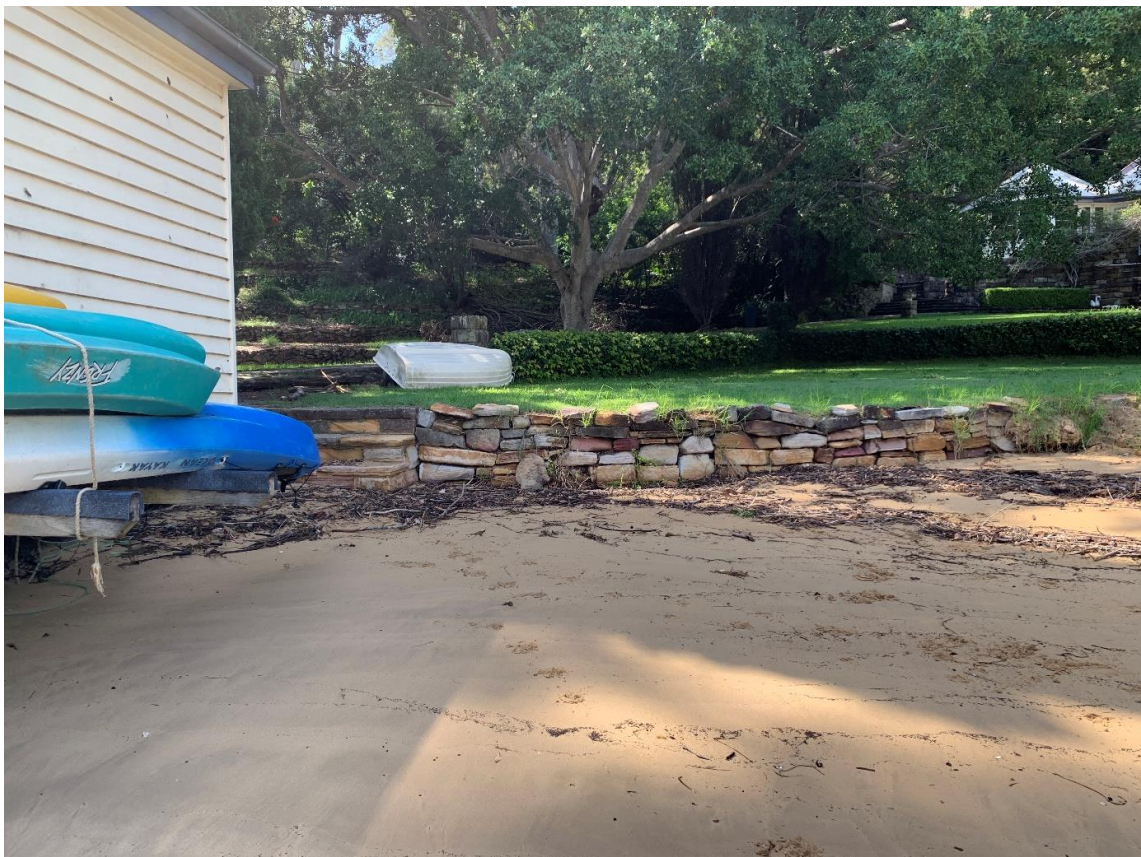
To the west of the stairs, a low, near vertical sandstone seawall demarcates the back of the beach for around 25m. When inspected on 16<sup>th</sup> February 2020, the eastern end of this seawall was around 500mm high above the sand level. Further to the west, the wall disappears below the sand, and the extent of the wall in this direction is uncertain. The beach surface at the eastern end of the beach comprises a flat berm of 5-10m extending seaward from the seawall, and a beach face slope of around 1 in 20. At the time of inspection in 2017, the width of the berm was noted to narrow and the beach to steepen slightly, with distance west. The variation in beach shape reflects slightly more exposure to wind waves from the north east with distance west along the beach.

The seawall is of non-cemented dry-stone construction comprising prismatic sandstones of, typically, 400 to 600mm alongshore by 100mm high by 200mm shore normal. By excavating pits in front of the seawall, the condition of the toe was determined. The wall contains a vertical section around 400-500mm high (4-5 stones) and a sloped “self-launching” toe of around 1m width at a slope of 1V:2H. The entire structure appears to be founded on a gravel base. Accordingly, the seawall is around 1m high. Considering surveyed elevations of the top of the wall, this places the toe at around 0.6 to 0.7m AHD.

**Figure 9**      **Back Beach Seawall, 25-33 Robertson Rd, Scotland Island**

The seawall is in reasonable repair and is suitable for its present purpose. However it is likely that the seawall provides more of a landscaping function (demarcation of beach from lawn) than any protective function at present. Over time, with sea level rise, some lowering of the beach may occur, and overtopping of the back of the beach may begin to occur more frequently. These actions will likely begin to test the structural integrity of this wall; however, a reasonable degree of thought has gone into the engineering of this structure and it may prove robust for some time into the future. Regardless, there is plenty of space for the optional landward relocation of the seawall (to maintain sandy beach width), and other options, including re-armouring with larger stone and/or raising the seawall, remain possible. Given the small scale of the seawall, ongoing monitoring following any significant storms and repair as necessary is an appropriate management strategy for the seawall. Future adaptation of the structure can be considered if it becomes necessary in future.

As part of this assessment, we have also considered the condition of the existing foreshore seawall. The wall appears to be in reasonable condition, although it is prone to attack during elevated water levels. Future conditions may test its integrity as sea levels rise. There exist potential adaptation options that could be applied to this seawall in future, if the need for repairs becomes too frequent. The need for such adaptation actions will not be affected by the proposed boat shed modifications.

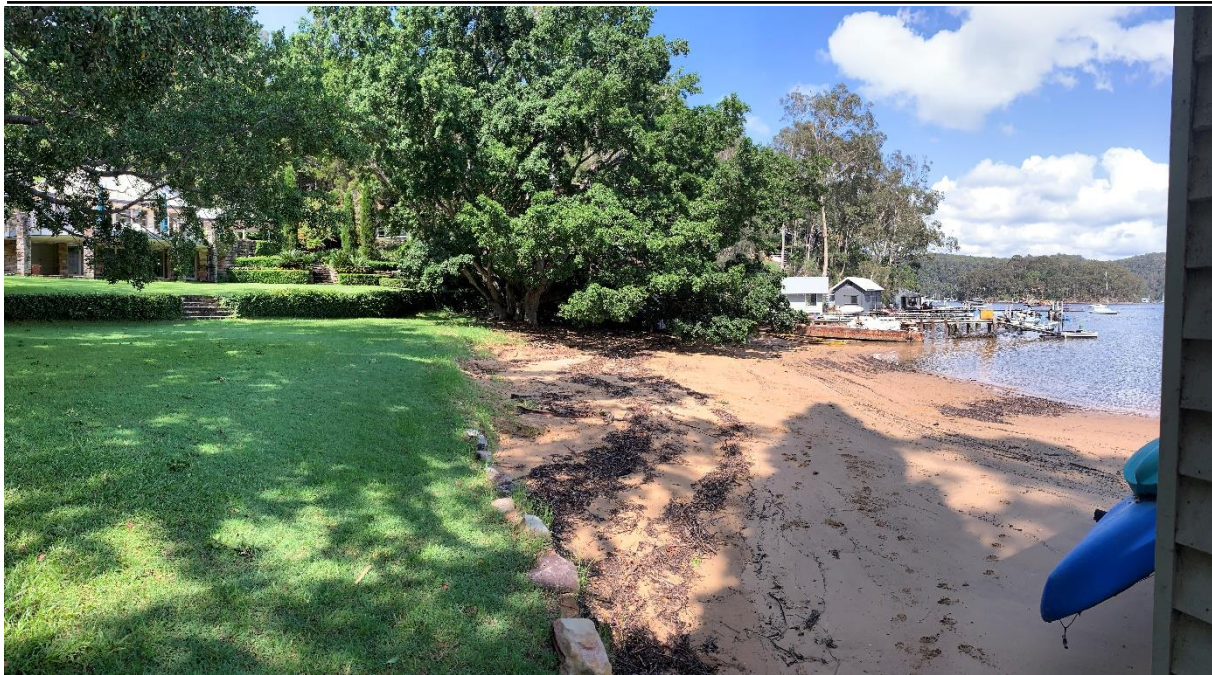
**Figure 10 Back Beach Seawall, 25-33 Robertson Rd, Scotland Island (view towards west)**
