**GEOTECHNICAL RISK MANAGEMENT POLICY FOR PITTWATER
FORM NO. 1 – To be submitted with Development Application**

Development Application for _____	Name of Applicant _____
Address of site <u>11 ADDISON RD, INCLISIDE</u>

REPORT TO
MATTHEWS FAMILY

ON
GEOTECHNICAL ASSESSMENT
(In Accordance with Pittwater Council Risk
Management Policy)

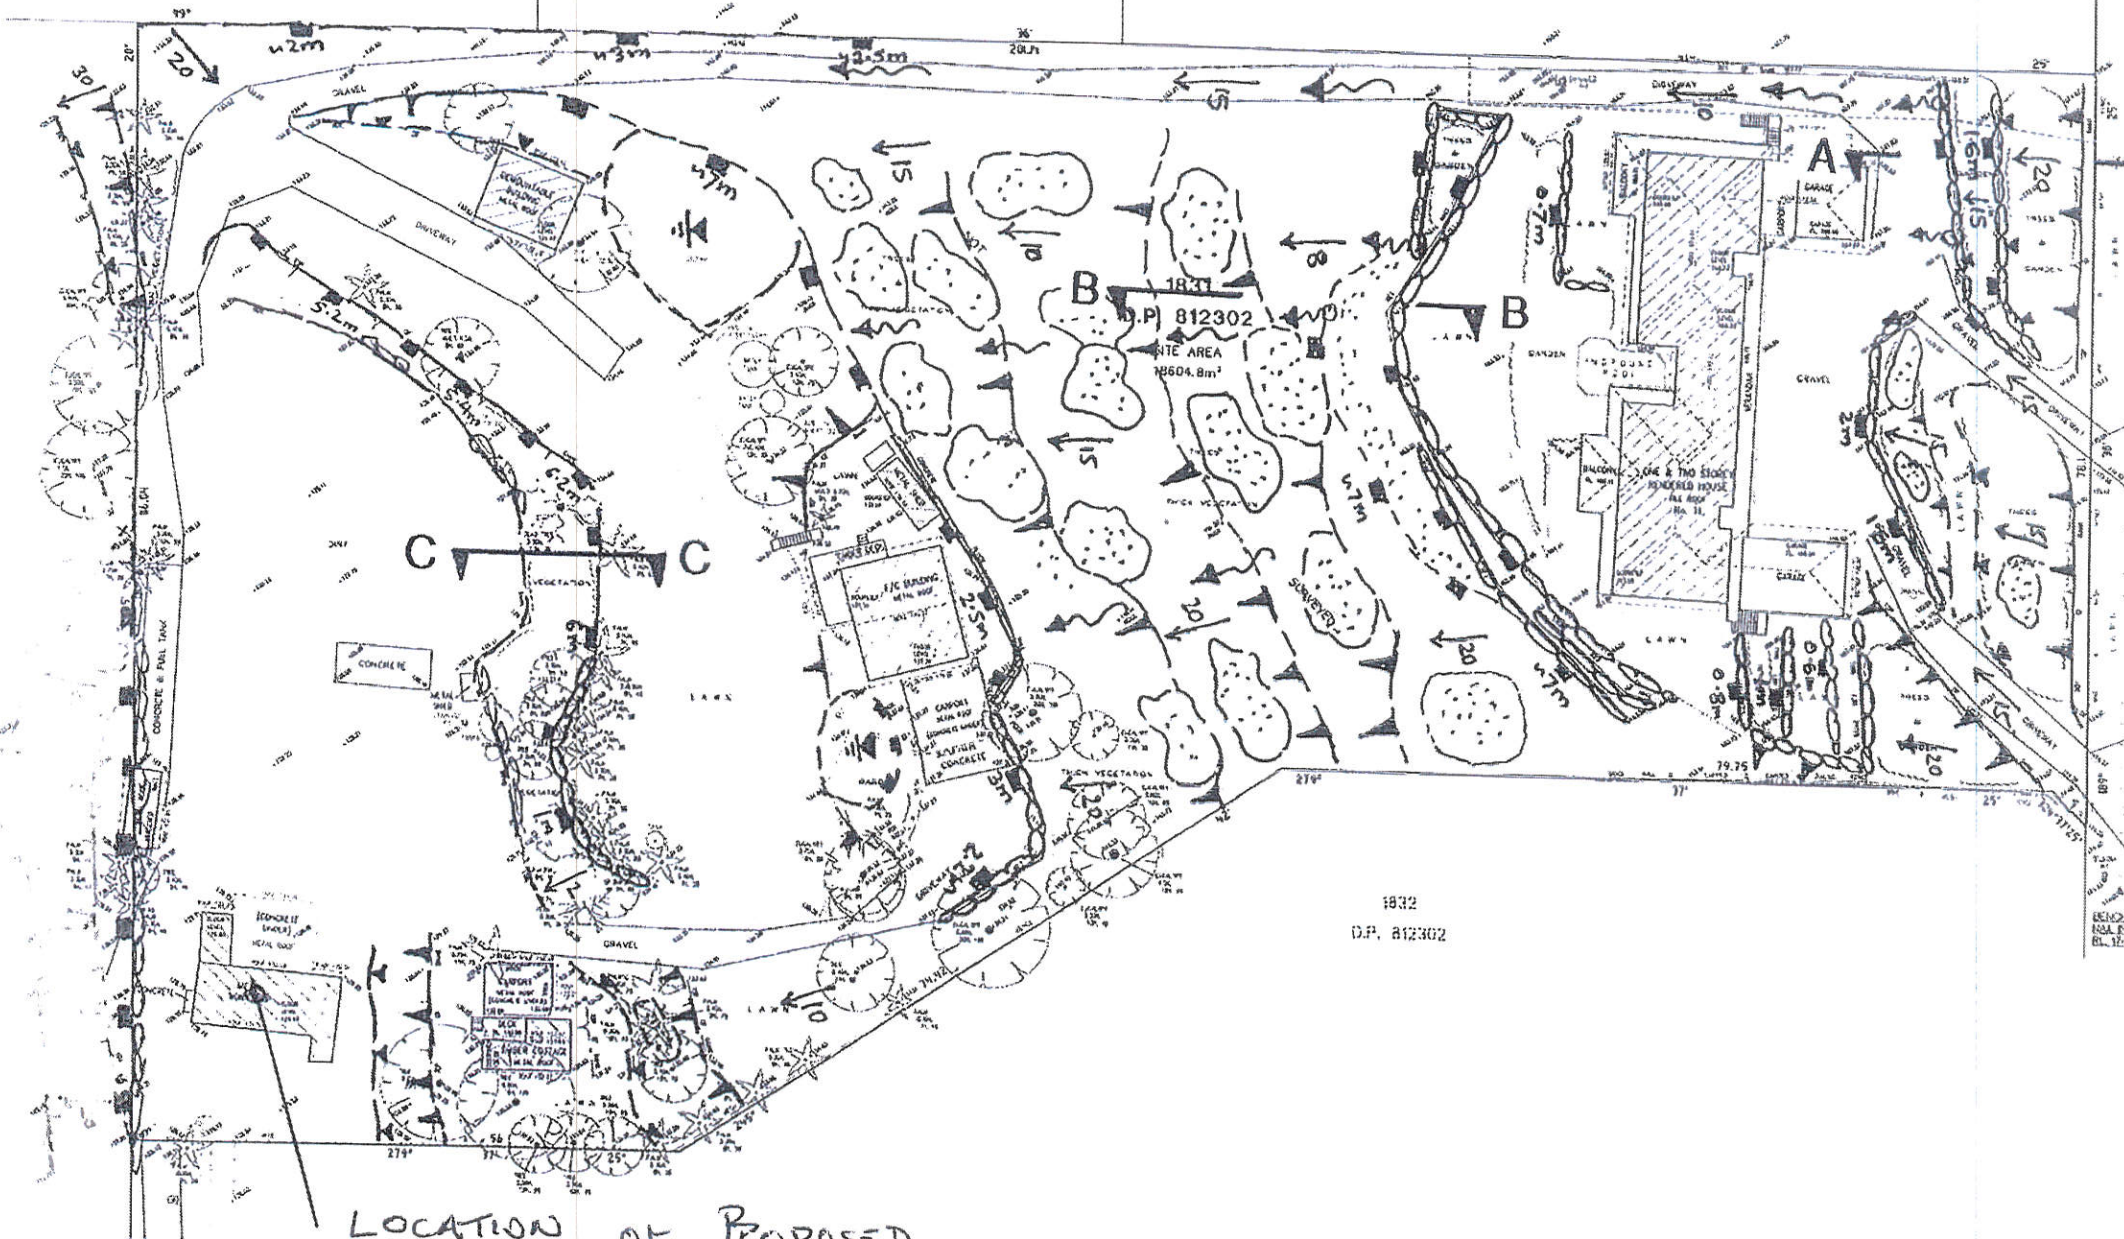
GEOTECHNICAL PLAN

The attached Figure 2 presents a geotechnical sketch plan showing the principal geotechnical features present at the site. Figure 2 is based on the survey plan (ref 6384 G-01, Sheet 1 of 2, dated 24-4-2013) prepared by Bee and Lethbridge Pty Ltd. The survey datum is the Australian Height Datum (AHD). Additional features on Figure 2 have been measured by hand held inclinometer and tape measure techniques and hence are only approximate. Should any of the features be critical to any proposed works, we recommend they be located more accurately using instrument survey techniques. Figure 4, 5, and 6 present typical cross-sections through portions of the site based on the survey data augmented by our mapping observations.

LOCATION OF PROPOSED NEW SHED.

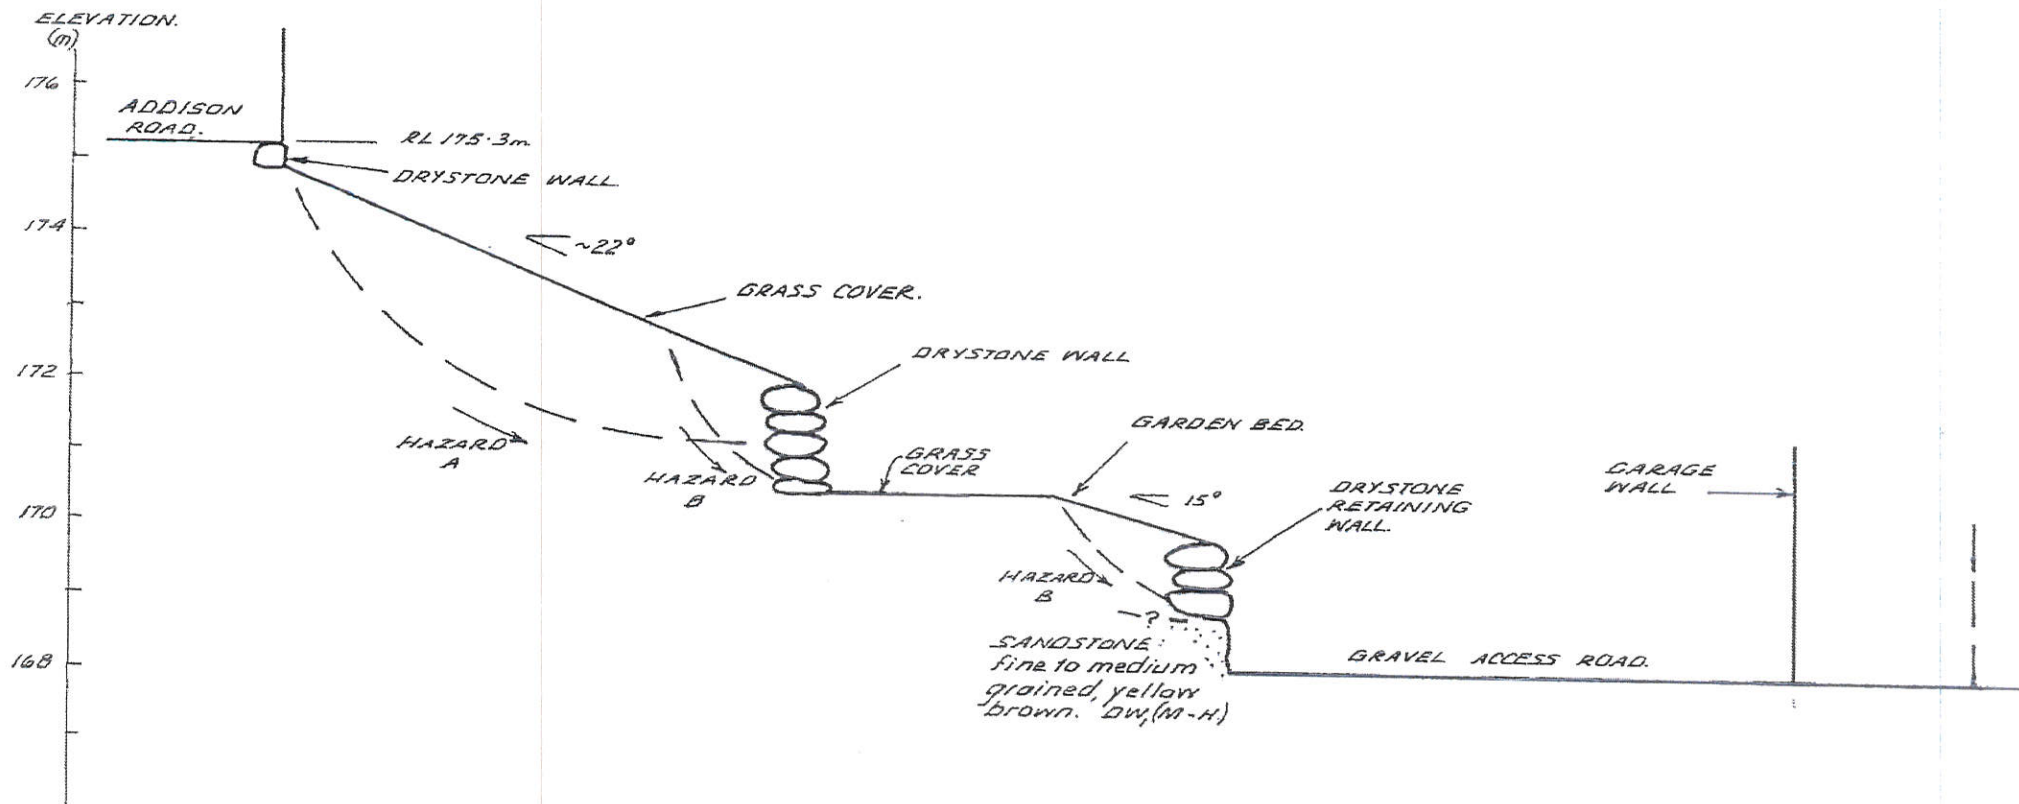
CROSS SECTIONAL SKETCH A-A

- The front yard to the east is characterised by gently sloping vegetated benches supported by variable height drystone walls, together with a sub-vertical sandstone cut face of maximum 2m height. Seepage was noted at the base of sandstone cut face along the bedding partings. The area between the existing house and the sandstone cut face comprises a level surface covered by gravel and forms part of the driveway. Figure 4 shows a typical cross-section through this portion of the site.

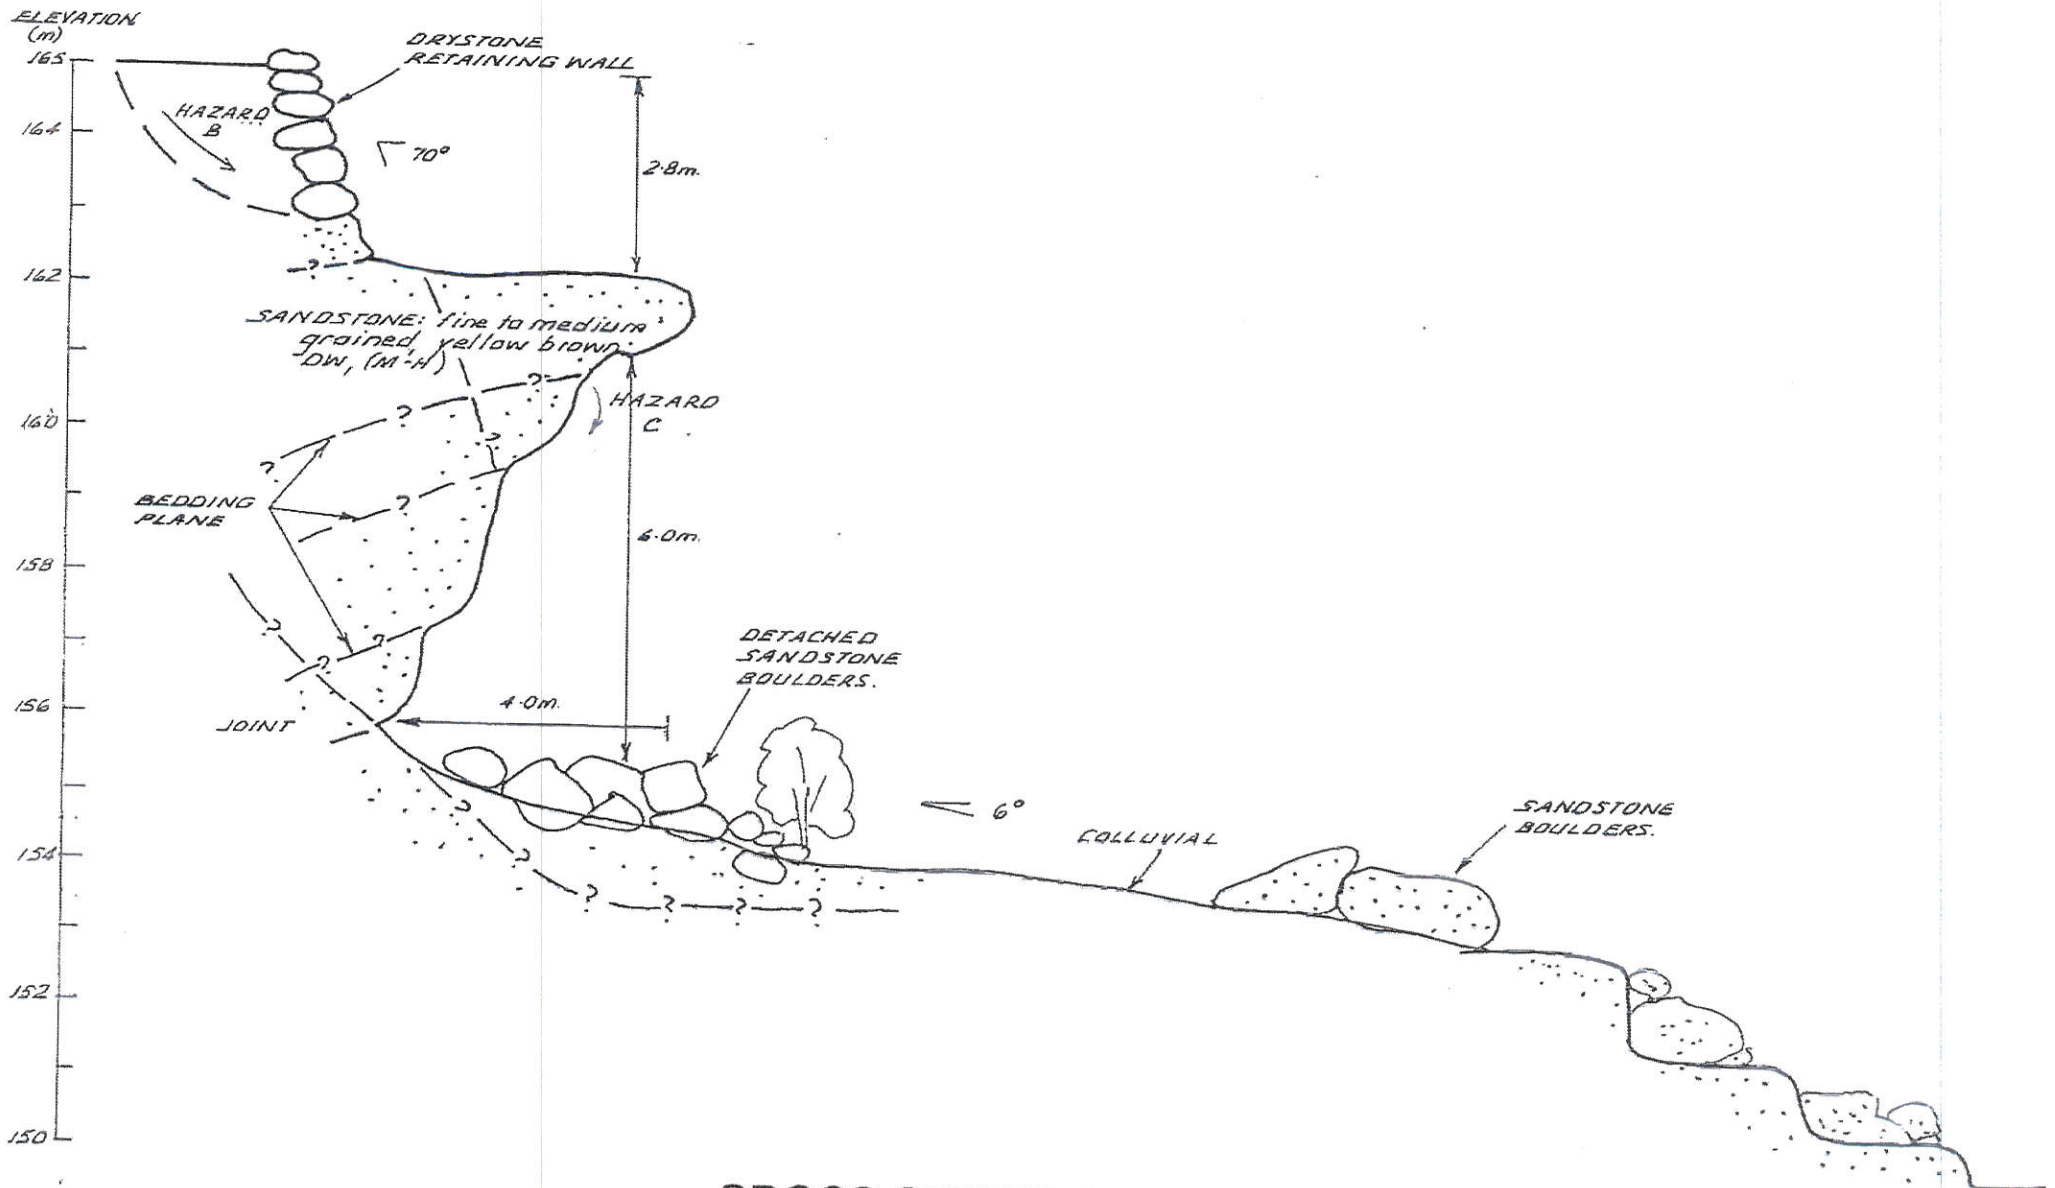
CROSS SECTIONAL SKETCH B-B

- The area immediately to the west of the house (in the rear yard) appears to have been levelled by cutting and filling. This portion of the site is retained by a loosely packed drystone wall about 2.8m maximum height and is founded behind the crest of a sandstone cliff line oriented generally north-south. The cliff line varies in height from about 2m to 7m.

overhang feature. Groundwater seepage was noted at the toe of the cliff line through the intersecting bedding partings and joints. Much of the cliff line toe area had been cleared of undergrowth.

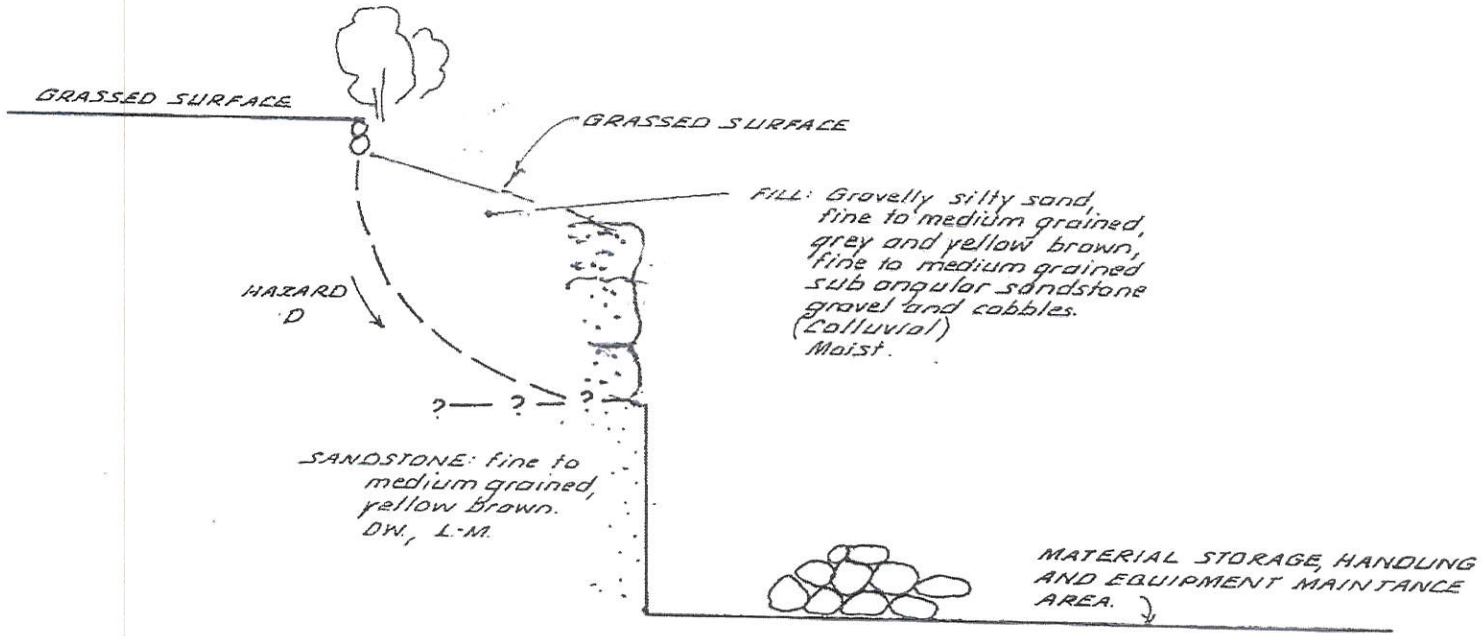
CROSS SECTIONAL SKETCH C-C

- The lower western bench area is a relatively level gravel surface and is occupied by a metal clad workshop, a timber building and a metal carport along the southern boundary. Two small water storage tanks and a metal shed are located adjacent to the cut face over the mid-eastern section. Some portions of the cut face within this area of the site exposed colluvium and/or gravelly sandy fill over sandstone bedrock. The fill/colluvium is supported by large sandstone and concrete blocks up to 4m high. These retaining walls appeared to be in good condition. The lower bench area is mainly used for storage of heavy earth moving equipment.
