GEOTECHNICAL INVESTIGATION:

Alterations and Additions at 5 Kooloora Avenue, Freshwater

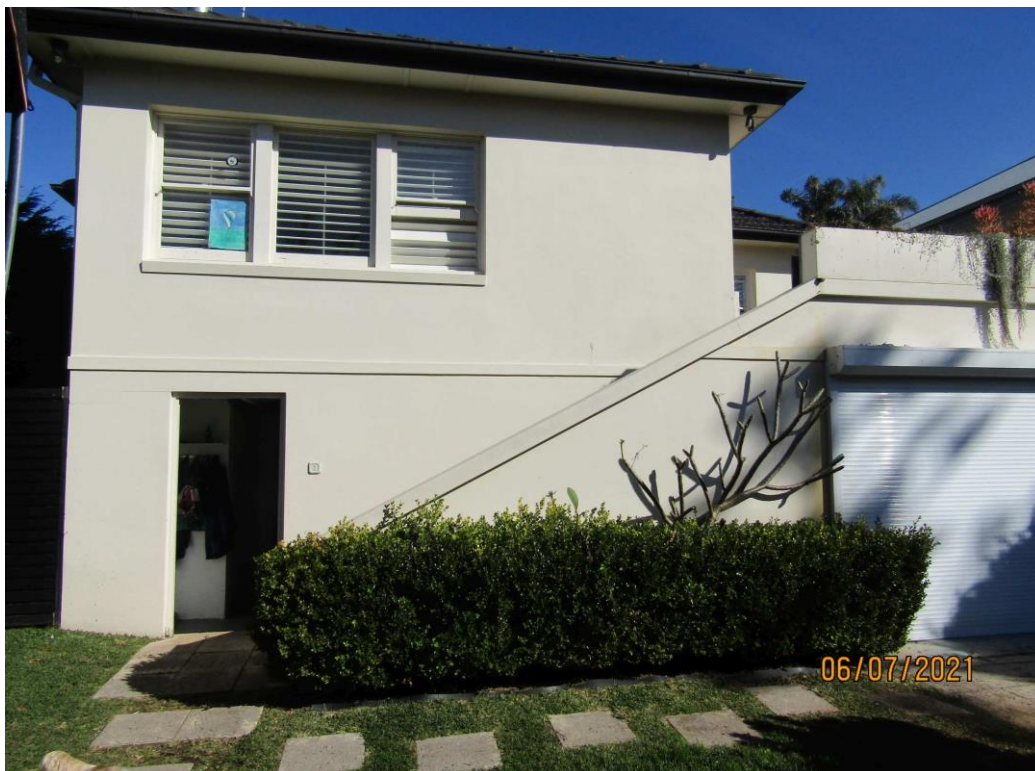
Photo 2

two storey rendered brick house is supported by brick walls, brick piers and steel posts (Photos 2 & 3). The supporting walls, piers and posts stand vertical and show no significant signs of movement (Photo 4). A near level lawn and paved area extends off the uphill side of the house (Photo 3). No signs of slope instability were observed on the property. The adjoining neighbouring properties were observed to be in good order as seen from the street and subject property.

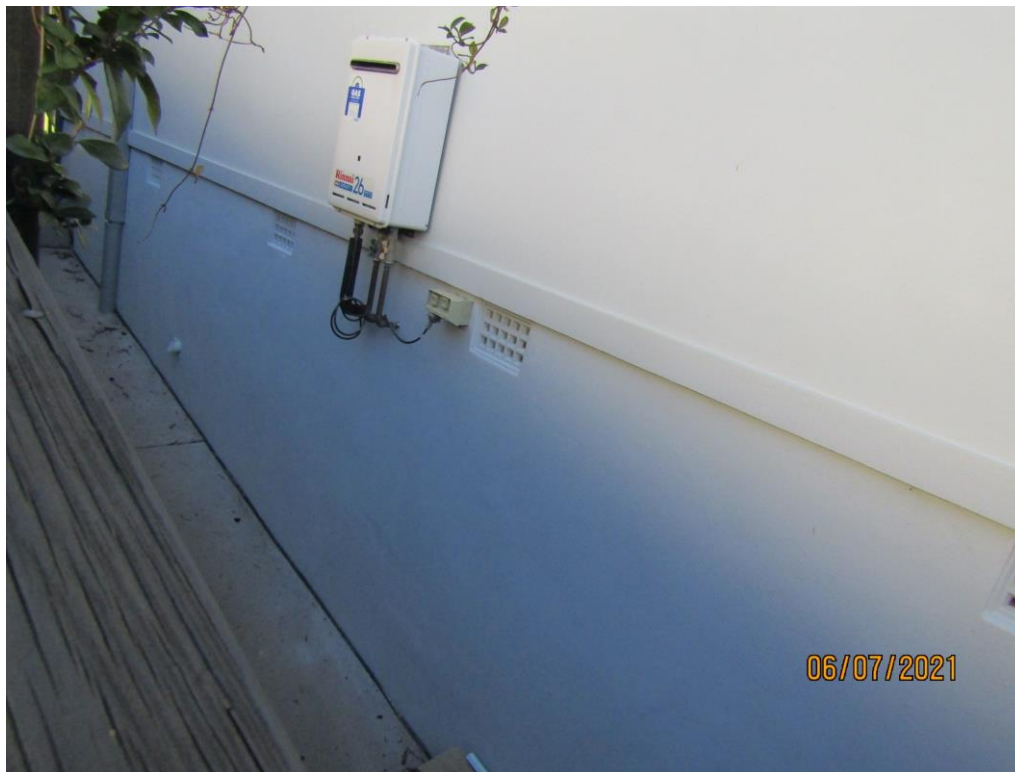
Photo 5

retaining walls are in place (**Hazard One**). The proposed lower ground floor excavation undercutting the subject house, NW neighbouring concrete pathway (Photo 5) and NW neighbouring house (Photo 5) is a potential hazard (**Hazard Two**). The proposed excavation for the pool undercutting the existing low rendered masonry retaining wall (Photo 6), Rendered masonry boundary fence/retaining wall (Photo 7) and SW neighbouring pathway (Photo 8) is a potential hazard (**Hazard Three**).

- ~2.0m from the NW neighbouring house and ~0.6m from the NW neighbouring concrete pathway (Photo 5).

The subject house, NW neighbouring house and NW neighbouring pathway will be within the zone of influence of the excavation. In this instance, the zone of influence is the area above a theoretical 30° line through soil/sand and a 45° line through clay/weathered rock from the base of the excavation towards the surrounding structures and boundaries.

The structures supporting the existing house (within the zone of influence of the excavation) are to be propped or underpinned to beyond the zone of influence of the excavation, prior to the excavation commencing.

It is recommended a secant or contiguous pile wall be constructed along the NW side and SW side of the excavation where underpinning is not required before the excavation commences. See the Lower Floor Plan attached for the minimum extent of the required shoring shown in blue. Secant piers are the preferred option but if contiguous piers are used, the gaps between the piers are to be grouted closed as the excavation is lowered so no material moves through the wall. The piers can be temporarily supported by bracing and/or embedment below the base of the excavation but are to be tied into the house structure during construction.

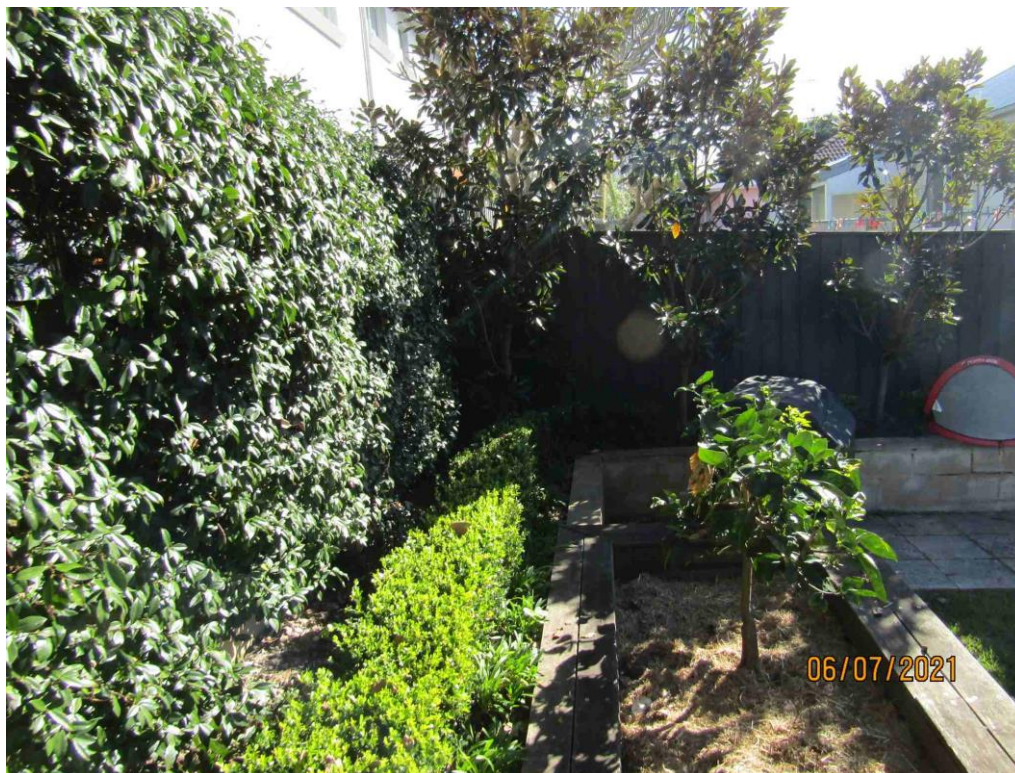
Photo 6

- Flush with a low rendered masonry retaining wall on the subject property (Photo 6).
- ~1.3m from the SW rendered masonry boundary fence/retaining wall (Photo 7) and ~1.5m from the SW neighbouring pathway (Photo 8).
- ~1.0m from the NW common boundary.

The low retaining wall, SW boundary fence, SW neighbouring pathway and NW common boundary will be within the zone of influence of the excavation.

1. If the low rendered masonry retaining (Photo 6) is to remain, it is to be underpinned to the base of the excavation, prior to the excavation commencing.
2. If the low rendered masonry retaining is to be demolished, ground support will be required for the SW cut and temporary pool shoring will be required for the NW cut. A secant or contiguous pile wall is recommended for the SW cut as per the recommendations for the lower ground floor excavation. For ease of design and construction it may be considered desirable to pile the entire excavation perimeter.

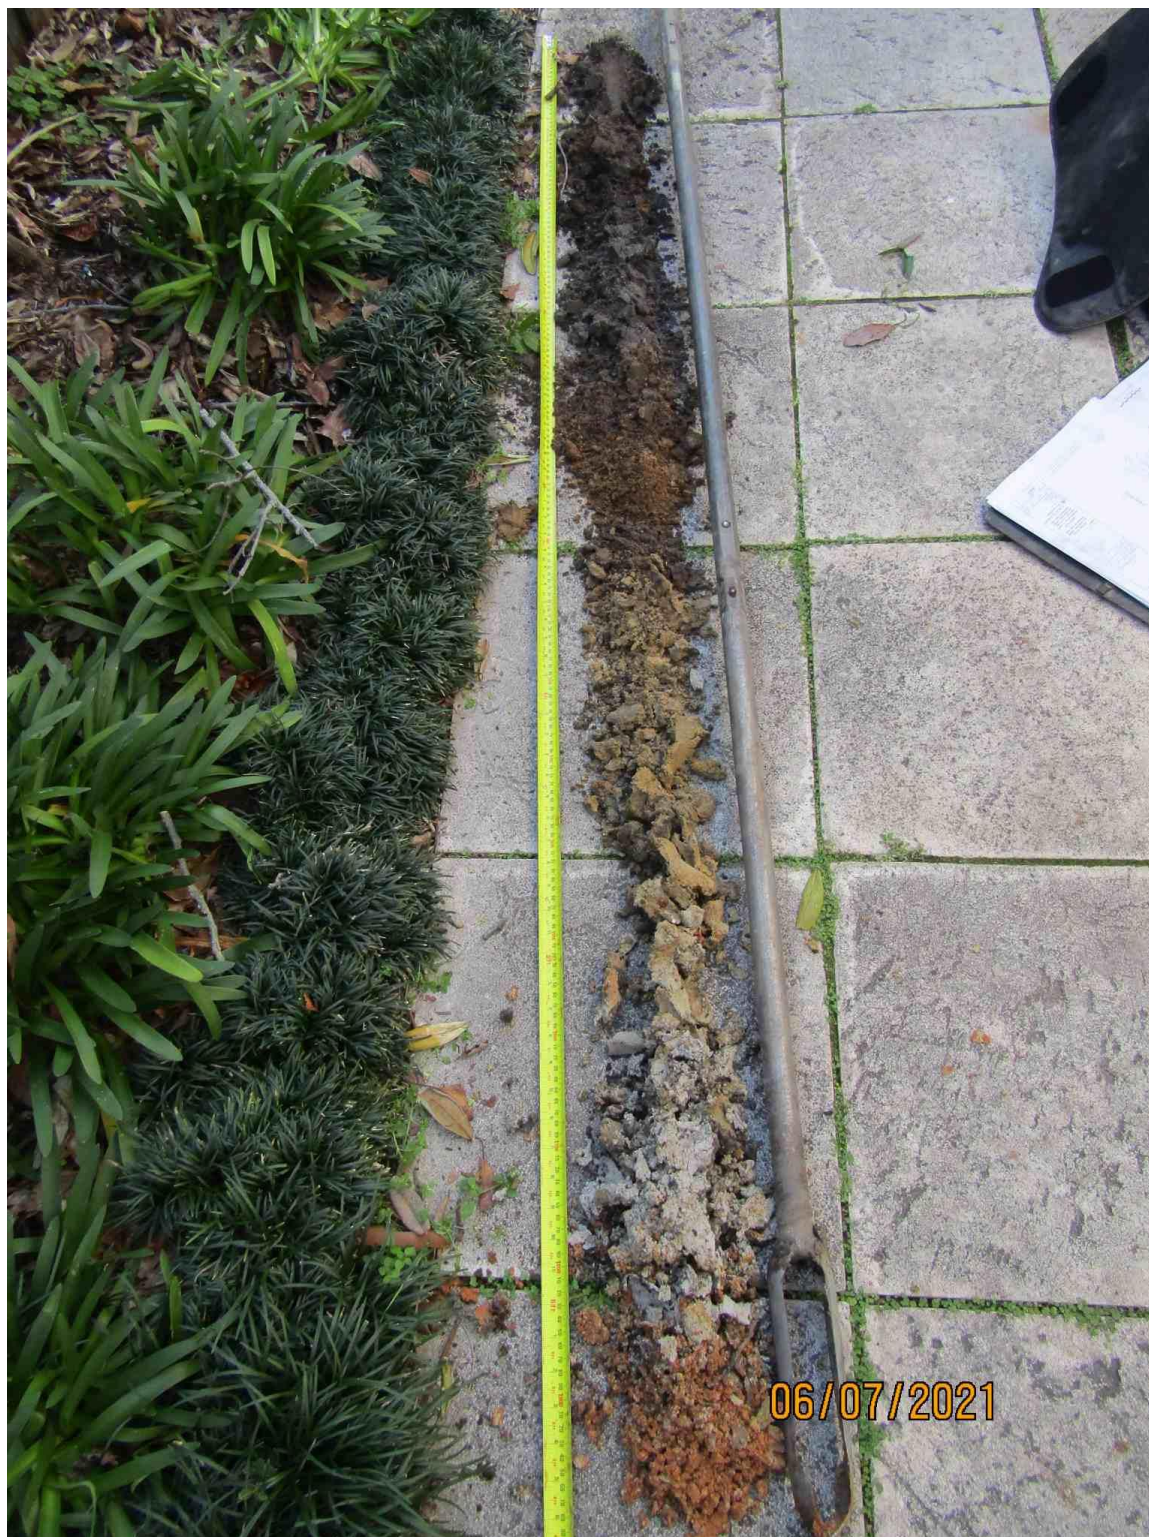
AUGER HOLE 1 (~RL8.4) – AH1 (Photo 9)

Depth (m)	Material Encountered
0.0 to 0.4	TOPSOIL , sandy soil, dark brown, damp, fine to medium grained with fine trace organic matter.
0.4 to 1.0	SILTY SAND , dark grey and brown, moist, loose to medium dense, fine to medium grained.
1.0 to 1.4	SAND , light orange brown, damp, medium dense, medium grained.
1.4 to 1.8	SANDY CLAY , light brown and light grey, firm, moist to damp.
1.8 to 2.0	SANDY CLAY , derived from Very Low Strength Sandstone, orange, moist, sugary texture.

End of Hole @ 2.0m in sandy clay. No watertable encountered.

Photo 9: AH1 – Downhole is from top to bottom.

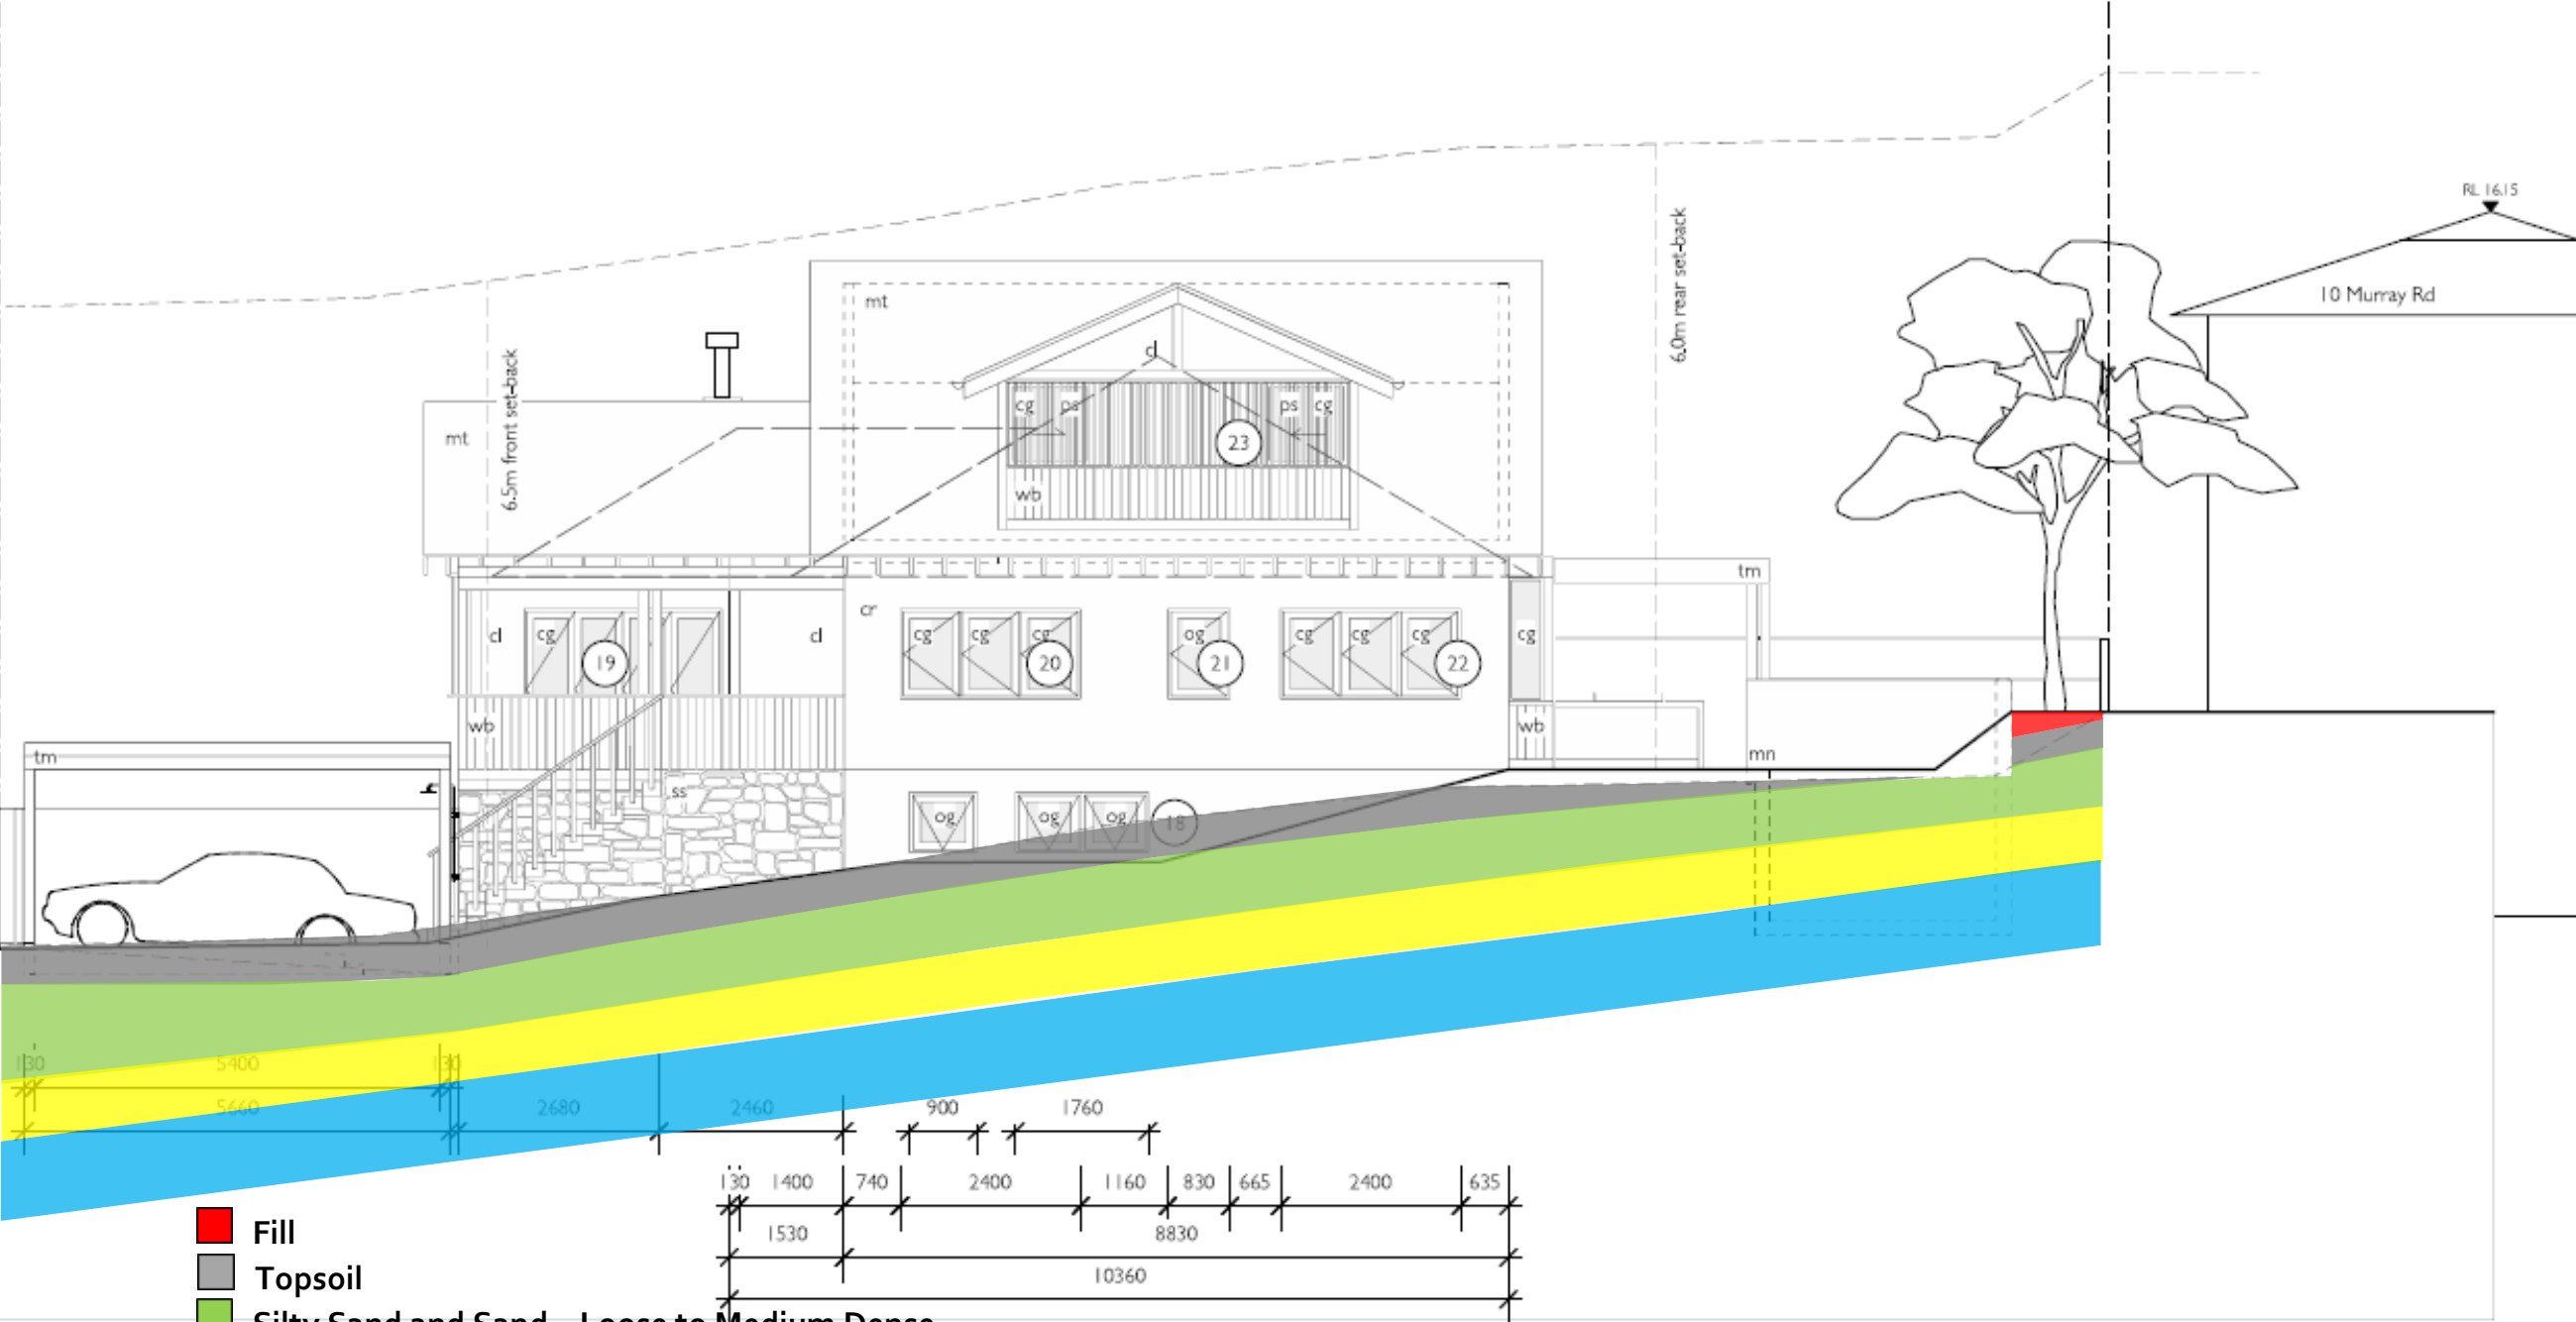
TYPE SECTION – Diagrammatical Interpretation of expected Ground Materials

In the test locations, the ground materials consist of a sandy topsoil, Loose to Medium Dense silty sand and Medium Dense sand over sandy clays. The clays merge into the underlying weathered rock at depths from between ~2.1m to ~2.4m below the current surface. The weathered rock is interpreted to be Very Low Strength Rock or better. See Type Section attached for a diagrammatical representation of the expected ground materials.

Fill
Topsoil
Silty Sand and Sand – Loose to Medium Dense.
Sandy Clay
Very Low Strength Rock or better.
