## **PRELIMINARY GEOTECHNICAL ASSESSMENT:**

### **40 Crown Road, Queenscliff**

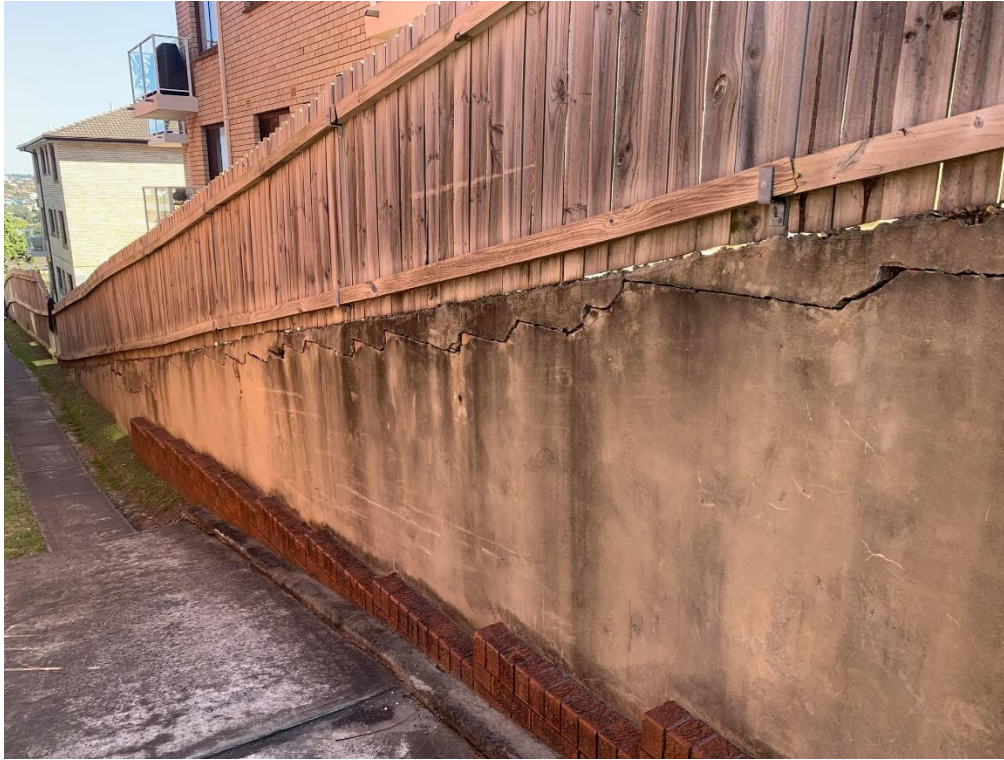
*Photo 1*

There is minor cracking that extends down the first few courses of the brick boundary retaining wall. Further down the driveway the cracking is more severe (Photos 1 & 2). The fence runs down the length of the wall. The cracking appears related to the supporting posts of a timber fence that are embedded into the top of the wall. It is recommended the fence be assessed for stability by a structural engineer. This will likely involve obtaining the embedment depths that the fence posts were drilled into the brick retaining wall.
