# Arboricultural Impact Assessment Report

**Client Name:** Luke Anglicas  
**Site Address:** 145 McCarrs Creek Road, Church Point, NSW  
**Authors Details:** Hugh Millington  
**Email:** [hugh@hughtheArborist.com.au](mailto:hugh@hughtheArborist.com.au)  
**Phone:** 0426836701  
**Date Prepared:** 17<sup>th</sup> October 2019

This report has been commissioned by L. Anglicas to assess two adjoining sites 143 and 145 McCarrs Creek Road in Church Point.

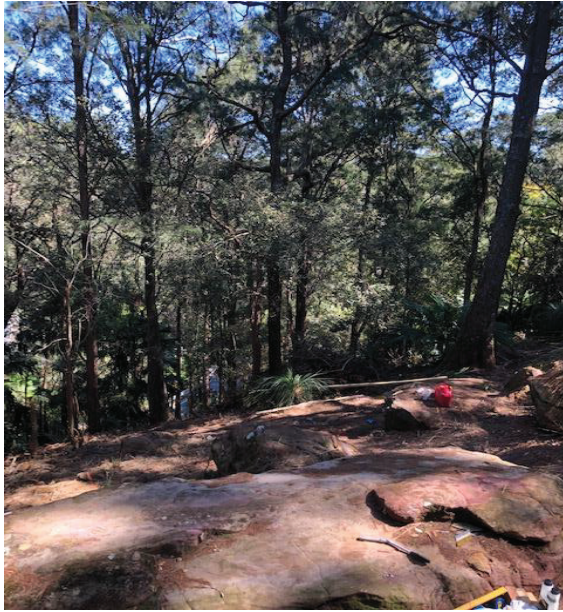
**Photo a:** Looking to the north of the site where the proposed dwellings are to be constructed.

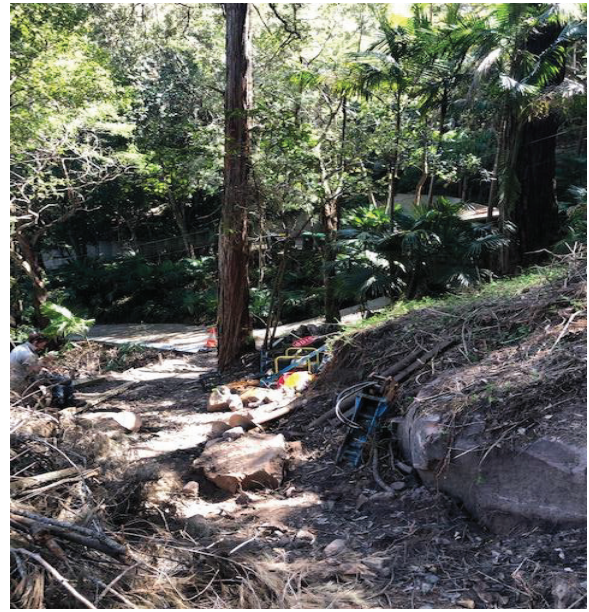
**Photo b:** Looking and the existing access and area for the proposed driveway to both sites.

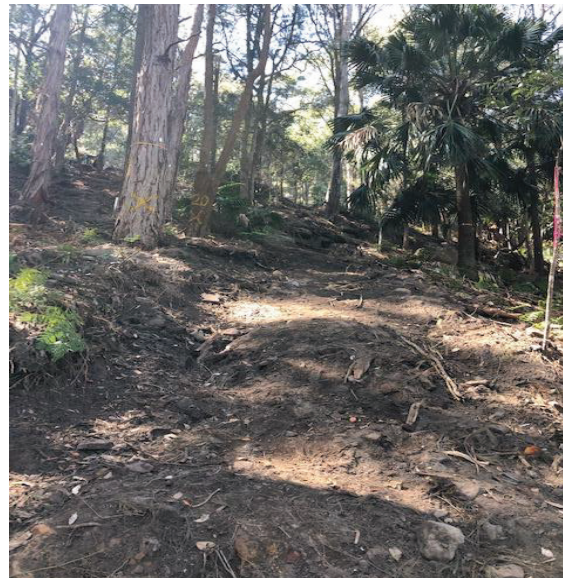
**Photo c:** Looking up from the west at site 143.

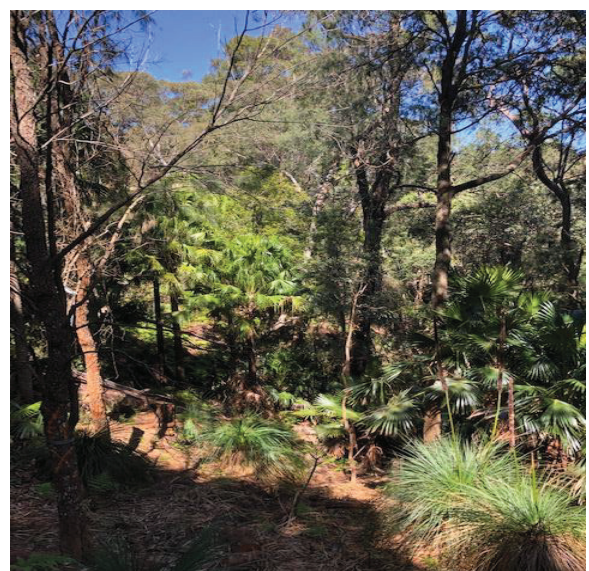
**Photo d:** Looking to the southern side of the site.

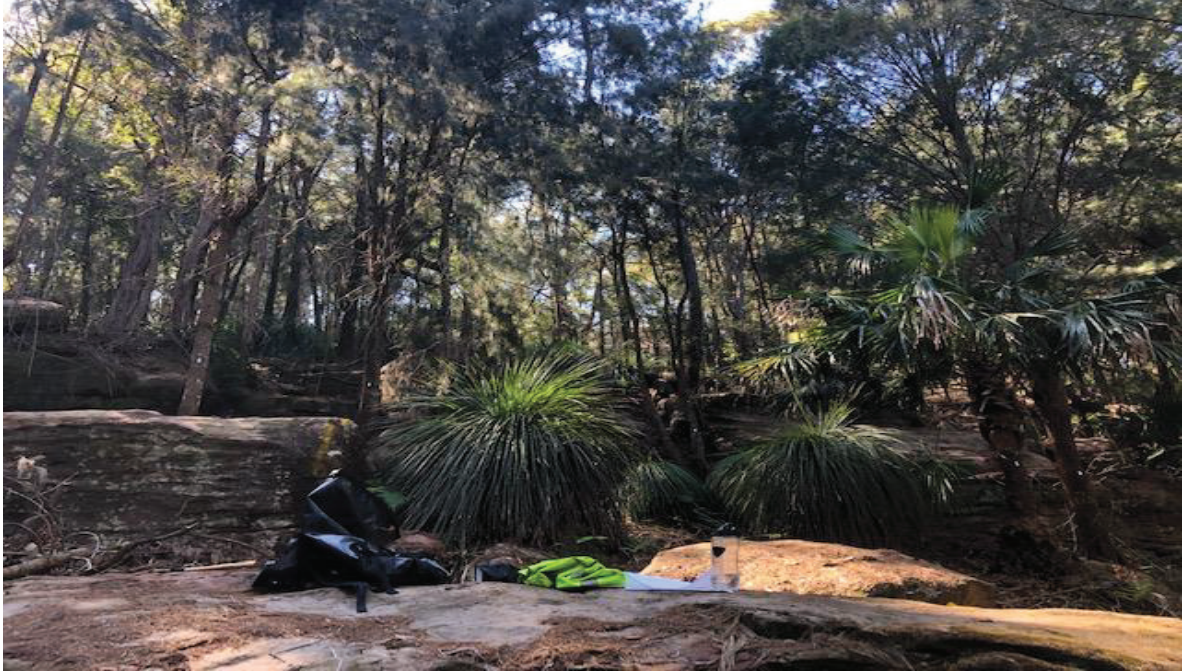
**Photo e:** Looking east at the top of the site and Group 1.

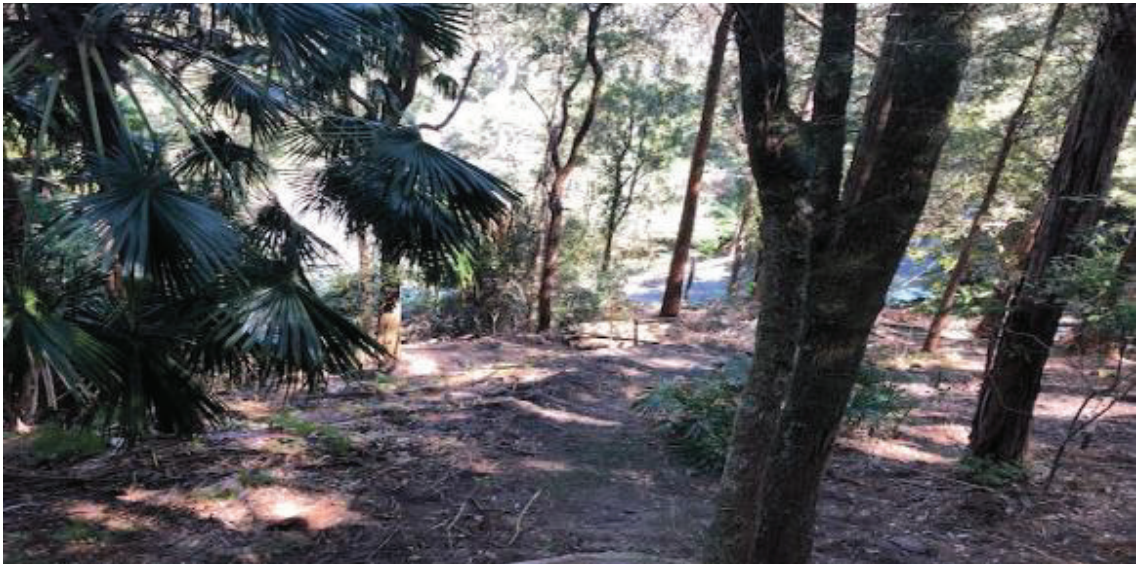
**Photo f:** Looking down to the west of the site the area proposed for the garages.
