# Accessibility Assessment and Recommendation Report

**Pilu Restaurant, 80 Undercliff Road, Freshwater NSW**

Report Number: RE220643 Access

JUNE 2023

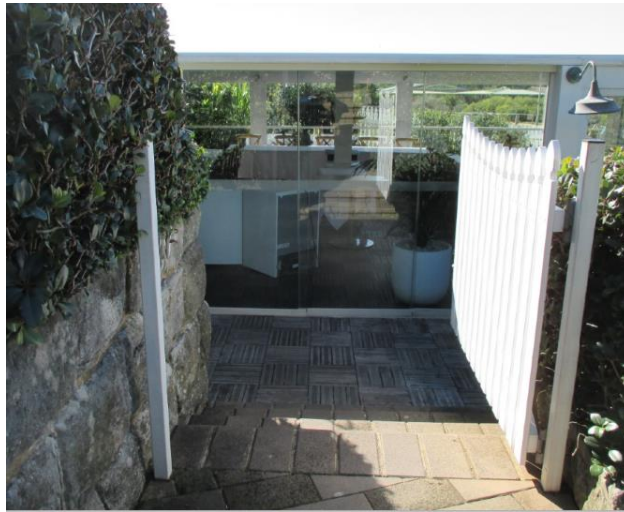
*Figure 4- The entry to the pavilion building via steps*

Though the pavilion is proposed to be used for special occasions such as wedding ceremonies, an accessible path of travel is not available for a wheelchair user to enter and exit the pavilion building ( Refer to Figure of this report).

The Finished Floor Level (FFL) of the pavilion is 500mm below the pathway at the entry point and access to and from the pavilion is provided via steps limiting wheelchair users' entry to the pavilion. Therefore the accessible path of travel to the building is not provided in accordance with Clause D3.2 (i), (ii) and (iii) of BCA for the use of people with disabilities, especially wheelchair users.

Being a significant space used by the public, an accessible path of travel must be established between the walkway and the pavilion. There are two recommendations to achieve access to the pavilion as below.

**i) Providing a ramp as an accessible path of travel between the two spaces.**

As the level difference is approximately 500mm, no recommended mobile ramps are available to provide safer access for wheelchair users. A 1: 14 ramp is impractical, requiring 7.0m as a ramp length.

**ii) Providing access to the pavilion via a second door**

Access via a new entrance to the pavilion with an extension to the walkway can be considered a reasonable solution ( Refer to Figure 8 below). The position of the door can be at a location where the FFL of the existing access path is equivalent to the FFL of the pavilion.

**Note:** The new sliding or swing door width, door clearances and the width of the extension of the accessible path shall be designed in accordance with the requirements of AS1428.1.2009.

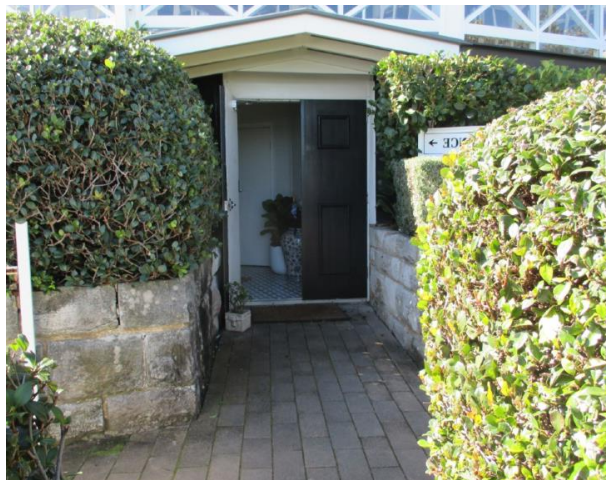
*Figure 5- Entry door to the restaurant lobby via the path*

The main entrance to the restaurant is provided via an accessible path of travel up to the ground-level restaurant lobby and reception area. The main restaurant, which is at the upper level of the building, is accessed via the timber stair, limiting access to the restaurant for wheelchair users.

Therefore the *Deemed to Satisfy* provisions of BCA Clause D3.2 is not satisfied.

The only way to access the restaurant is via the stairs. One way to gain access to the upper floor is via a stair platform lift to gain access between the two levels.

Consequently, the building is heritage listed, and due to the structural changes required to upgrade, the accessibility within the existing building is not practical and viable.

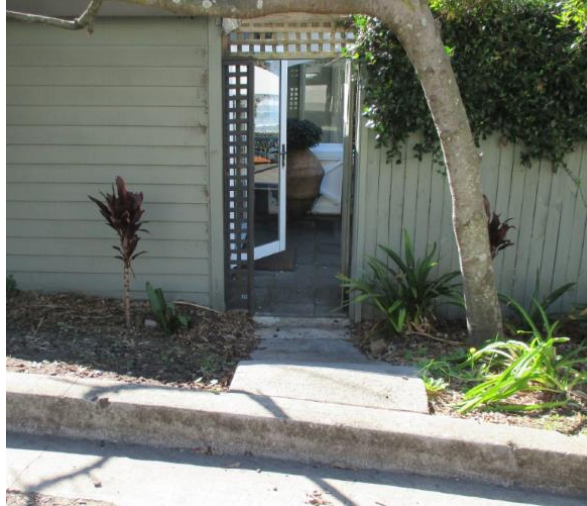
- (ii) The second entry is only used as emergency/service access from the cul-de-sac of Undercliff Road via a secured gate. However, this entry/exit point is not in use due to safety concerns and the carparking and the main entrance are provided from Moors Road.

*Figure 6- The entry with a steep ramp*

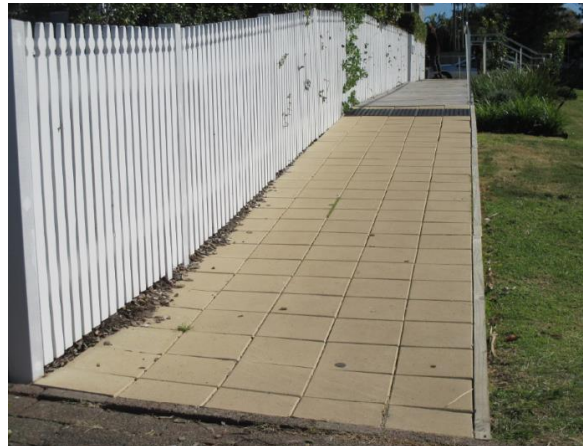
Based on the photographic survey conducted within site, the coffee shop and the external kiosk counter are provided with a 1500mm wide path of travel via a walkway from the property boundary. Though accessible parking lots are not provided within the site, an accessible path of travel is available from the Moore Road car park. The existing accessible path of travel does not comply with all the features of the current Australian standards, this path has been used by customers, including people with disabilities, for decades to access the kiosk.

Figure 7- Ramp and walkway access to the coffee shop

It is not required to upgrade the accessible path of travel to the kiosk immediately as the reasonably accessible path of travel is provided. If any major building works are proposed within the complex, it is recommended to analyse the path of travel and provide the features based on AS1428 standards to comply with the Clause D3.3 of BCA.

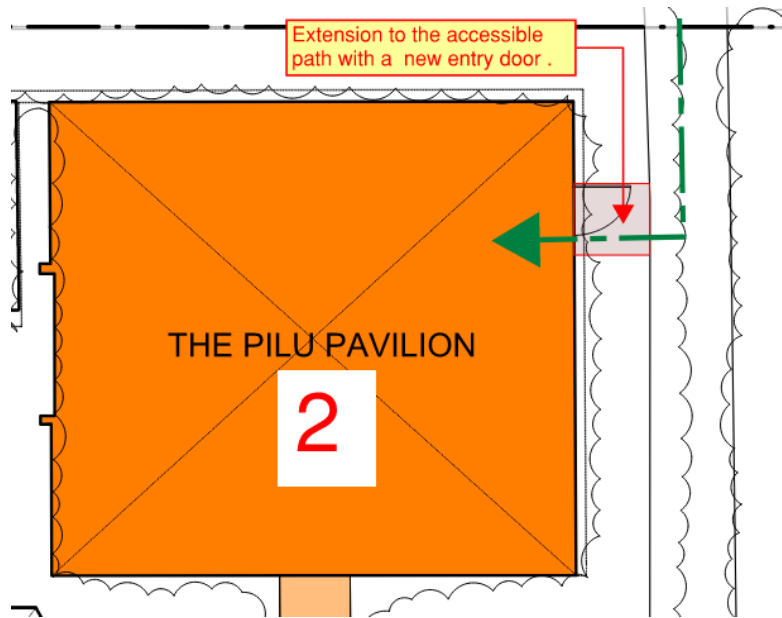
Figure 8- Proposed accessible entry to the pavilion

The existing stepped entry can be used as an entry for everyone except for people using wheelchairs.

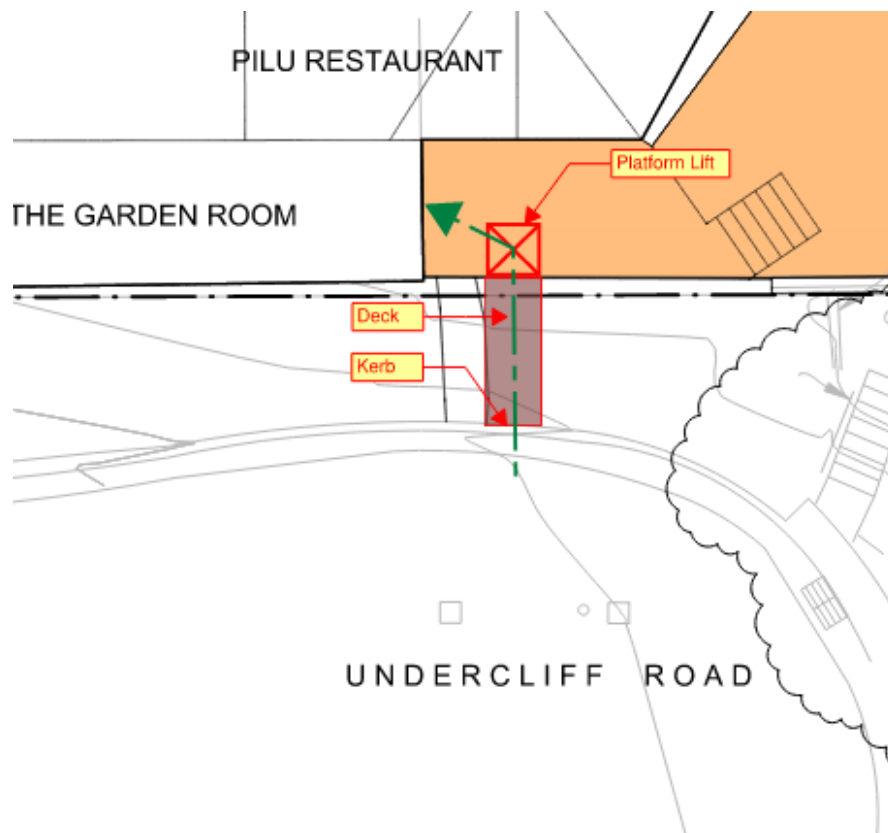
*Figure 9- Access to the Restaurant from Undercliff Road.*

An accessible path of travel could be obtained via a platform lift installed within site with a path of travel (deck) beyond the boundary of the premises. As the level difference between the road and the deck in front of the 'Garden Room' is less than 1000mm (approximately 750mm at the steep ramp area), a platform lift can be considered an option.

Constructing a path of travel beyond the property boundary may need permission from the council.

As the main entrance to the buildings is from the carpark over Moors Road, and accessible parking is not provided within the cul-de-sac of Undercliff Road, it may not gain any customer advantage unless it is used as a drop-off area for people with disabilities.

This option can be considered a secondary option to access Pilu Restaurant when major refurbishment occurs within the complex.
