## Geotechnical Assessment

**Project:** Swimming Pool & Landscaping  
9 Poate Place, Davidson NSW

**REF: AG 21310**

28 September 2021

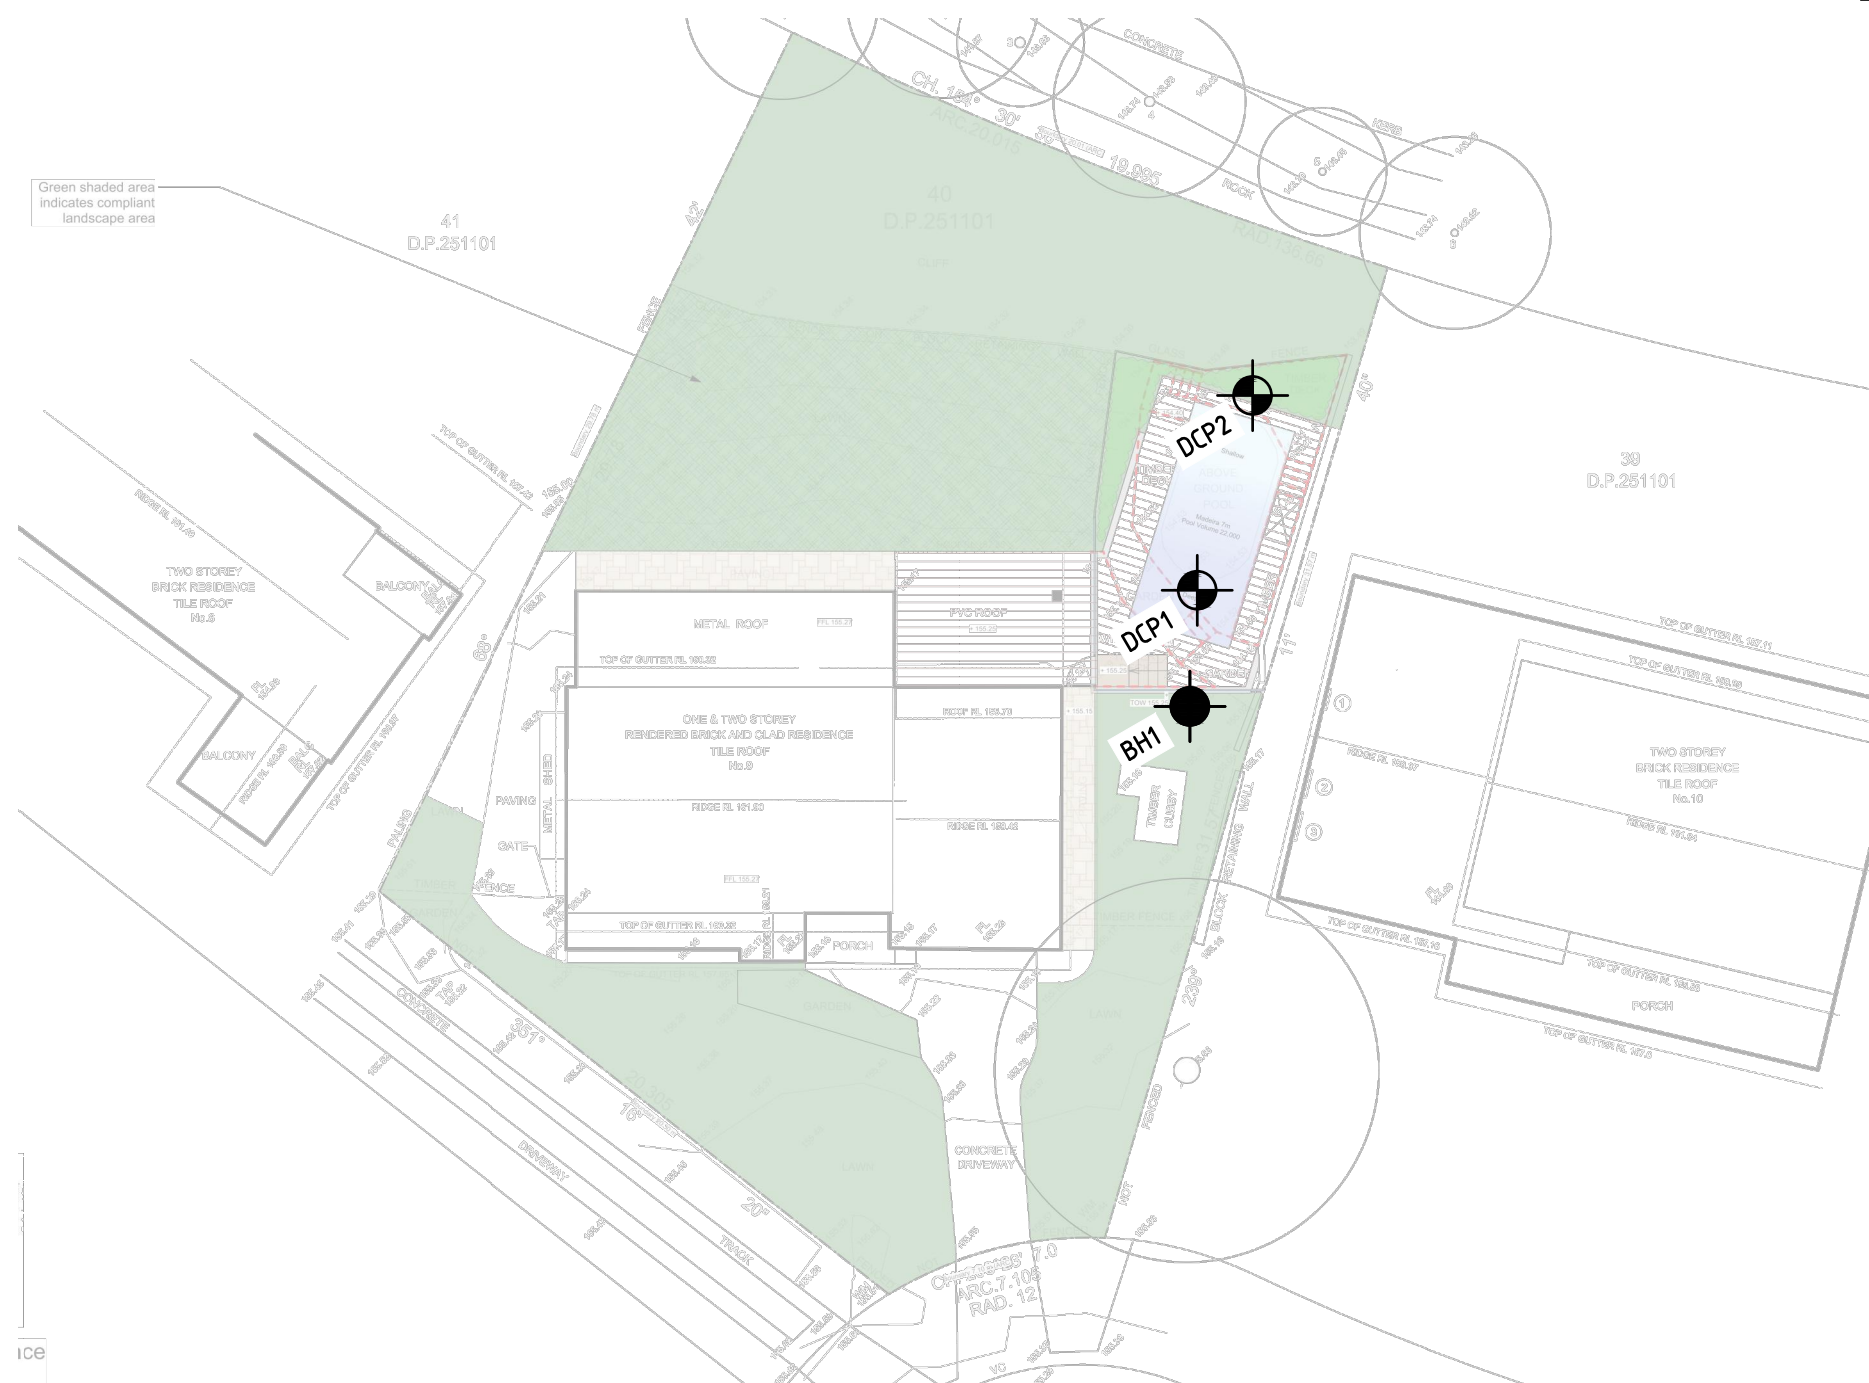
### SITE PLAN/GROUND TEST LOCATIONS

BOREHOLE LOCATION

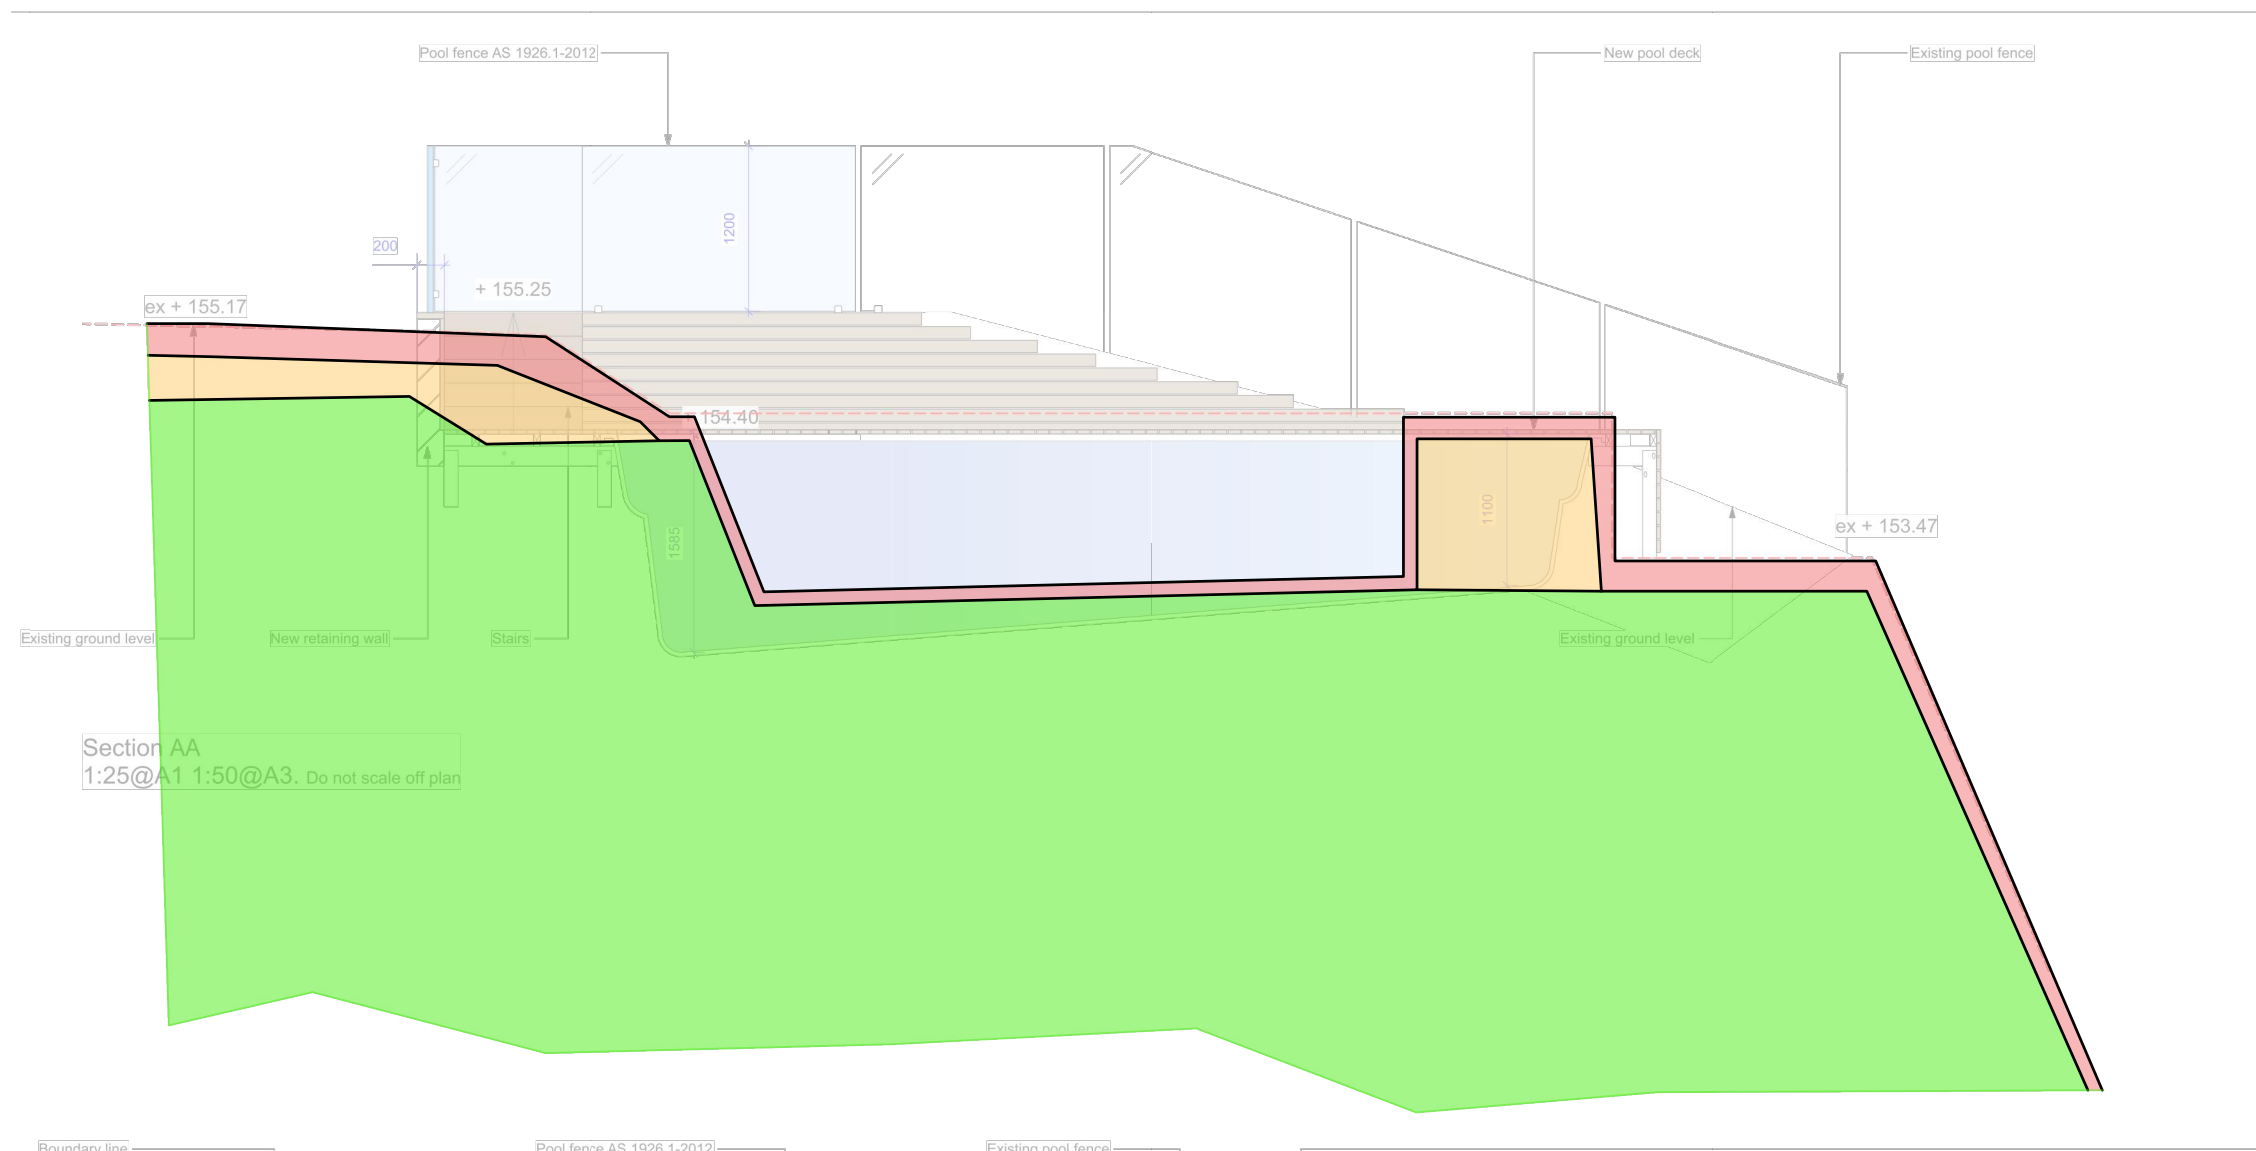
**INFERRED GEOLOGICAL SECTION**  
SCALE NTS

INTERPRETED SUBSURFACE SECTION ONLY.  
ACTUAL GROUND CONDITIONS MAY VARY.
