## **Geotechnical Assessment**

**Project:** Alterations & Additions  
37 Radio Avenue, Balgowlah Heights

**REF: AG 21002**  
13 January 2021

For Alternations & Additions at  
37 Radio Avenue, Balgowlah Heights NSW

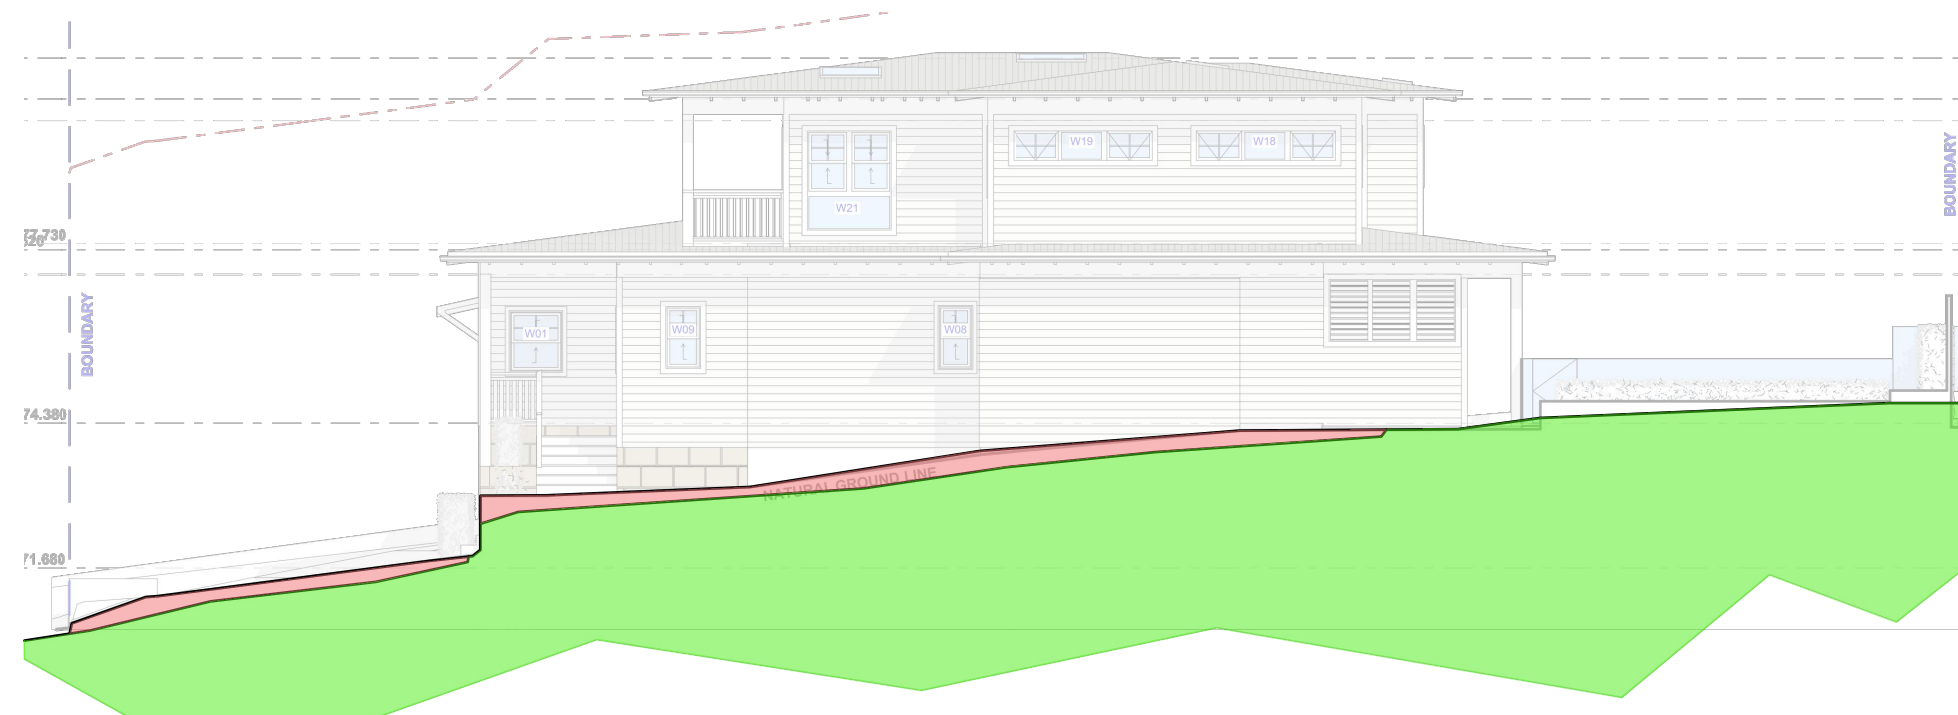
**INFERRED GEOLOGICAL SECTION**  
SCALE NTS

The soil profile consists of shallow uncontrolled fill and silty/sandy topsoils (O & A Horizons), clayey sand (B Horizon), and weathered sandstone bedrock (C Horizon). Based on our observations and the results of testing on site, we would expect competent weathered bedrock, to be found within 400–1300mm from current surface levels across the area of the proposed works.

INTERPRETED SUBSURFACE SECTION ONLY.  
ACTUAL GROUND CONDITIONS MAY VARY.
