## **REPORT ON GEOTECHNICAL INVESTIGATION**

## **PROPOSED ALTERATIONS AND ADDITIONS**

**10 MANOOKA PLACE, WARRIEWOOD, NSW**

**Project No.: 2021-144**

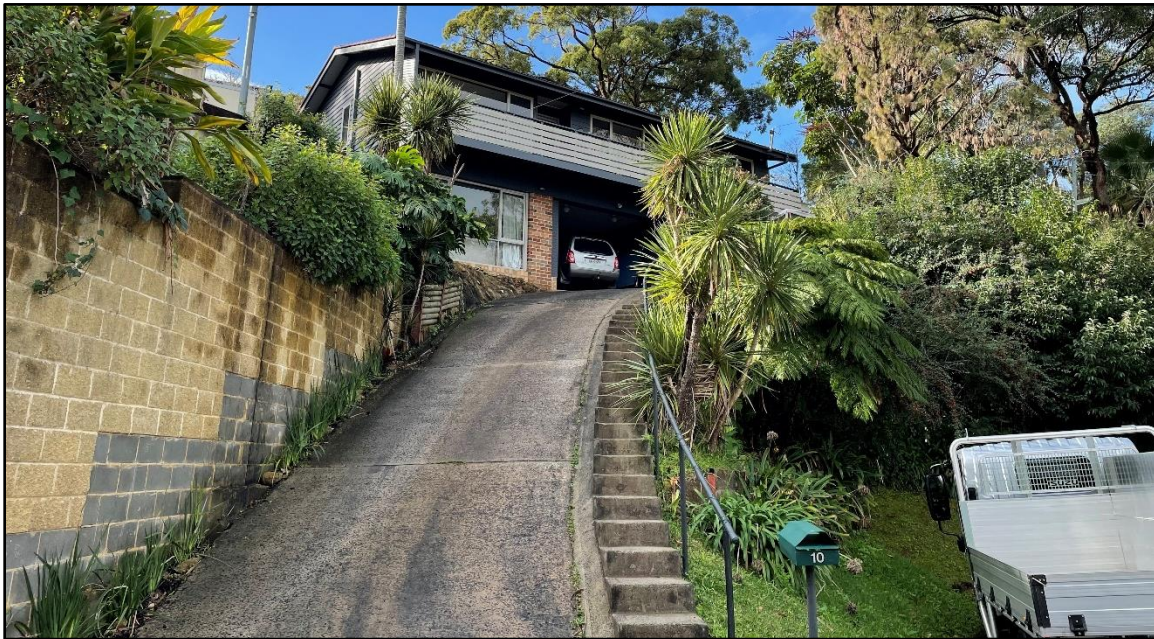
*Photograph 2: View of the site residence looking broadly north-east from the driveway*

The site residence comprises a two-storey brick and timber clad residence with carport under which appears to be of approximately 1990's style construction and shows no signs of excessive settlement or cracking visible on the external walls.

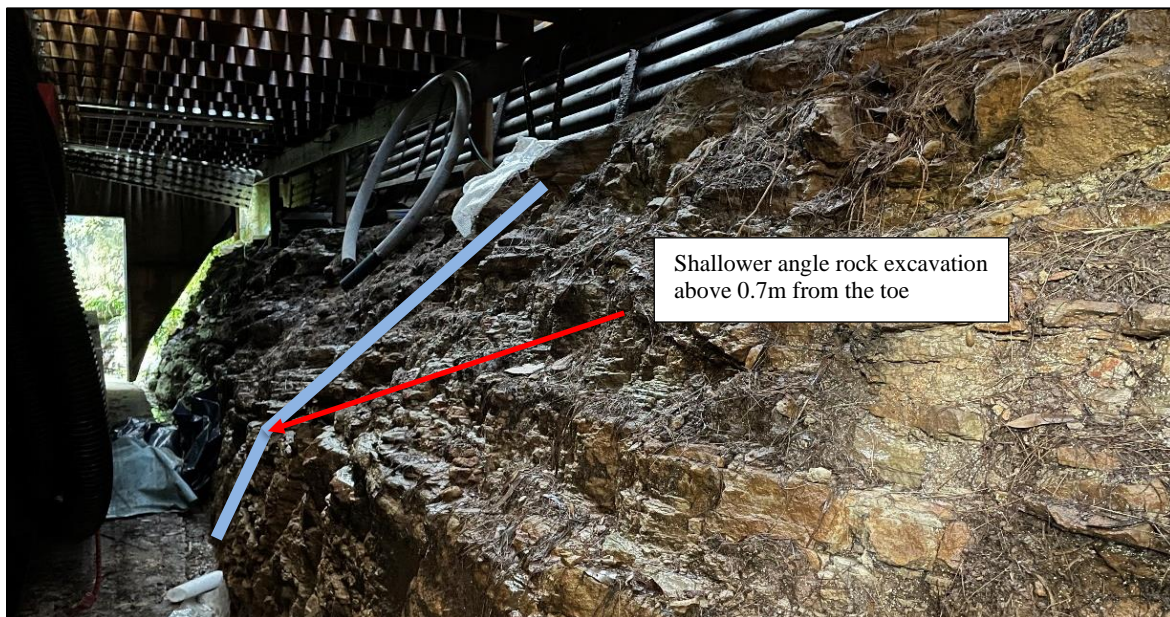
A concrete pathway wraps around the structure at ground level which provides access to the rear of the property and bedrock cutting. The cutting (shown in Photograph 4) varies in height between approximately 1.4m (south) and 2.0m (north) and extends along the full width of the rear of the site residence. The strata comprised sandstone bedrock with minor shale/siltstone lenses and appears to range from very low to medium strength. Near the base of the cutting (within the lower 0.7m), the bedrock appears stronger (low to medium strength typically) and massively bedded. Within the upper 1.5m (approximately) the frequency of both bedding and jointing defects increases, and the cutting has been excavated at a shallower batter slope angle than the lower, near vertical basal section. Some localized minor wedge type detached cobbles of sandstone were visible within the upper face however the cutting appeared globally stable with no significant weak or unstable zones observed. Groundwater was observed emanating from the rock face through defects.

*Photograph 4: View of the exposed rock rack abutting the northern edge of the dwelling*

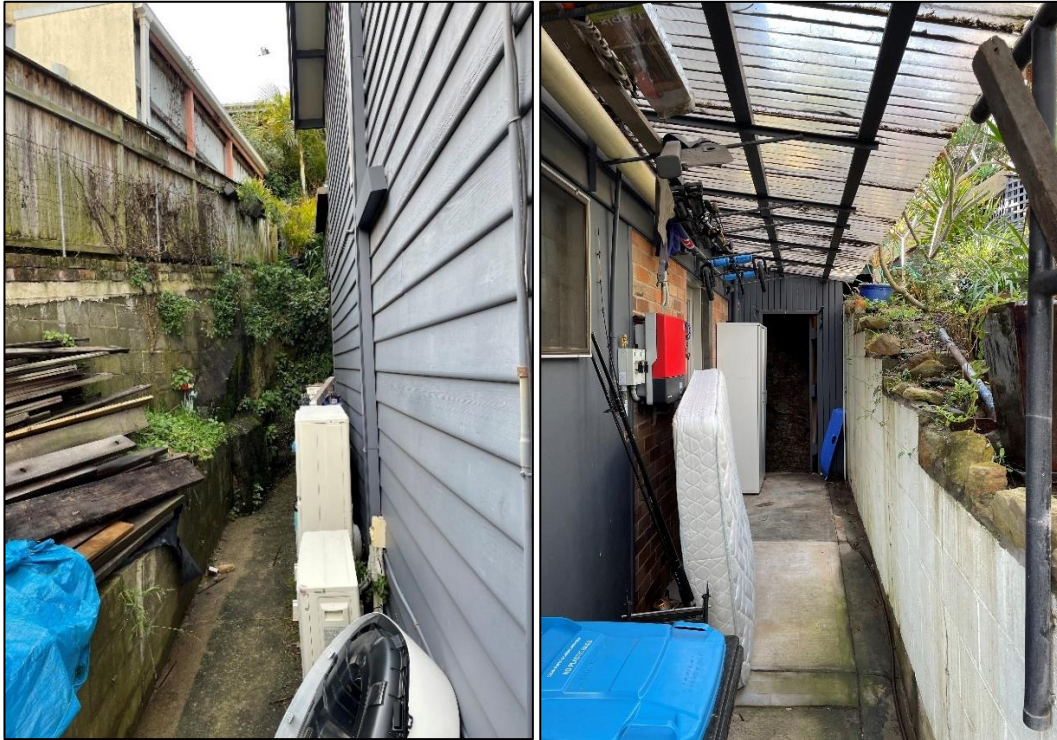
A timber retaining wall is founded near the crest of the cutting. Retaining walls surround the house structure to the east and west which appeared in good condition.

*Photograph 5 and 6: Western and eastern sides of the existing dwelling looking north*
