## **Geotechnical Assessment**

**Project:** Low Density Residential Development  
60 Binalong Avenue, Allambie Heights.

**REF: AG 18011**

2<sup>nd</sup> February, 2018

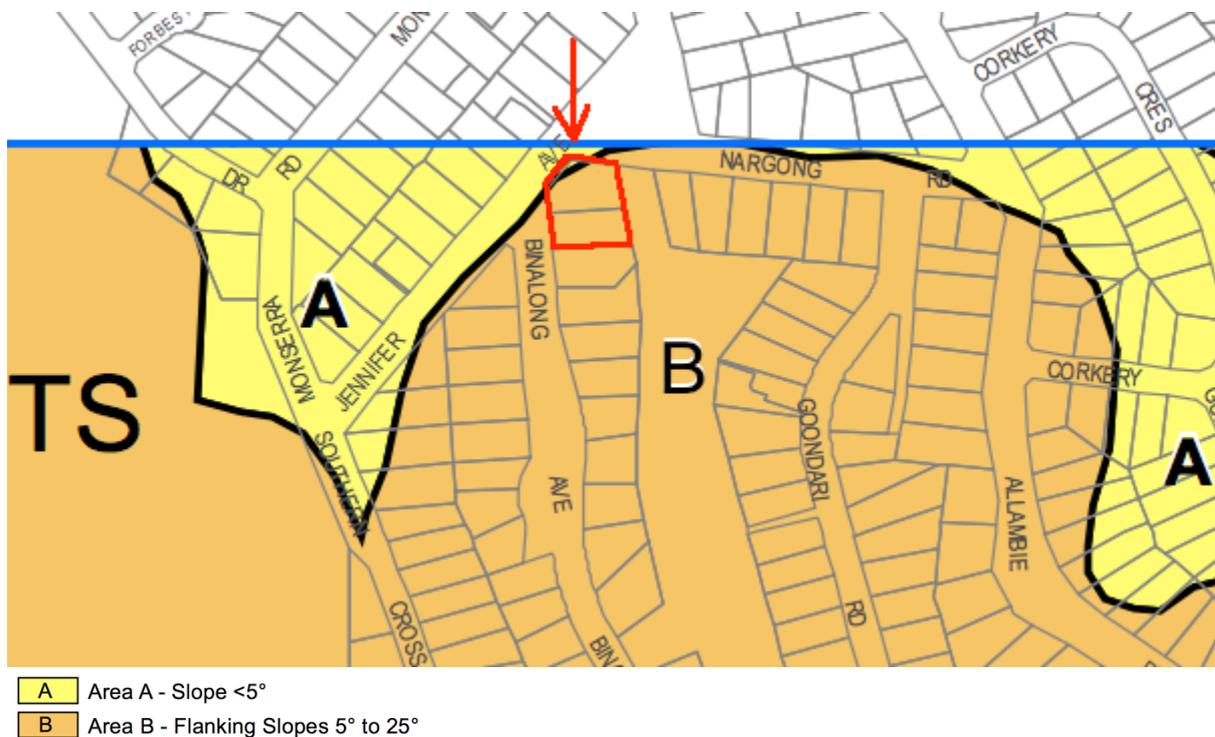
- No evidence of significant soil creep, tension cracks or other indicators of slope instability were identified at the time of our inspection.
- The proposed residential development will be situated on land that is gently to moderate sloped with a maximum gradient of ~10 degrees.
- The property is classified category 'A & B' in Northern Beaches Council WLEP Landslip Risk Map LSR\_008 (**Image 2:** Below. Site indicated by red arrow)
