74 Grandview Drive, Newport

Geotechnical Comments for Section 4.55

GEOTECHNICAL INVESTIGATION:

New Pool at 74 Grandview Drive, Newport

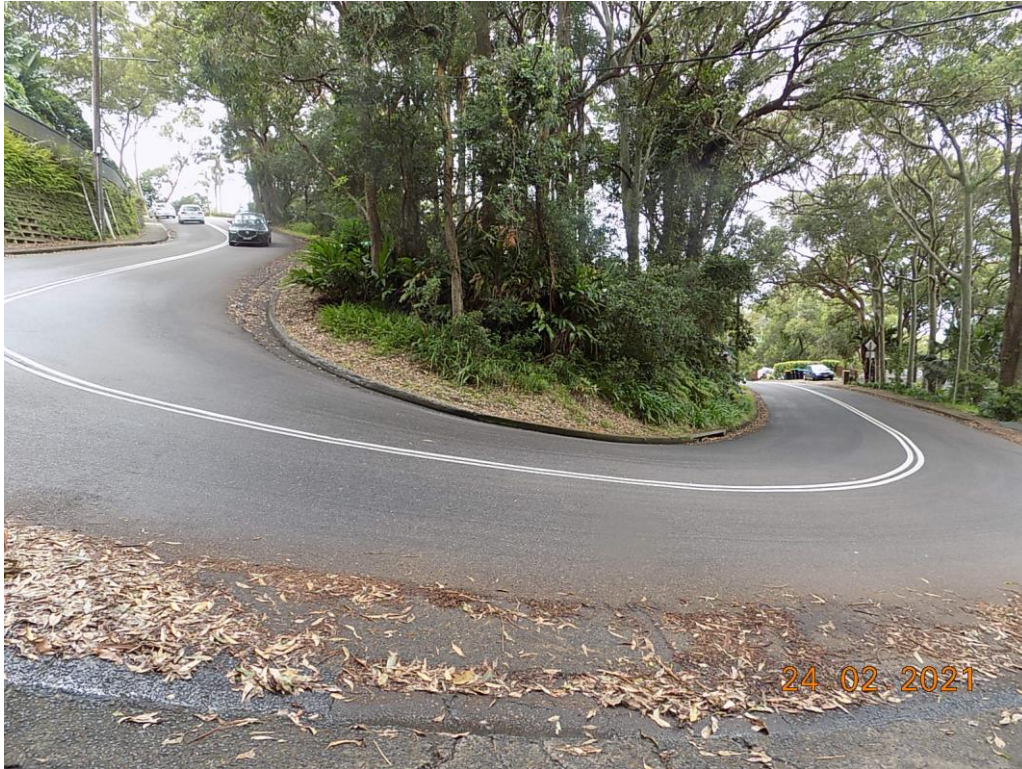
Photo 1

- 2.1** The site was inspected on the 24th February, 2021.
- 2.2** Grandview Drive wraps around the uphill, W, and downhill sides of this residential property (Photo 1). The property has a SE aspect. It is located on the moderate to steeply graded upper middle reaches of a hillslope. The natural surface rises across the property at an average angle of ~20°. The slope above the property continues at decreasing angles. The slope below the property continues at increasing angles.

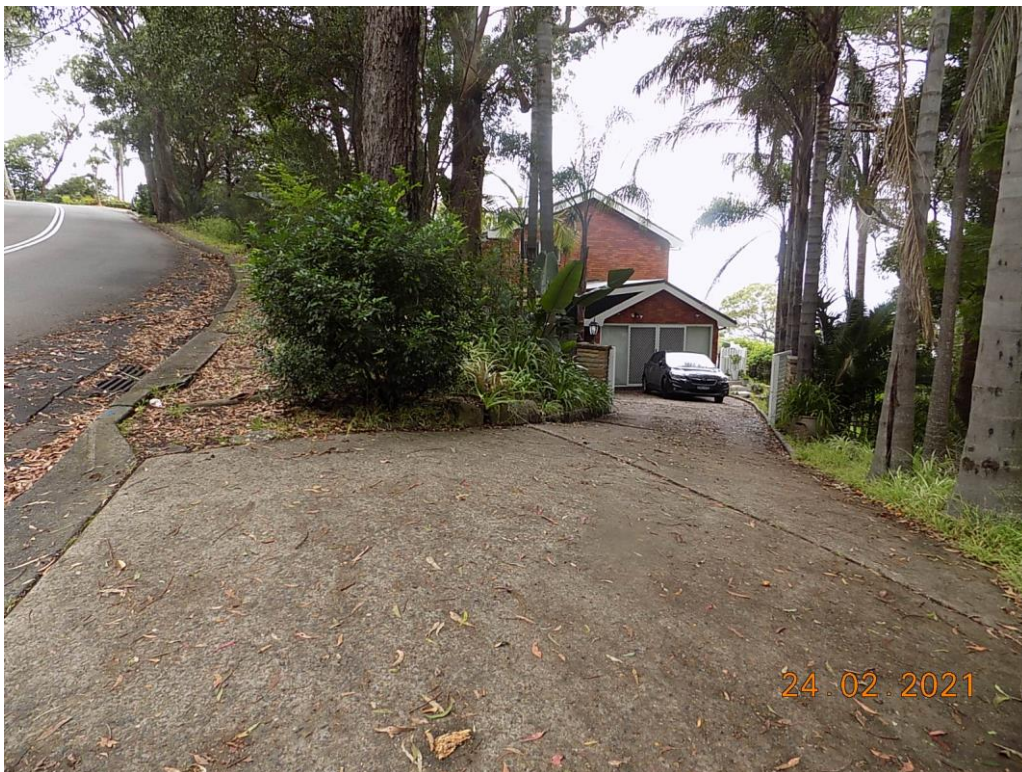
Photo 2

- 2.3** At the road frontage, a concrete driveway runs to a stable carport attached to the uphill side of the house (Photo 2). The cut for the driveway is supported by a mortared sandstone block retaining wall reaching ~1.2m high (Photo 3). The wall displays some cacking through the mortar but no signs of deflection and is considered stable. The part two-storey brick house is supported on brick walls (Photo 4). The supporting walls display no significant signs of movement. A large cut and fill encompasses the entire NE side of the property to create a level platform for the house and surrounding lawns and gardens. The cut is supported by a stable mortared

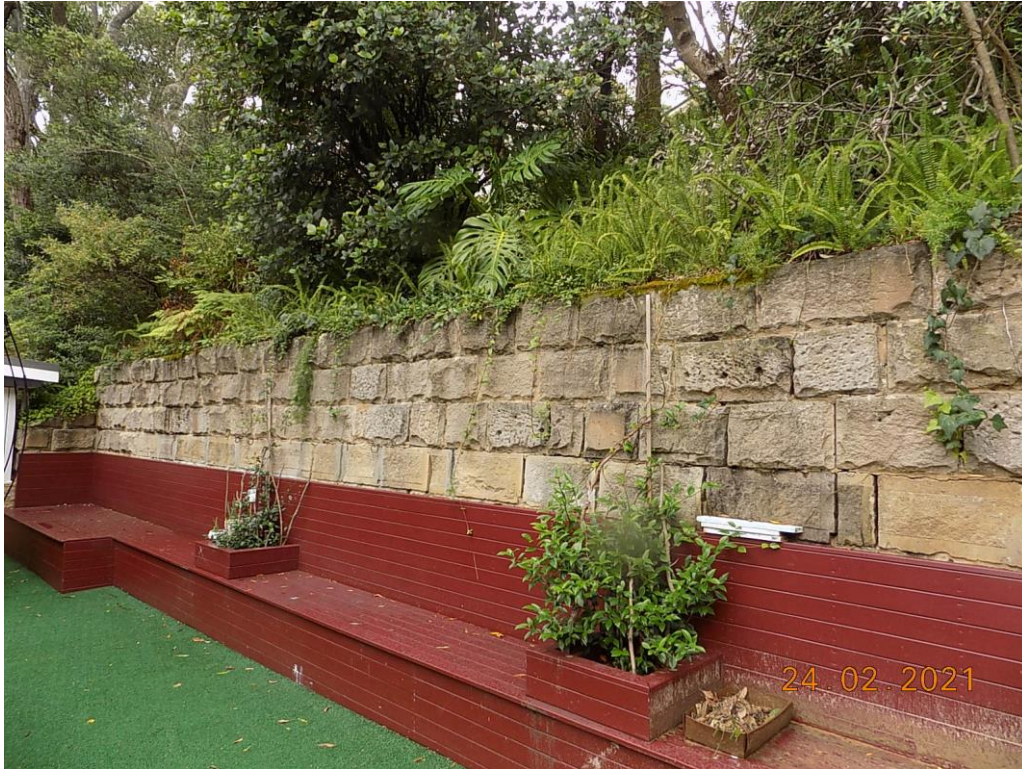
Photo 5

sandstone block retaining wall reaching ~2.0m high (Photo 5). The fill is supported by a concrete crib retaining wall reaching ~4.0m high (Photo 6). The condition of this retaining wall was difficult to determine as it has a thick covering of vegetation at the time of the inspection. However, from what could be seen of the wall and its surrounds, it appears stable.

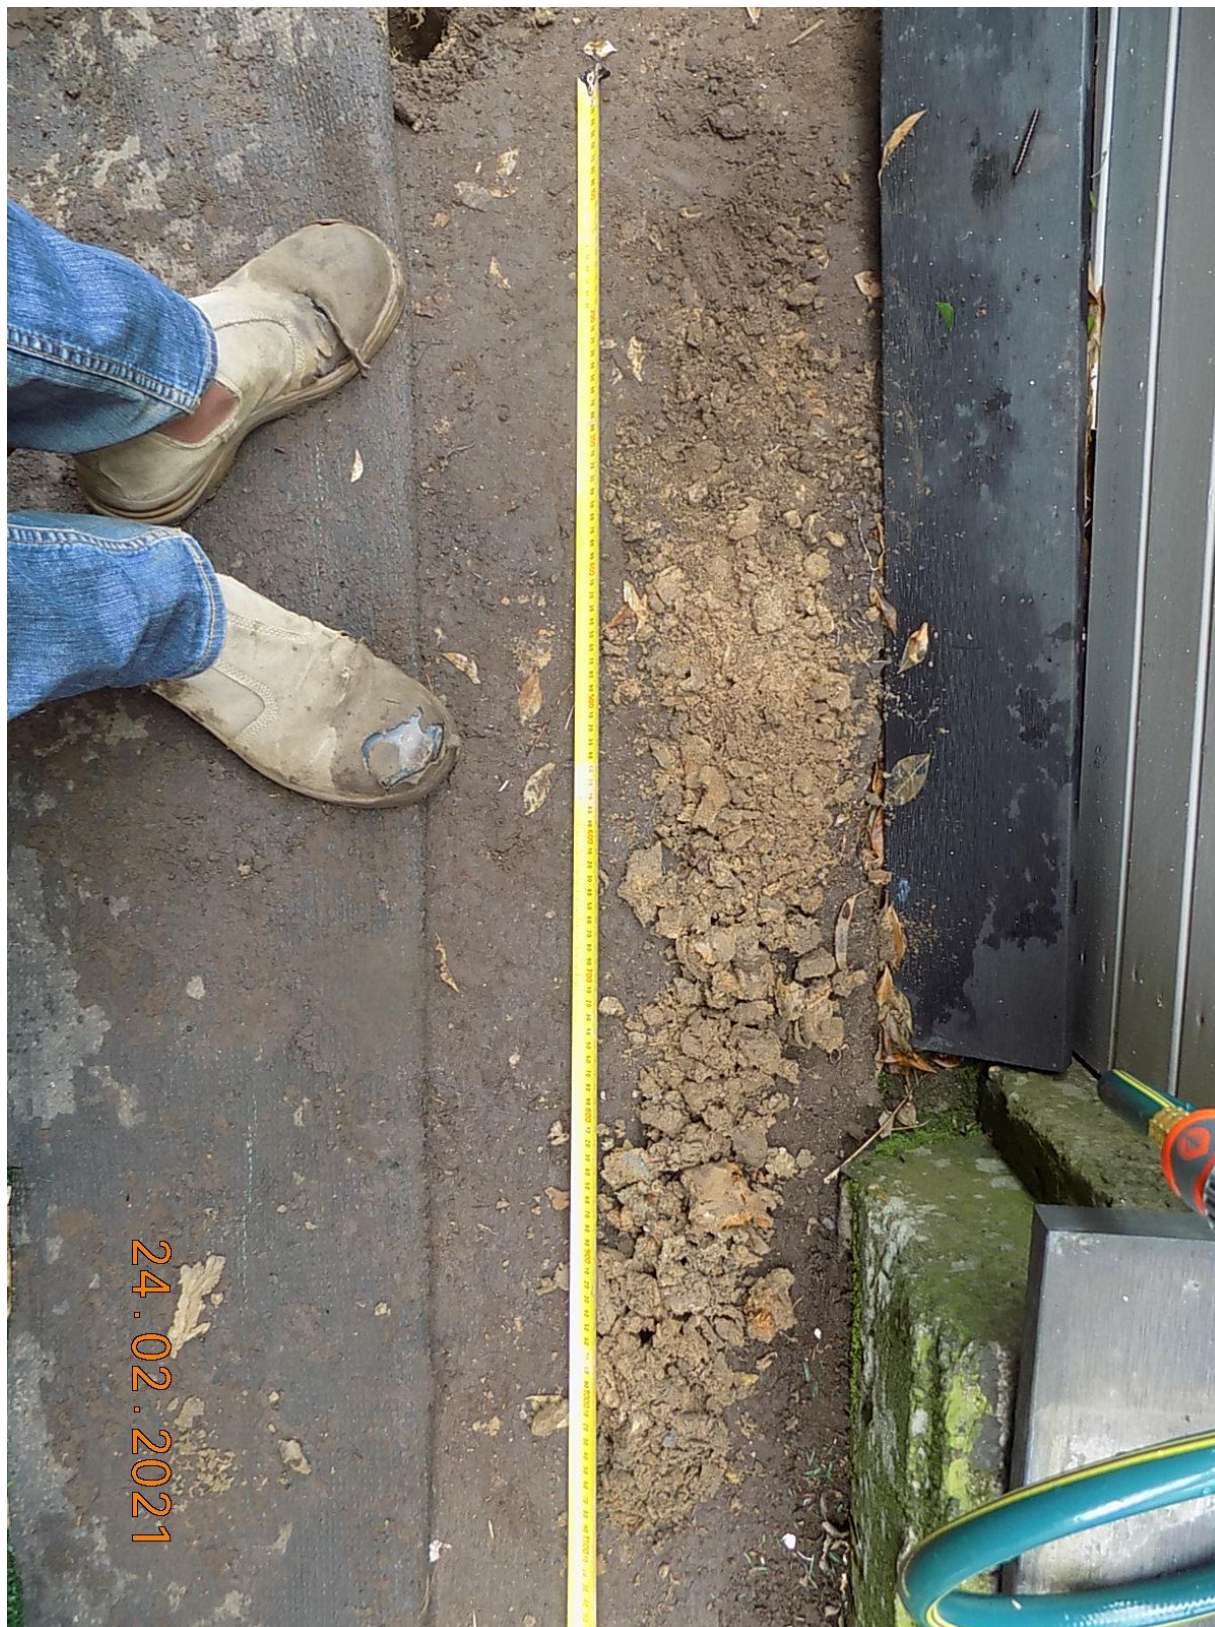
AUGER HOLE 1 (~RL99.9) – AH1 (Photo 7)

Depth (m)	Material Encountered
0.0 to 0.6	FILL , disturbed sandy soil, dark brown and brown, loose to medium dense, dry, fine to coarse grained with fine trace organic matter and trace clay.
0.6 to 0.9	FILL , disturbed clay, brown, firm, damp, fine to coarse grained with fine trace organic matter.
0.9 to 1.1	FILL , disturbed sandy soil, dark brown and brown, loose to medium dense, dry, fine to coarse grained with fine trace organic matter and trace clay.

Refusal @ 1.1m on unknown obstruction. No water table encountered.

Photo 7: AH1 – Downhole is from top to bottom.

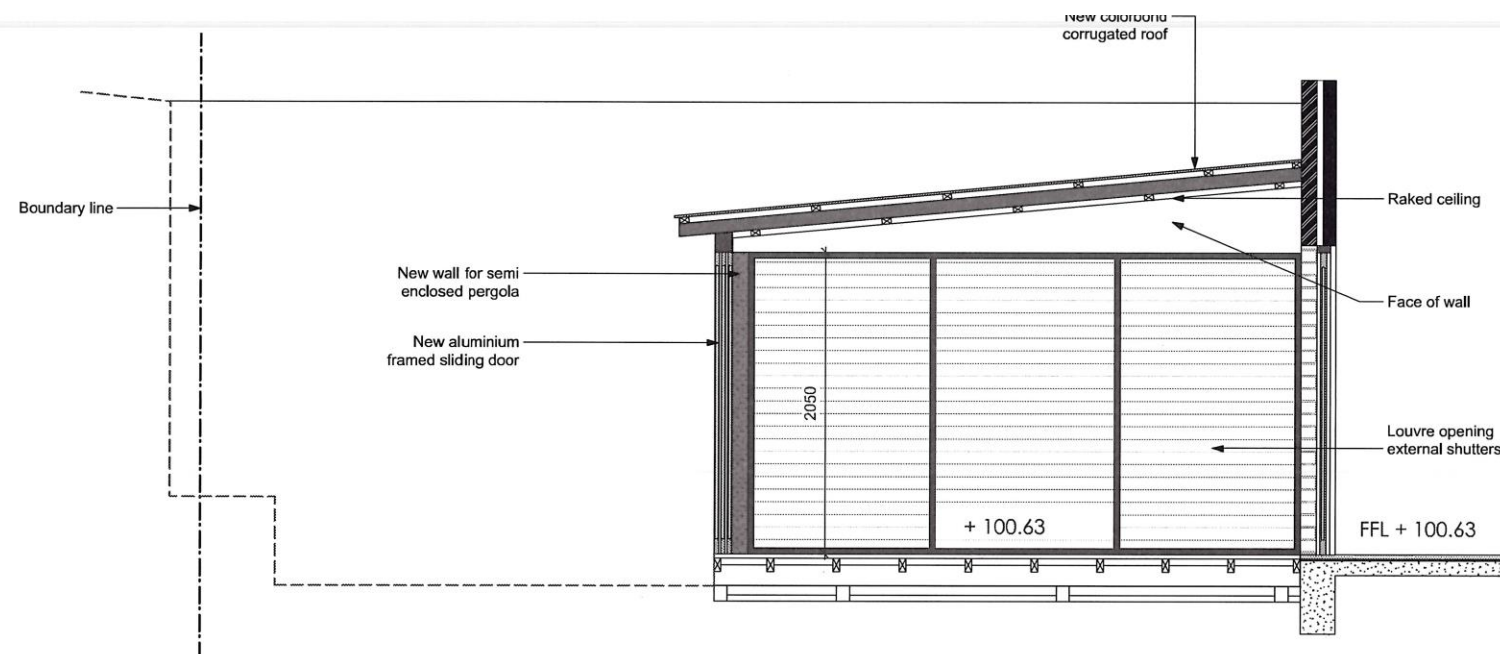
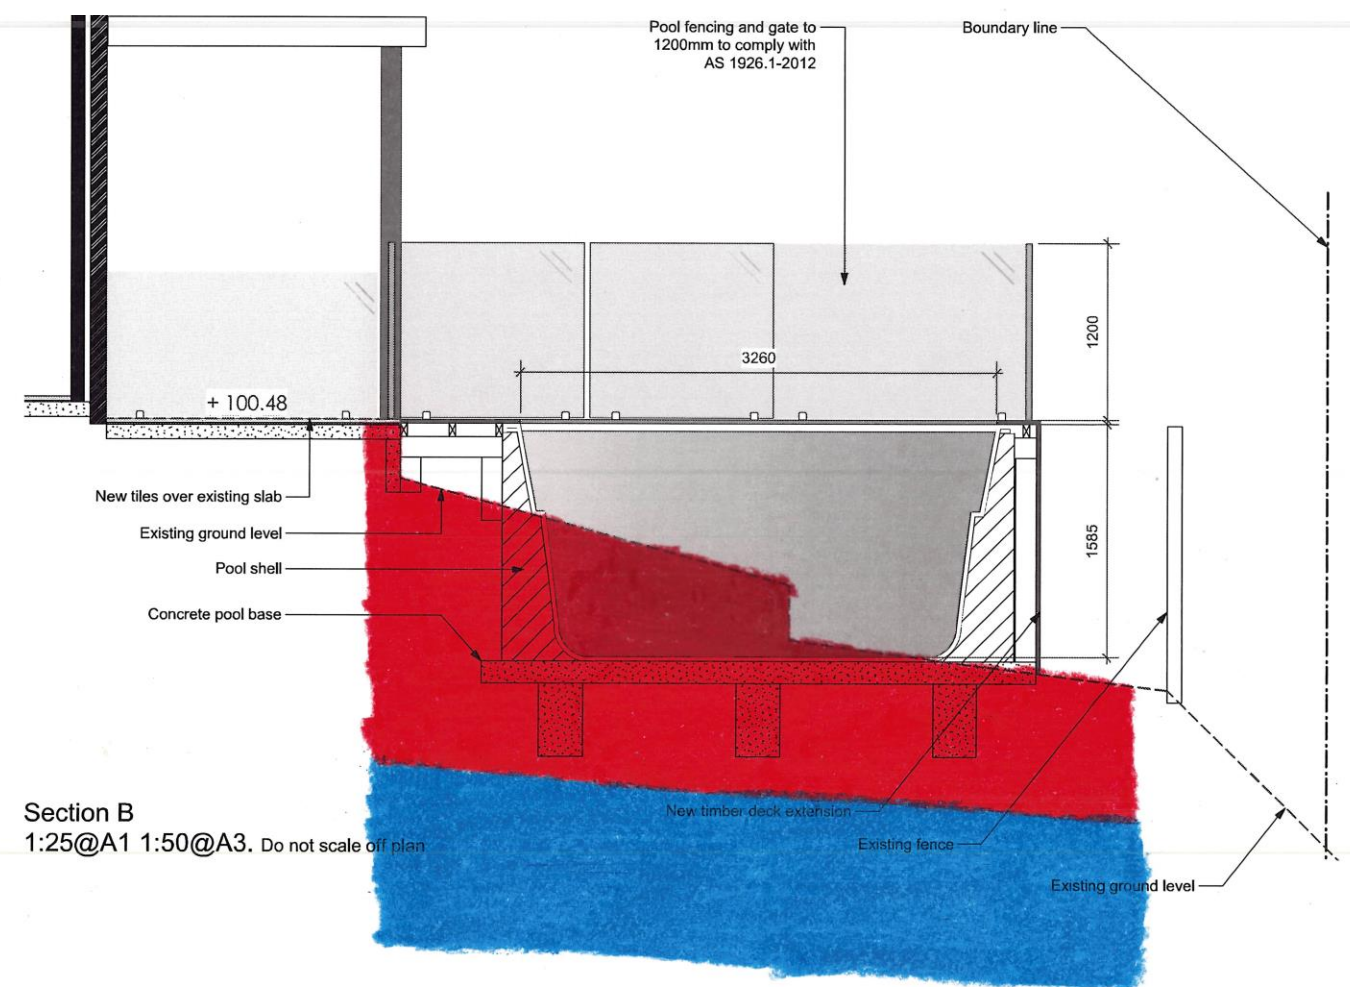
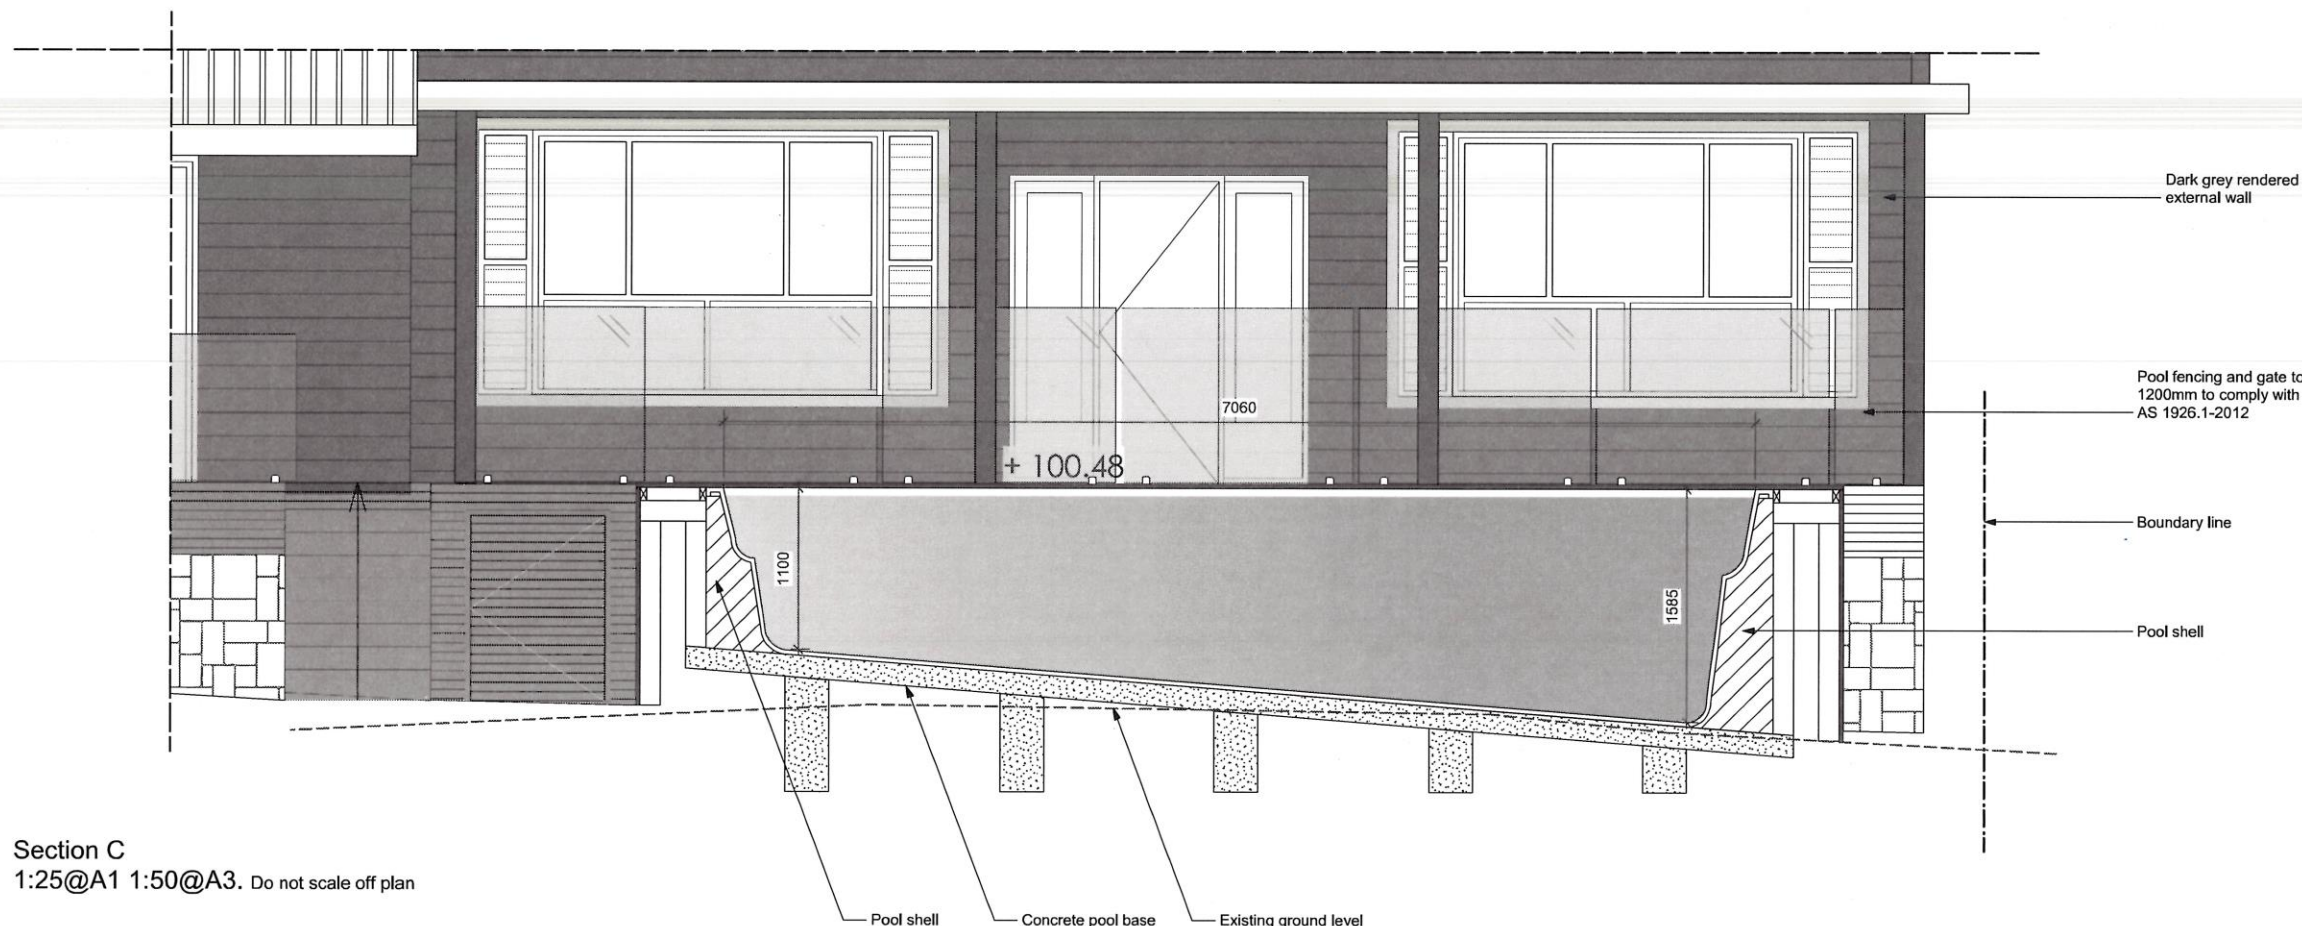
TYPE SECTION – Diagrammatical Interpretation of expected Ground Materials

We note solid refusal on rock did not occur in any of the tests so Medium Strength Rock or stronger is not confirmed to underly the property. However, the property is mapped as Hawkesbury Sandstone and Medium Strength Sandstone was observed to be outcropping above and below the property. Thus, it is interpreted that the sandstone continues under the property. As the DCP was still very slowly going down at the end of the tests, the underlying sandstone on the property is estimated to be Very Low to Low Strength Sandstone that becomes progressively stronger with depth. See Type Section attached for a diagrammatical representation of the expected ground materials.

Fill
Hawkesbury Sandstone – Very Low Strength. Rock is expected to become progressively stronger with depth.
