GEOTECHNICAL INVESTIGATION:

New Pool at 129 Upper Clontarf Street, Seaforth

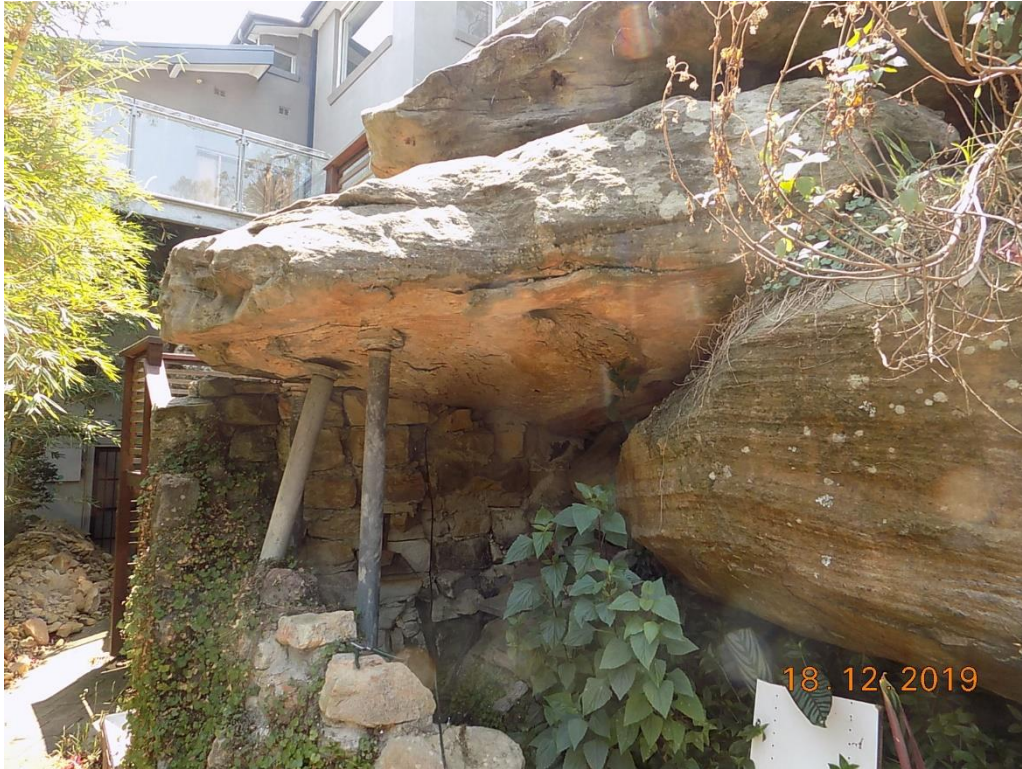
Photo 5

HAZARDS	Hazard One
TYPE	The construction of the proposed pool impacting on the undercut cliff face causing failure (Photos 5 & 6).
LIKELIHOOD	'Unlikely' (10^{-4})
CONSEQUENCES TO PROPERTY	'Medium' (35%)
RISK TO PROPERTY	'Low' (2×10^{-5})
RISK TO LIFE	4.2×10^{-6} /annum
COMMENTS	This level of risk is 'ACCEPTABLE' provided the recommendations in Sections 11 & 12 are followed.

The proposed pool will require partial excavation through Medium Strength Sandstone. The portion of the rock to be cut sits above the E undercut rock (Photo 5). To ensure the stability of the rock face into the future, we recommend all significant undercut portions of this rock face be cut back to form a sheer rock face.

The excavations through the undercut rock are to be carried out first. To reduce risk, they are to be undertaken using rock saws and are to be picked out without the use of pneumatic hammers. This is to ensure any vibrations generated during the excavation are below the threshold to impact on the rock face stability or to cause building damage. Following these recommendations, vibration monitoring will not be required.

We envisage most, if not all of the undercut rock will be removed by the pool excavation. If any significant undercut portions of the rock remain, these are to be supported with spaced blade walls. The requirement for this work will be assessed by the geotechnical consultant and is to be carried out before the construction of the pool commences. The blade walls are to be a minimum of 0.4m wide and are to be supported on foundations taken to rock. The tops of the walls are to be in full contact with the undersides of the undercut rocks so non-shrink grout will be required to achieve this. The blade walls are to be designed by the Structural Engineer in consultation with Geotechnical Consultant.
