## **Geotechnical Assessment**

**Project:** Refurbishment to Existing Waterfront Structures  
23 Robertson Road, Scotland Island NSW

**REF: AG 19209**

For Proposed Refurbishment to Existing Waterfront Structure at  
23 Robertson Road, Scotland Island NSW

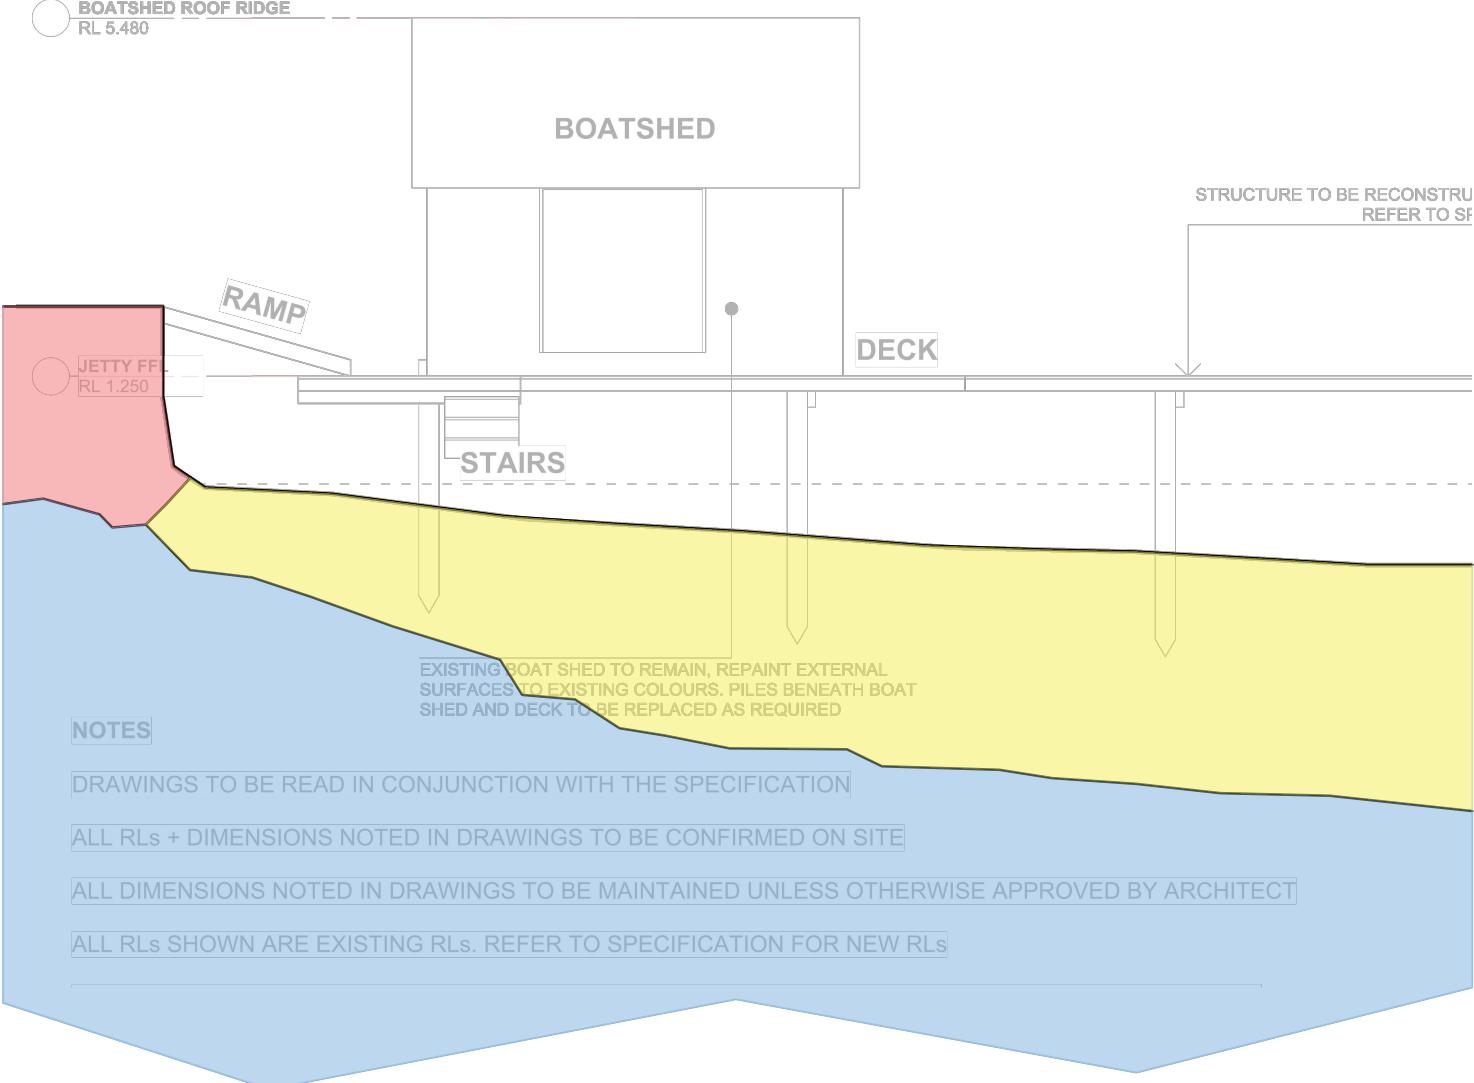
## INFERRED GEOLOGICAL SECTION

The soil profile consists of marine sands overlying weathered bedrock. Based on our observations and the results of testing onsite, we would expect competent weathered shale/ low strength sandstone bedrock to be found between 1400 to 2900mm from current surface levels across the site.
