PC Mouawad

57477

Question	Response	Details	
Client name	PC Mouawad		
Site Contact Name	Elias		
Site Contact Phone	0424155580		
Client email	Elias@pmcconstructions.com.au		
Has payment been received	No		
Please phone accounts to receive payments on 02 43410358			
Job/Work Location	683 Pittwater Rd brookvale		
Date	29/8/18, 4:59 pm		
Suresearch Job Number	57477		
Technicians name and times			
Add Technician 1			
Technician Name	Mark		
Start Time	1230		
Finish Time	4		
Total Hours	3.5		
Additional charges	Nil		
<p>All services/utilities have been marked to Australian Standard AS5488-2013 and are a guide only, it is the responsibility of the person/s undertaking works to adhere to asset owners duties of care when working in and around the utilities or areas marked or investigated by Suresearch, potholing is recommended prior to commencing excavation or any ground disturbance.</p> <p>I acknowledge the work has been carried out to my complete satisfaction in accordance with Suresearch Terms and Conditions.</p>

Locator Report

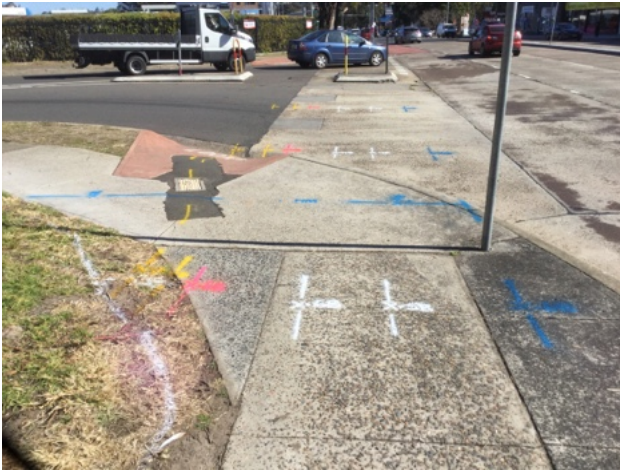
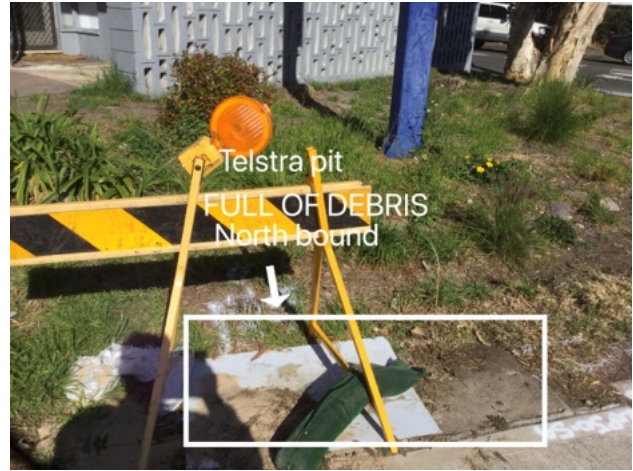
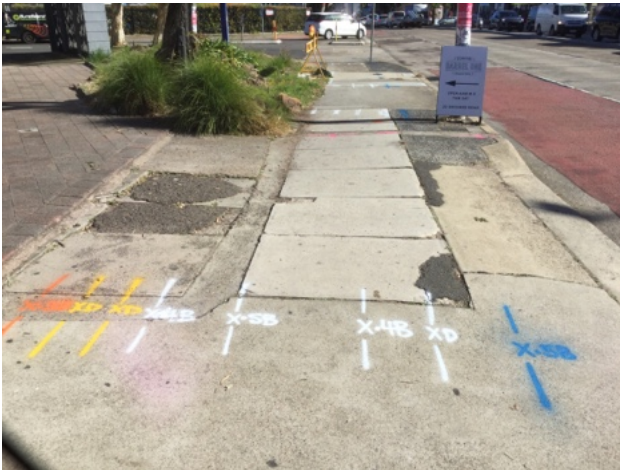
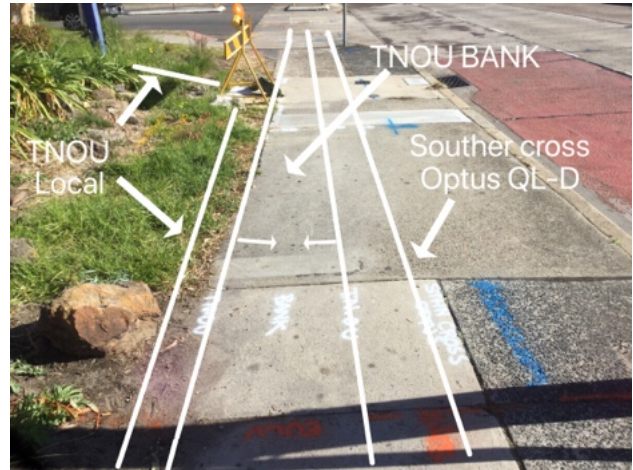
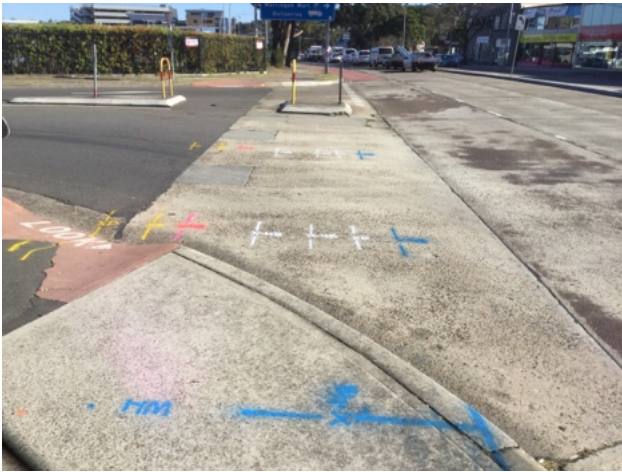
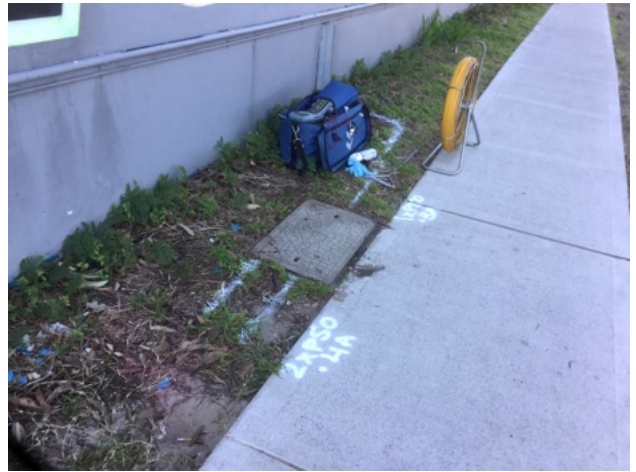
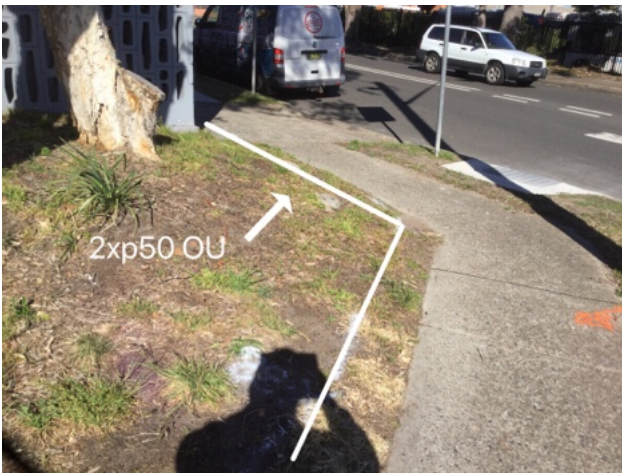
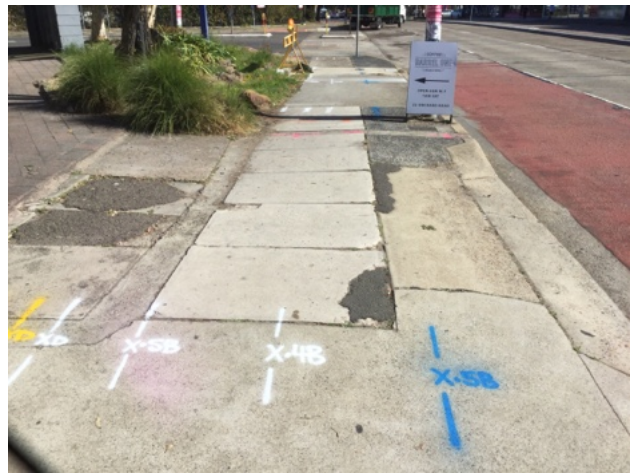
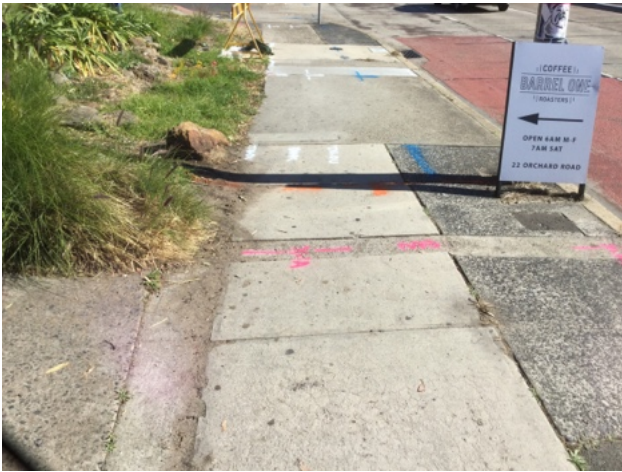
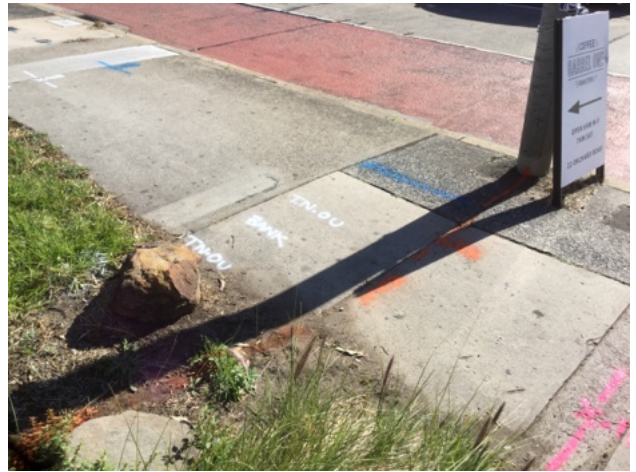
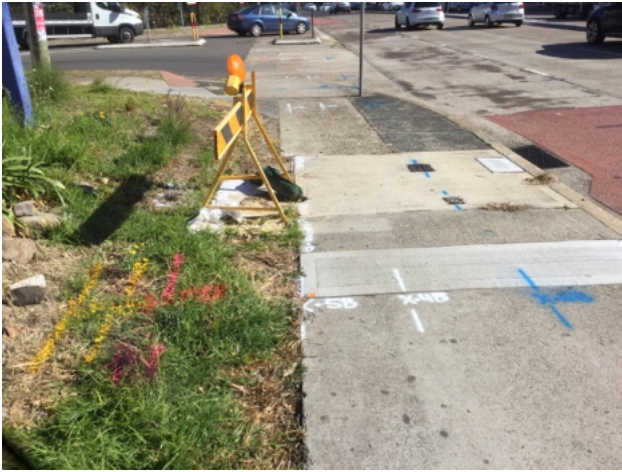
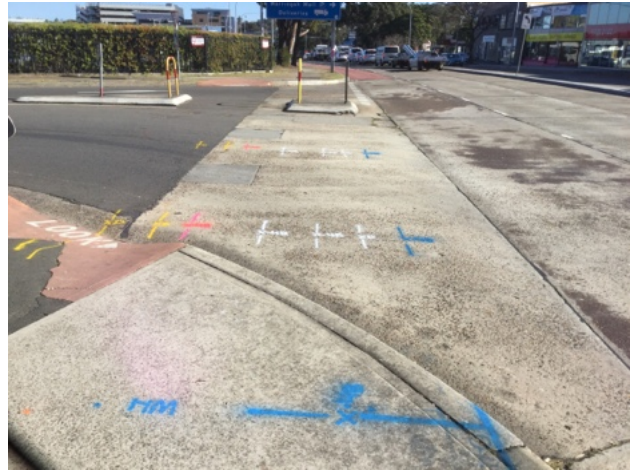
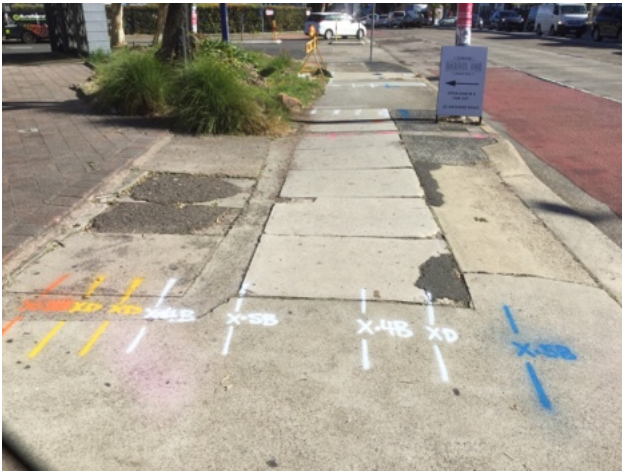
Traced and marked approximate location of Telstra Comms cables as per Dbyd. Telstra mains cable run in a bank across scope. Located the approximate extremities. Quality level b.

Located local Telstra fibre optic cable which is in 2xp50 ducts. Located using duct rod. Quality level B.

Local Telstra pit is half full of debris on one side of pit. Could see 2 p50 ducts on southern side of pit, could not see anything on northern end of pit.

Southern cross Optus cable is running through scope. Unable to locate. When digging within 5 metres of southern cross Optus cable, OPTus is to be notified prior to any ground disturbance. Asset needs to be potholed with Optus rep onsite. Marked quality level D

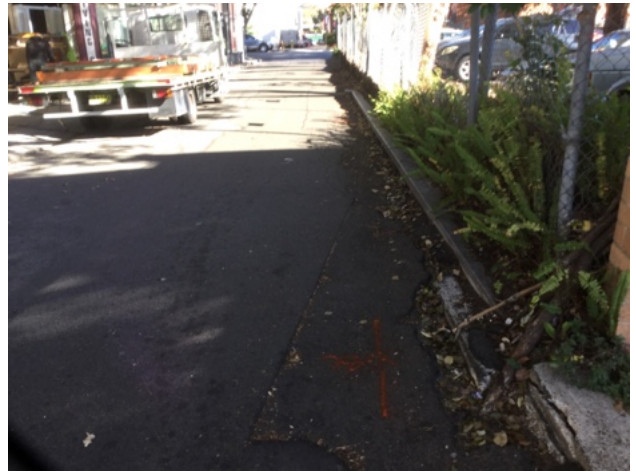
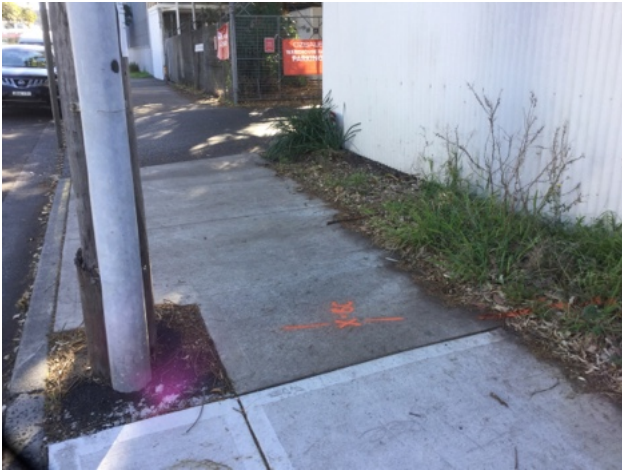
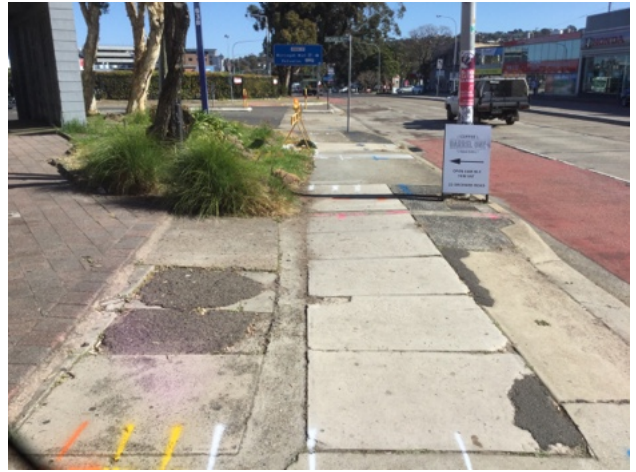
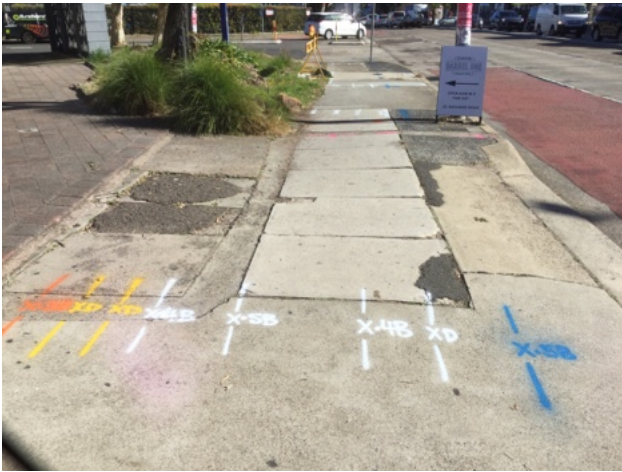
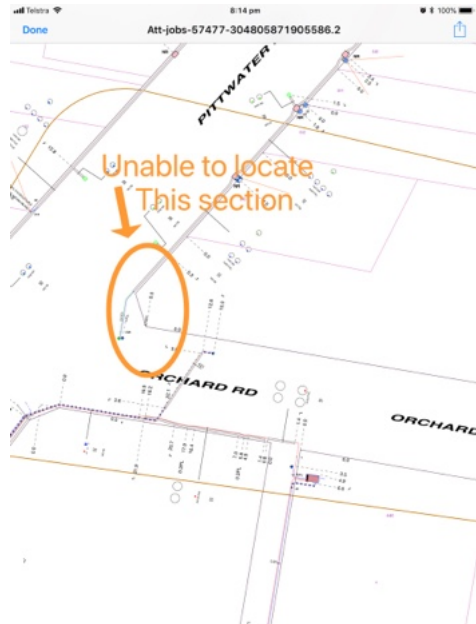
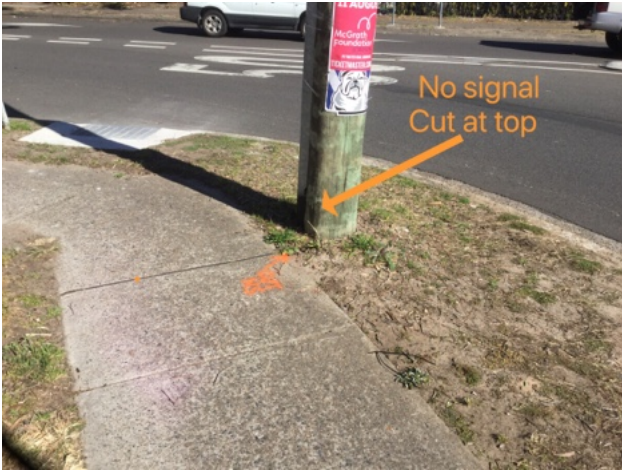
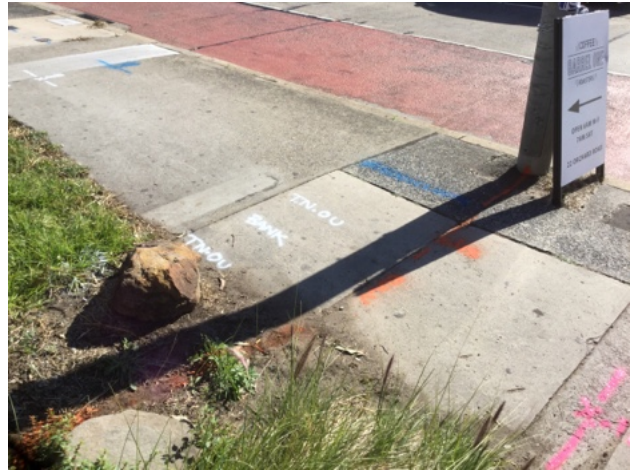
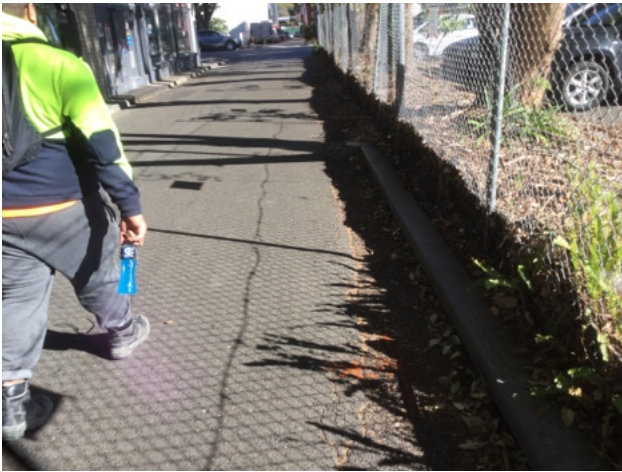
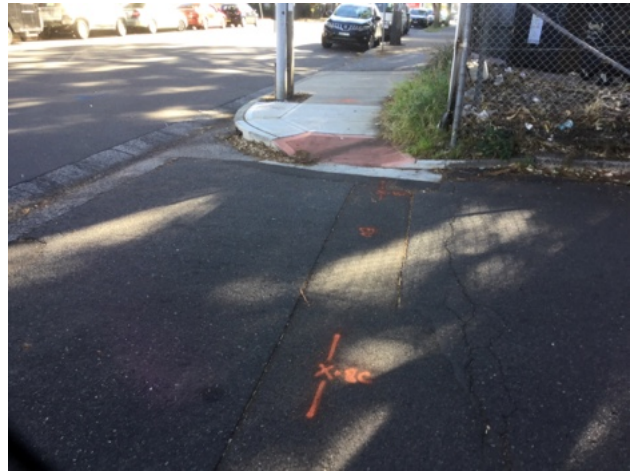
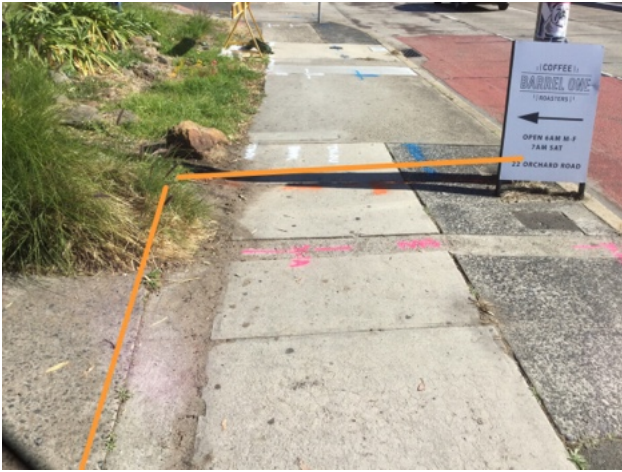
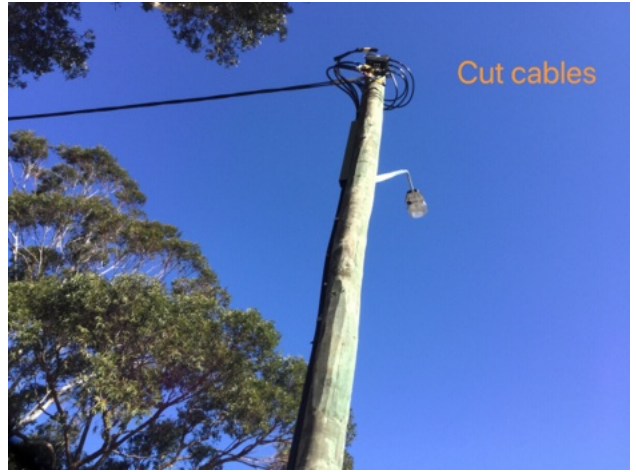
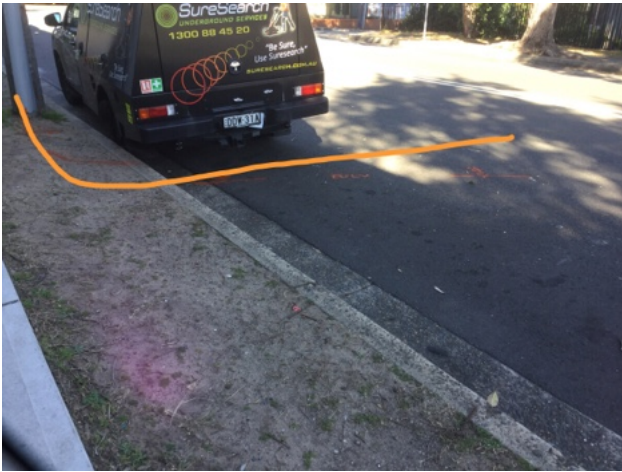
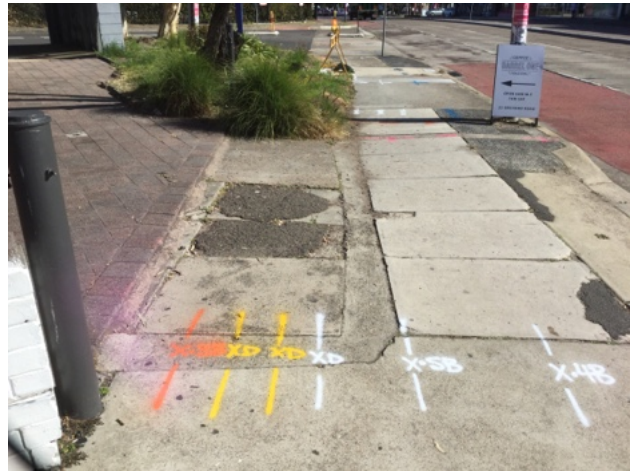
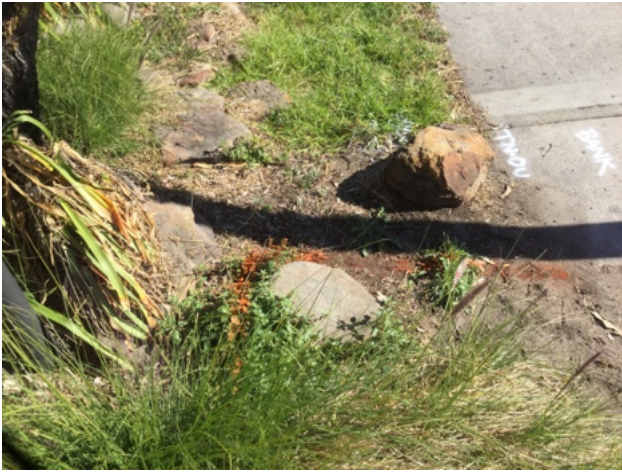
Traced and marked approximate location of of electrical cables as per Dbyd.

Ausgrid pole on the corner of Pittwater rd and orchard rd is capped off at top of pole and marked no signal NS. Quality level D. Refer to photo.

Pole down orchard st has electrical cable that comes down then crosses orchard st, marked quality level c.

Pole on the corner of laneway nd orchard rd was located using induction method. Quality level c.

Located power coming out of sub then unhinged boundary line in laneway.
u level c.

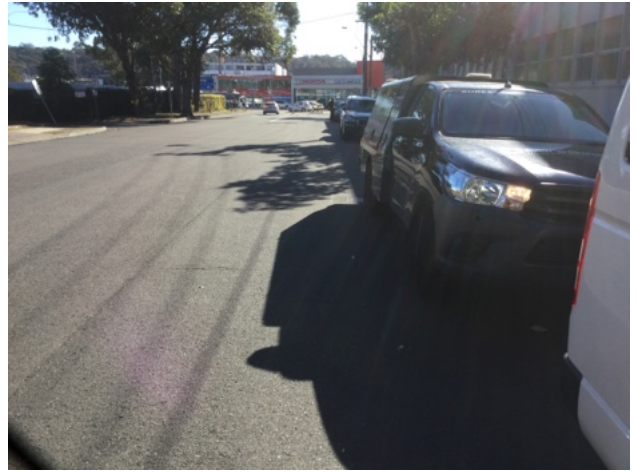
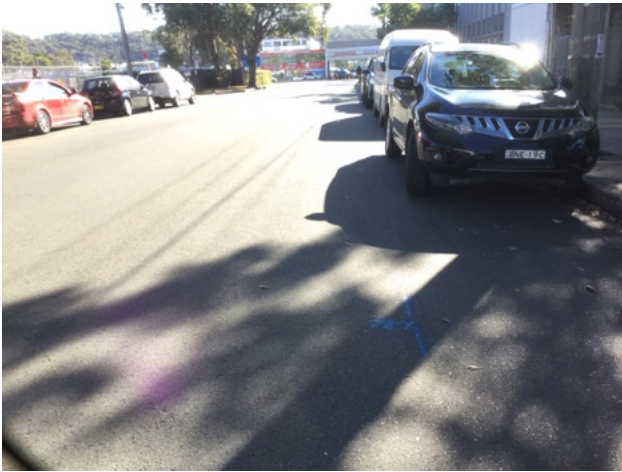
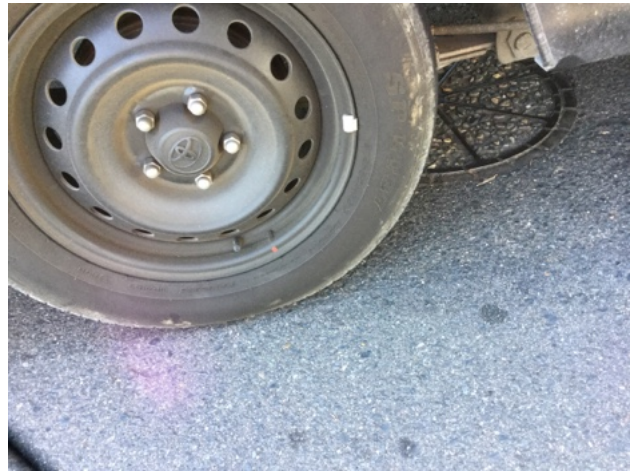
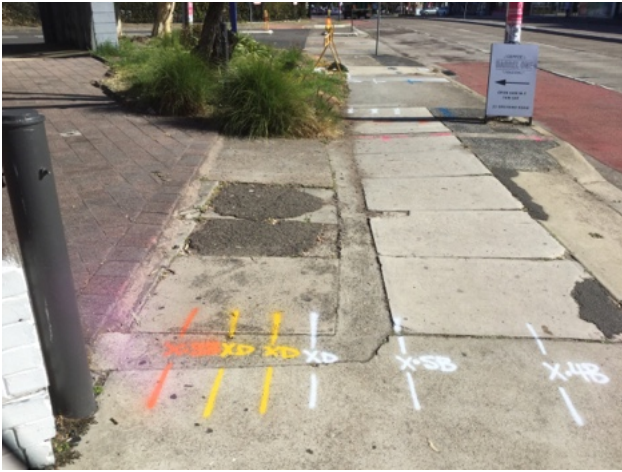
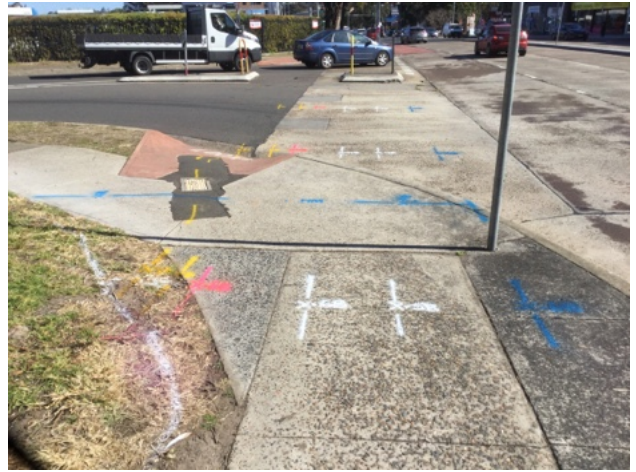
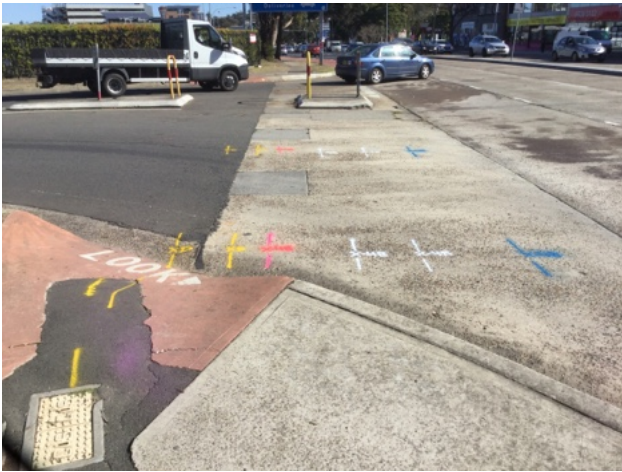
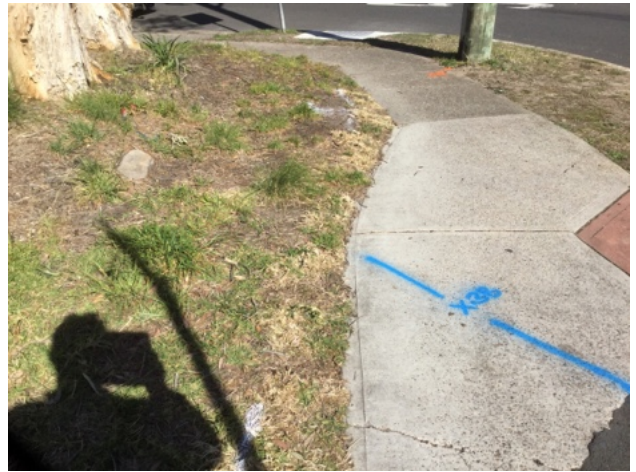
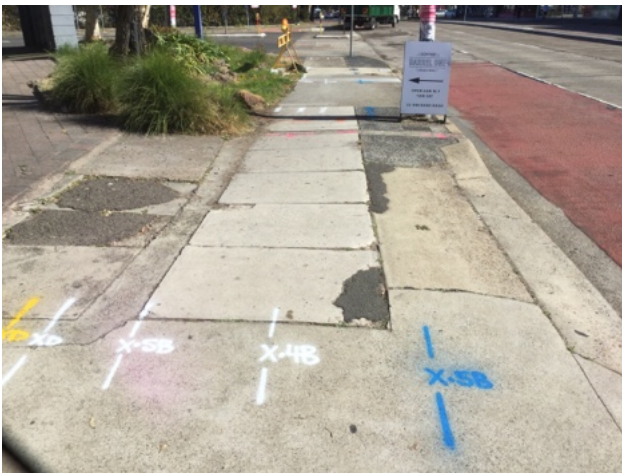
<p>Comments</p>	<p>Traced and marked approximate location of water services.</p> <p>Hooked onto water and traced out to main and traced through scope quality level b.</p> <p>Redundant main running down orchard st, located using induction method quality level C</p> <p>Unable to open sewer pit due to car parked over. Refer to dbyd or further investigation required</p>
-----------------	--

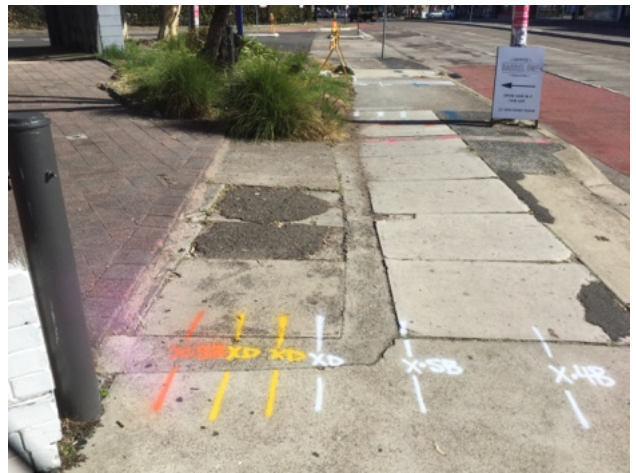
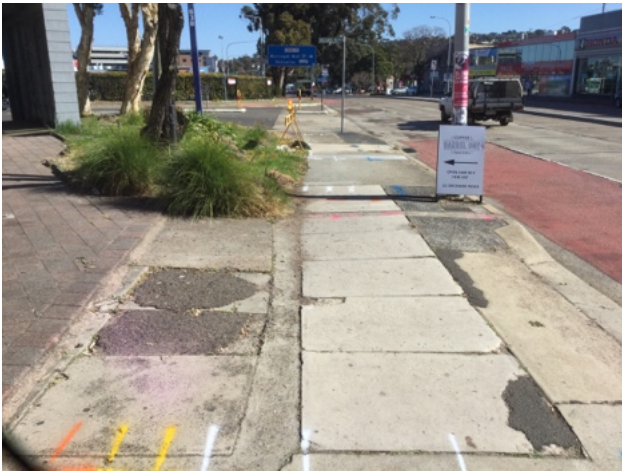
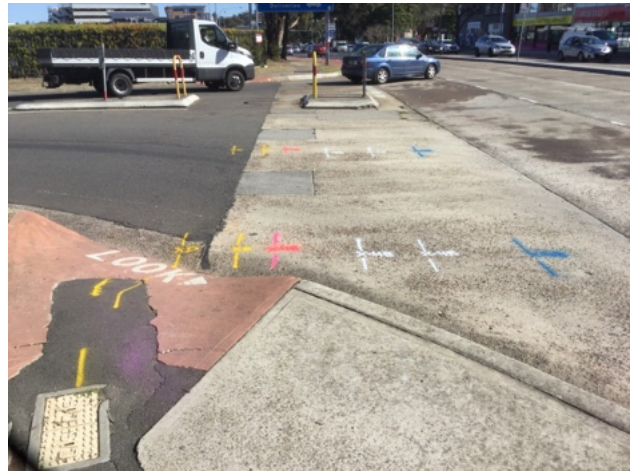
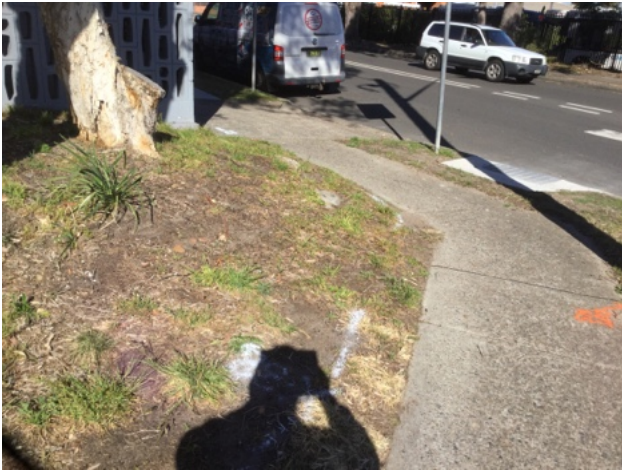
<p>Comments</p>	<p>No gas meters were visible in scope.</p> <p>2 gas mains running through scope. Unable to locate due to no signal. Area too congested with services to differentiate with gpr. Marked quality level D off jemena gas plans.</p>
-----------------	---

Potholing is required prior to any ground disturbance
