83 Parkes Road, Collaroy Plateau

Geotechnical Comments for Section 4.55.

GEOTECHNICAL INVESTIGATION:

New Houses at 83 Parkes Road, Collaroy Plateau

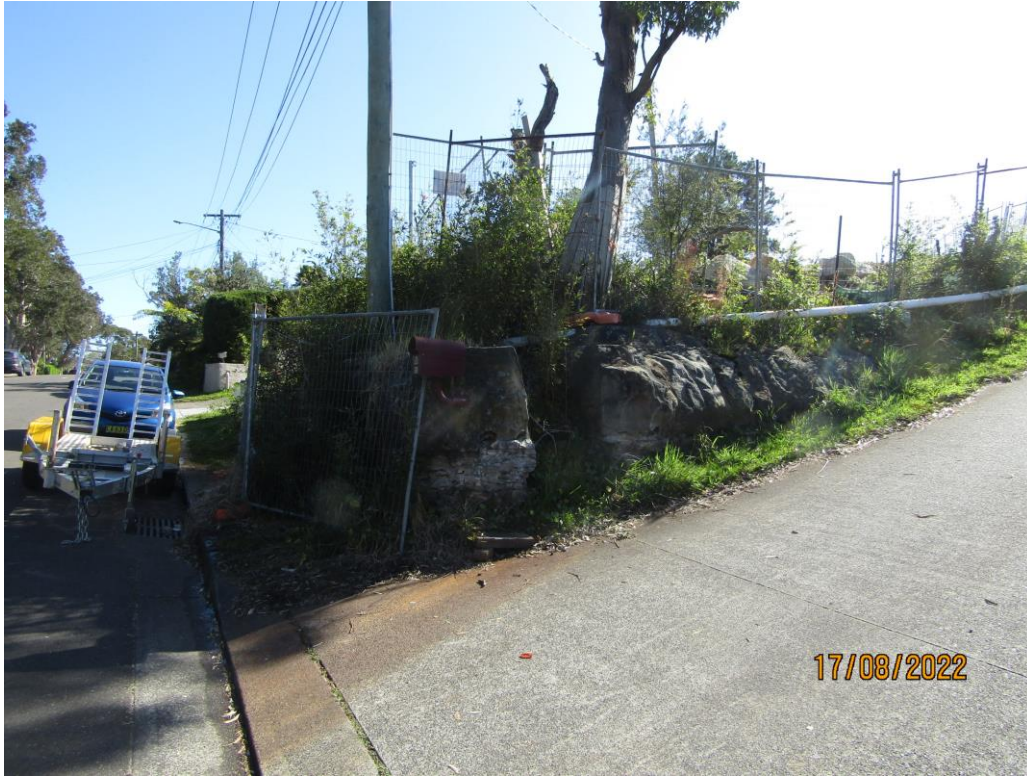
Photo 1

- 2.3** Medium Strength Hawkesbury Sandstone bedrock outcrops at the downhill property boundary (Photo 1). A ~1.4m high cut and fill provides a level platform for the road and reduces the grade of the downhill portion of the property (Photo 2). A formed plastic retaining wall mould has been placed against the lower portion of the cut as a temporary support measure. It is recommended an engineered retaining wall be built to support the cut as part of the proposed works. At the road frontage, a concrete driveway runs up the slope to each vacant lot (Photos 2 to 4). Apart from the

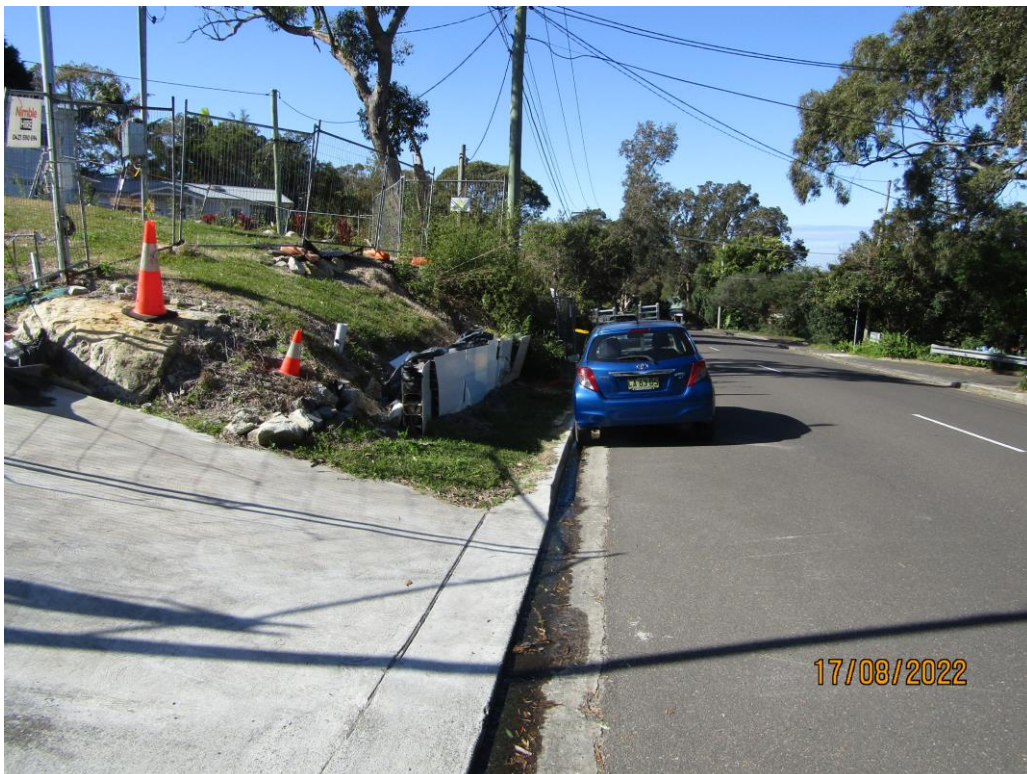
Photo 2

unsupported cut and fill at the road frontage, no signs of slope instability were observed on the property that could have occurred since the property was developed. The adjoining neighbouring properties were observed to be in good order as seen from the street and subject property.

The sides of the cuts through soil/sand that comes flush with the E common boundary and existing driveway will need to be temporarily or permanently supported prior to the commencement of the excavation through rock, or during the excavation process in a staged manner, so cut batters through soil/sand are not left unsupported. The support will need to be designed/approved by the structural engineer. See the site plan attached for the minimum extent of the required shoring shown in blue. No vehicles are to drive over the portion of the existing driveway that comes flush with the excavation until the retaining wall is in place. The driveway is to be barricaded until the retaining wall is in place.

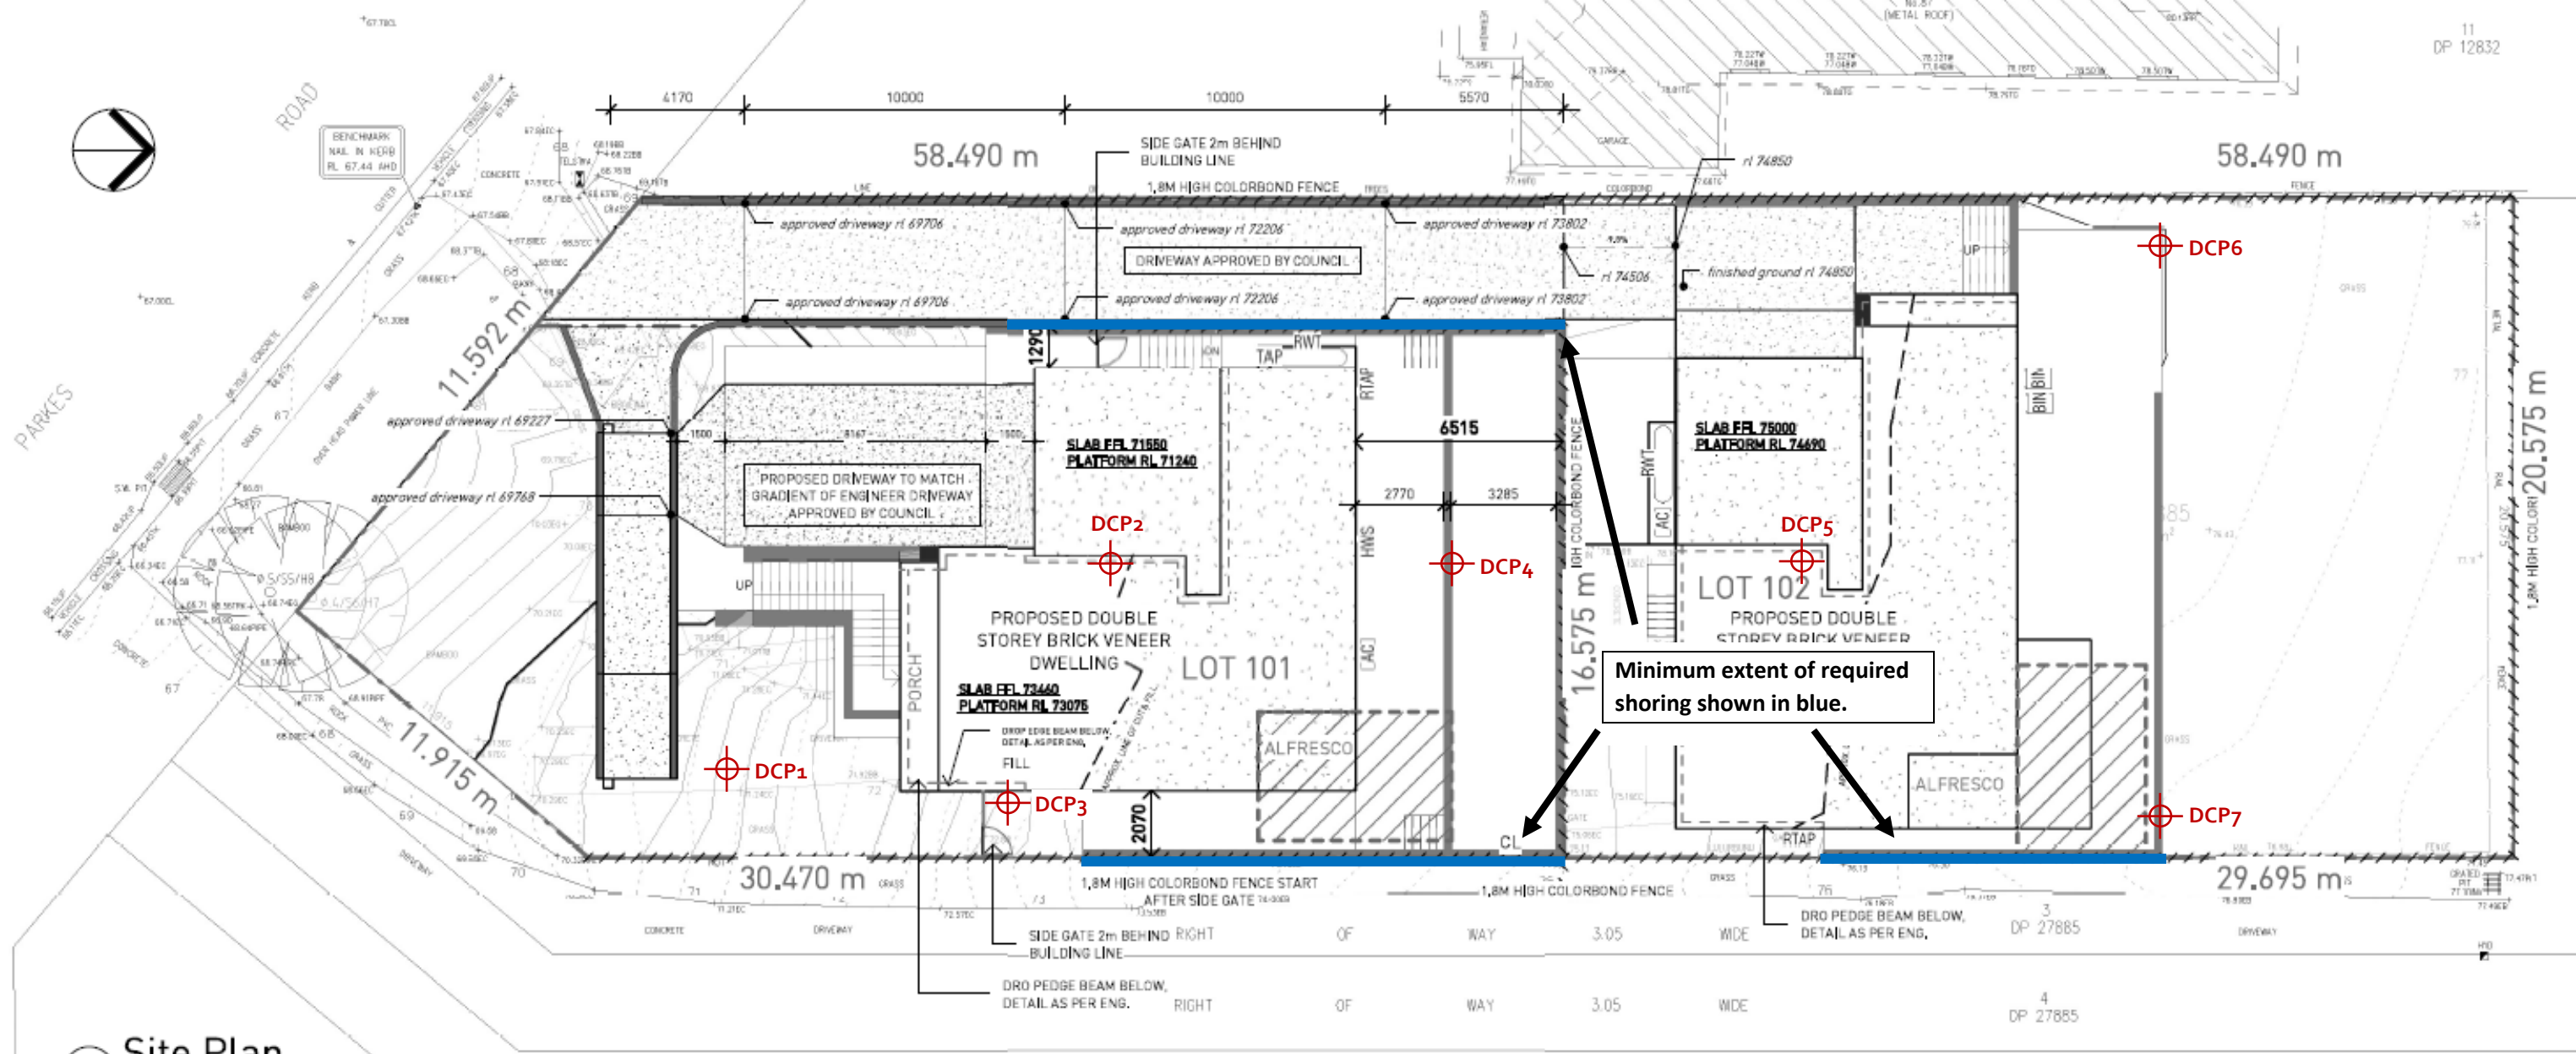
SITE PLAN – showing test locations

Seven Dynamic Cone Penetrometer (DCP) tests were put down to determine the relative density of the overlying soil and the depth to bedrock. The locations of the tests are shown on the site plan. It should be noted that a level of caution should be applied when interpreting DCP test results. The test will not pass through hard buried objects so in some instances it can be difficult to determine whether refusal has occurred on an obstruction in the profile or on the natural rock surface. This is not expected to have been an issue for this site. But due to the possibility that the actual ground conditions vary from our interpretation there should be allowances in the excavation and foundation budget to account for this. We refer to the appended "Important Information about Your Report" to further clarify. The results are as follows:

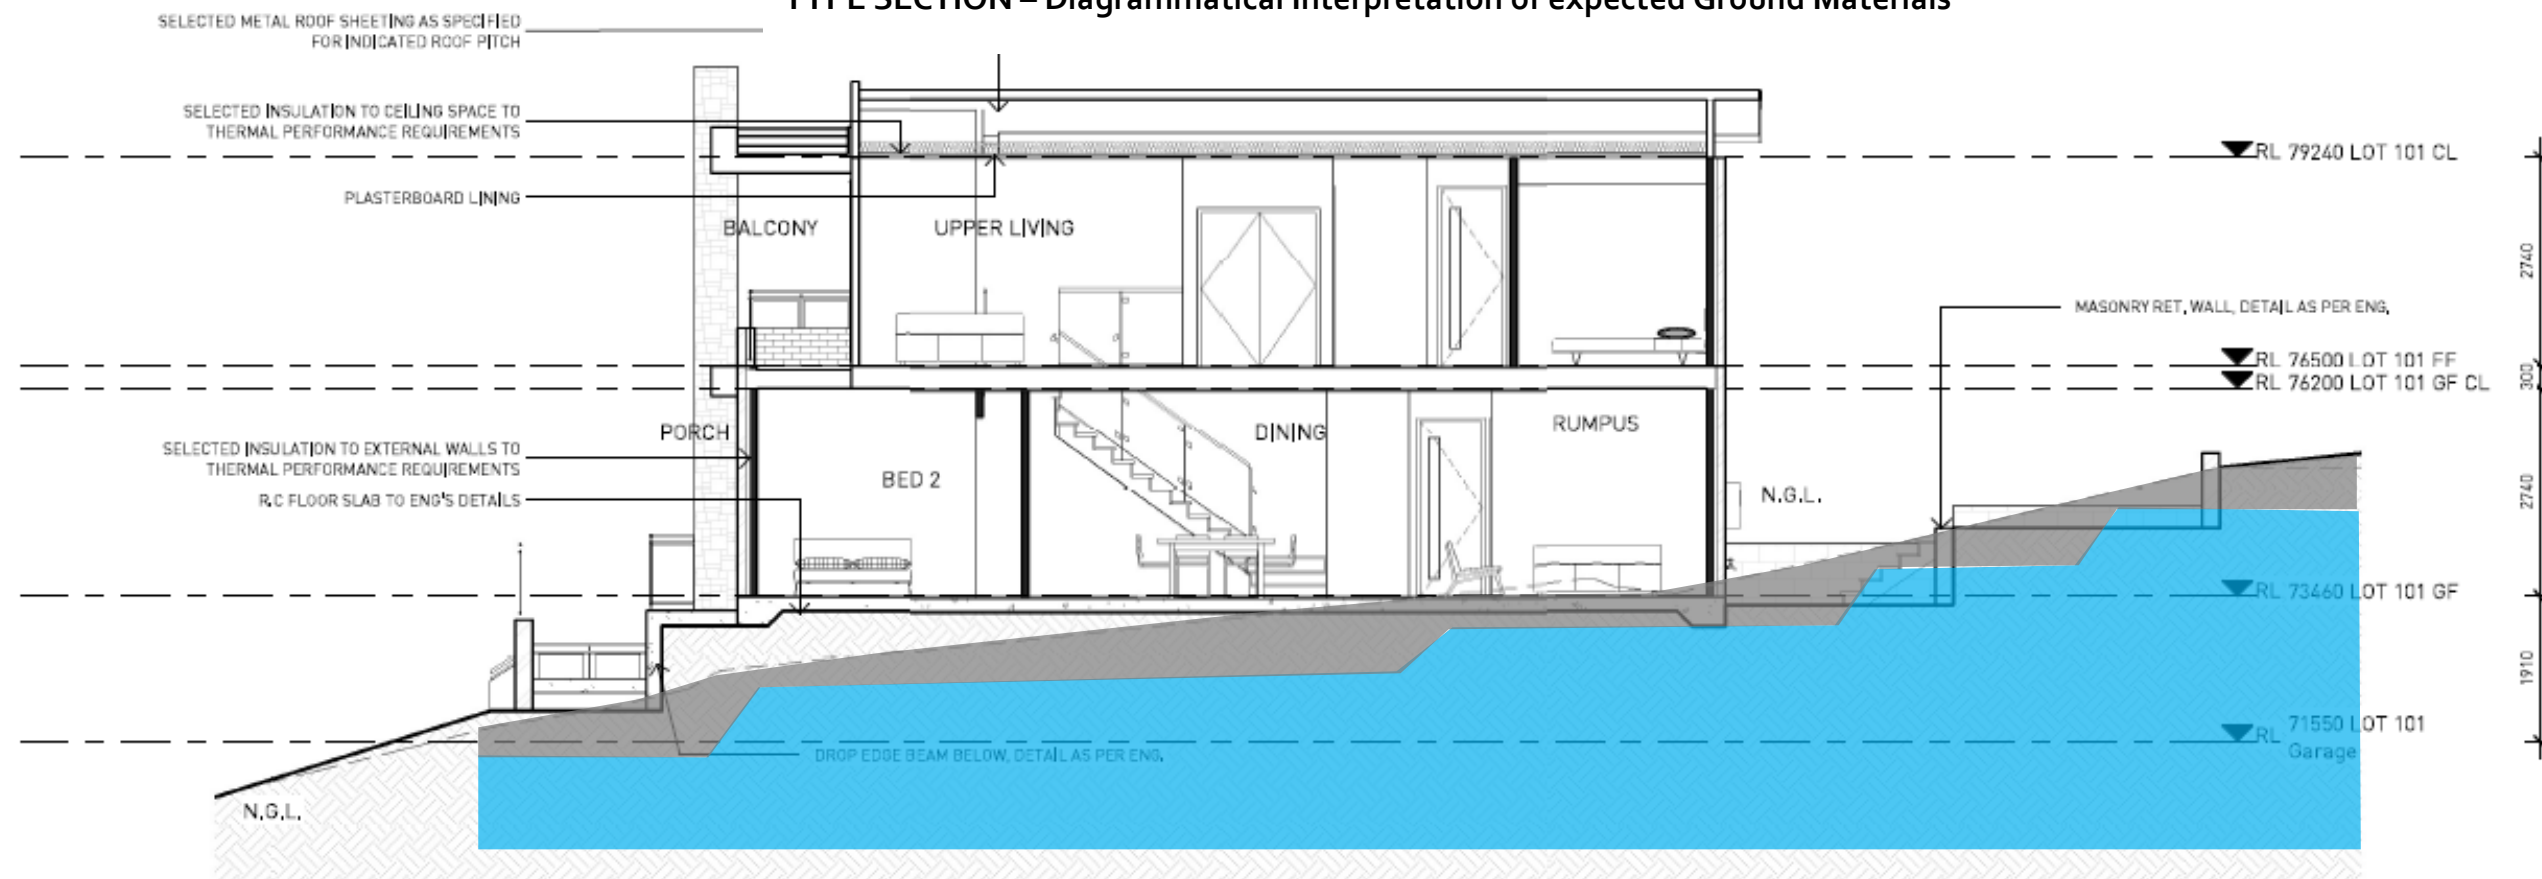
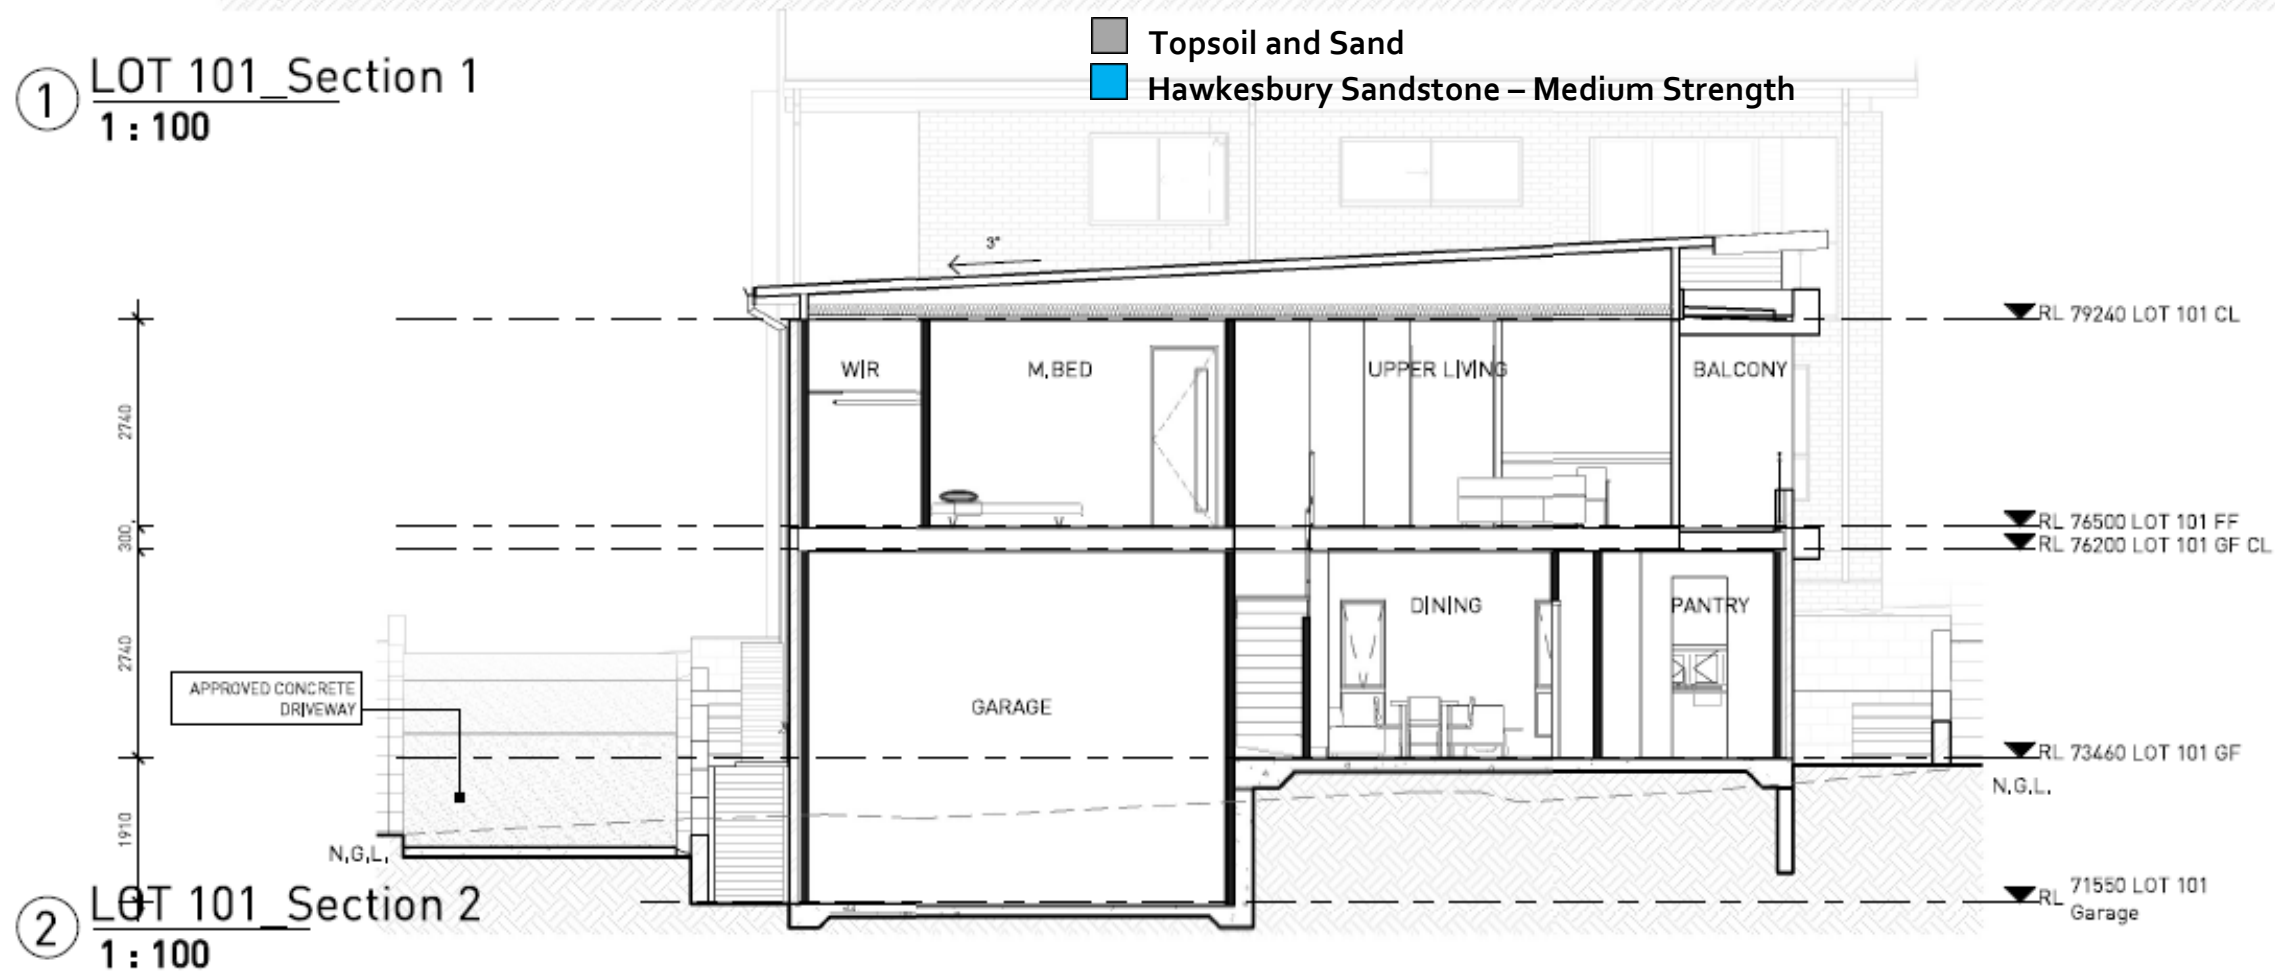
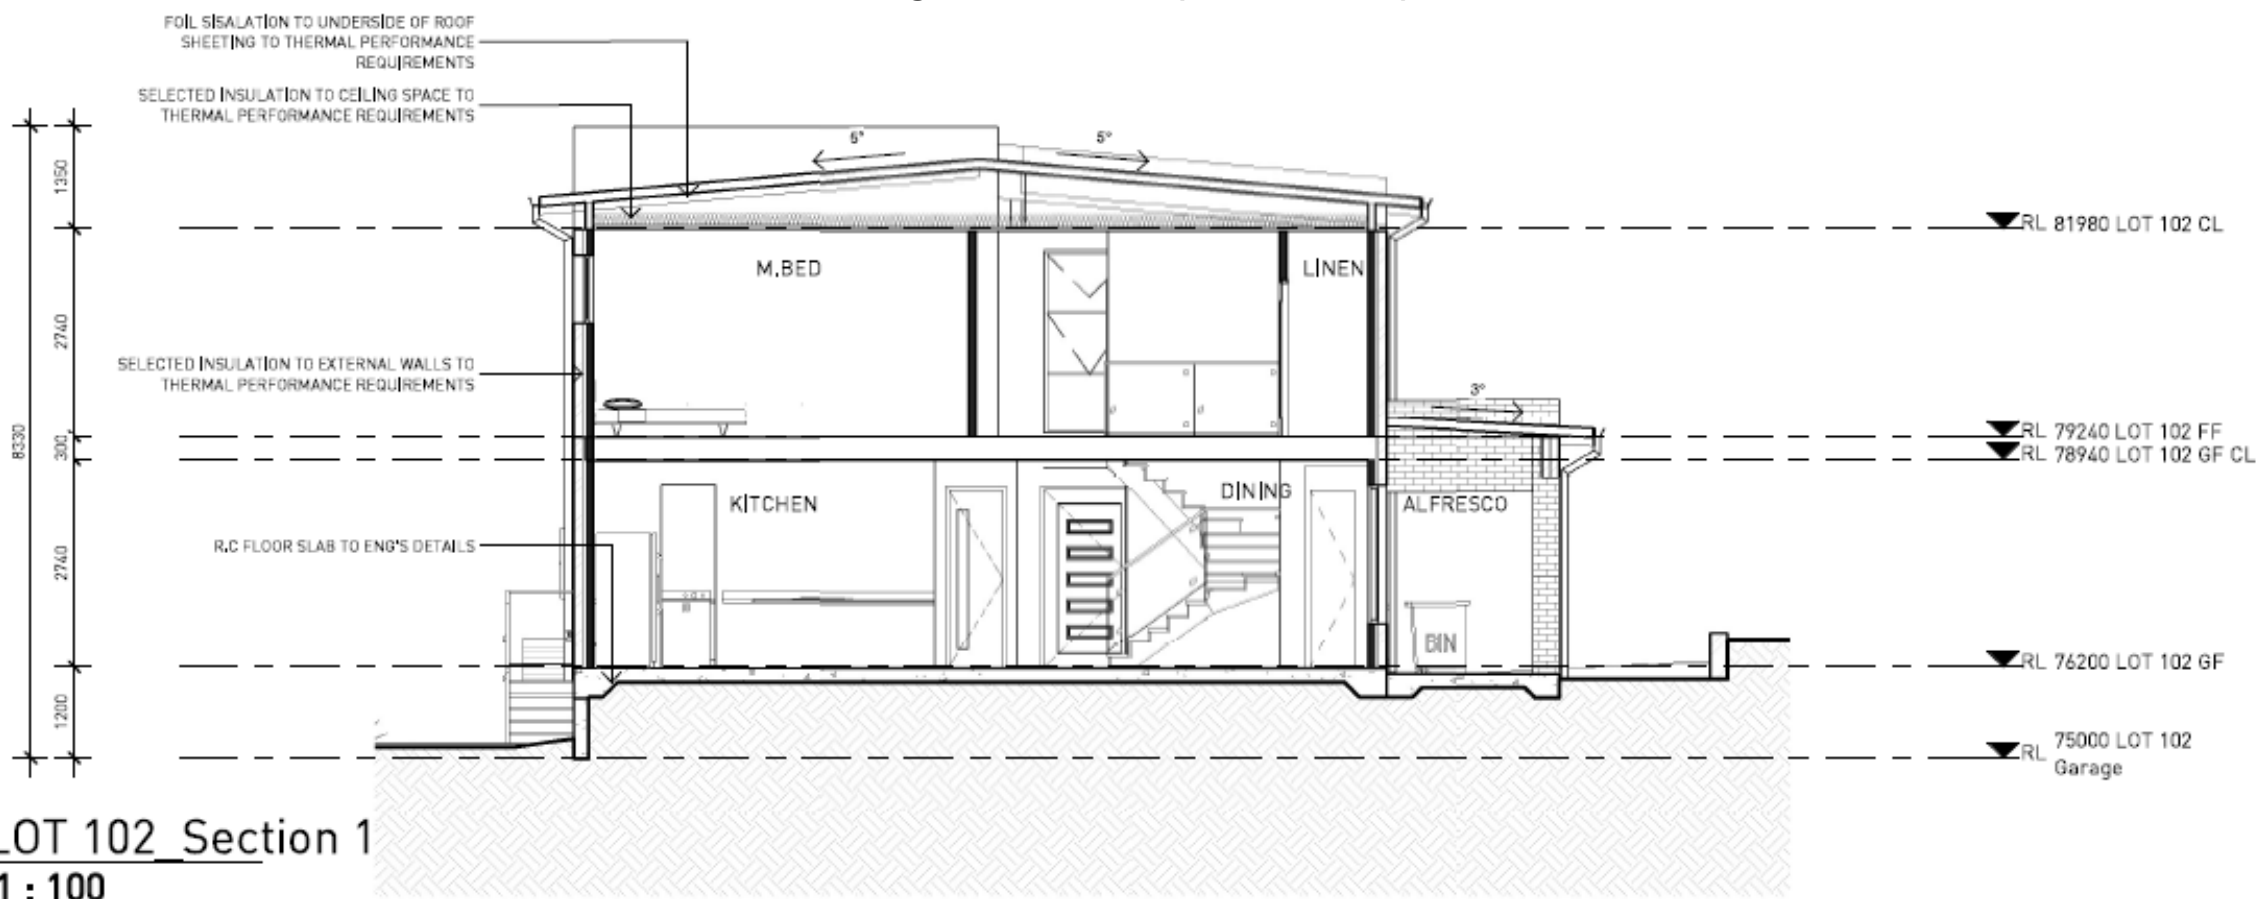
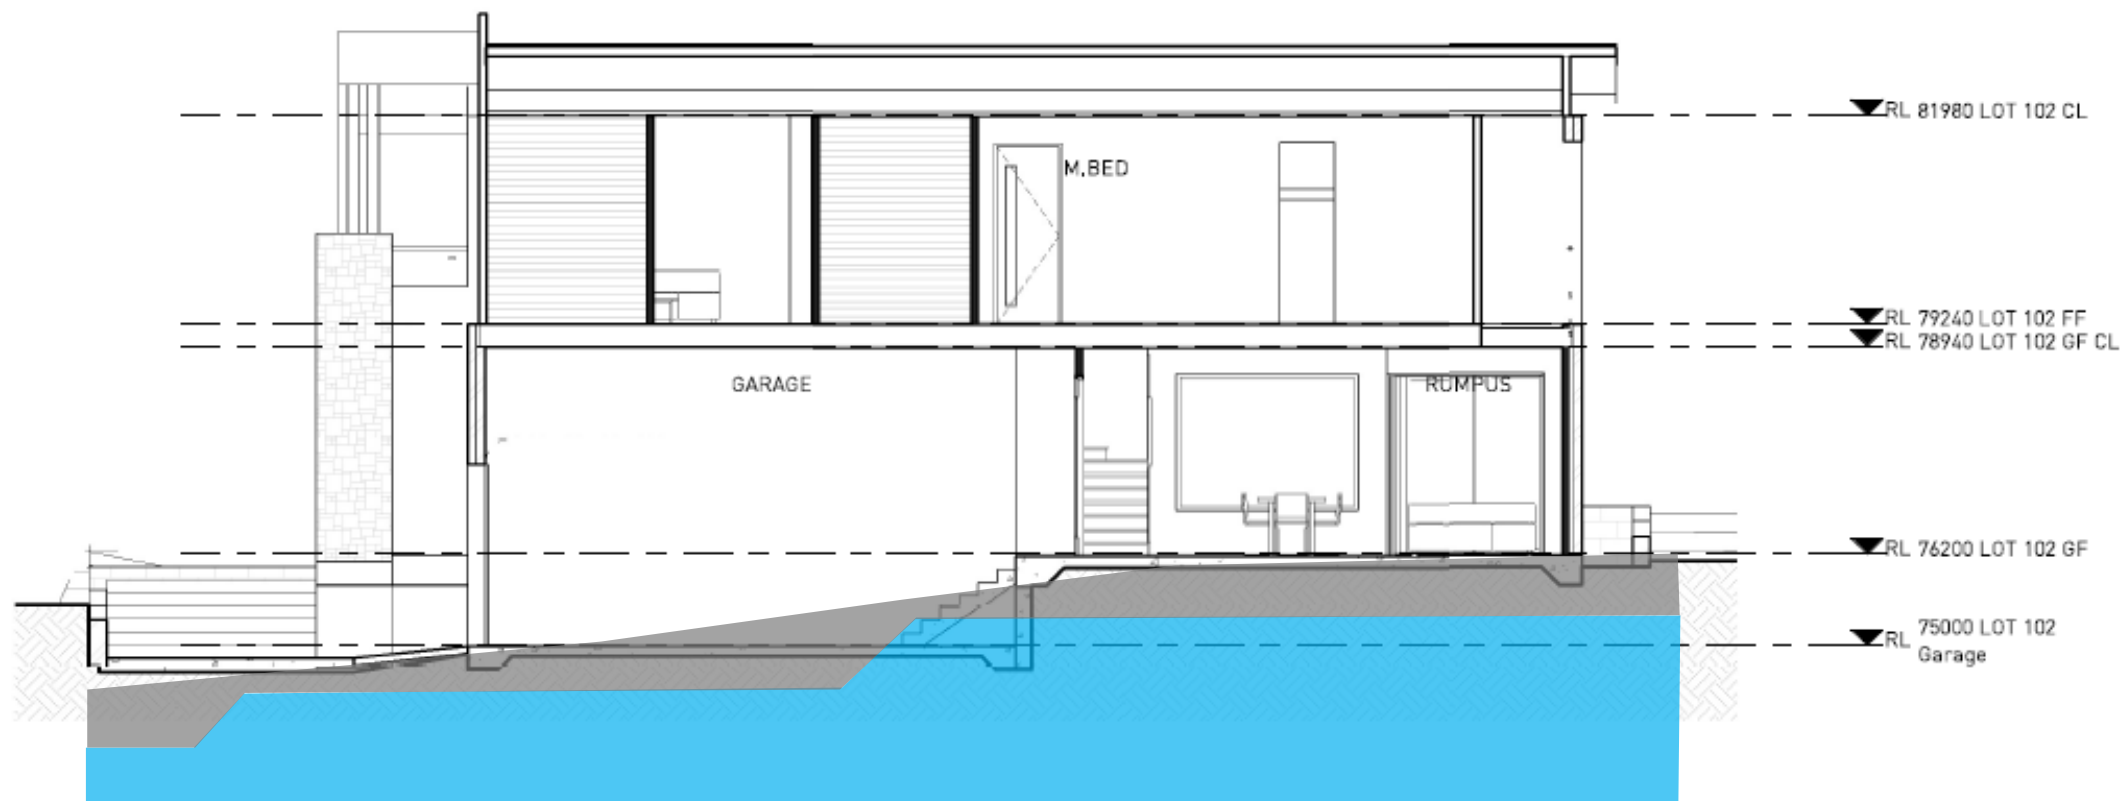
TYPE SECTION – Diagrammatical Interpretation of expected Ground Materials

step formation. Low filling reduces the grade of the slope across the downhill portion of the property. In the test locations, the depth to rock ranged from ~0.2m to ~0.9m below the current surface. The sandstone underlying the property is estimated to be Medium Strength or better as the DCP bounced off the rock surface in all of the tests. See Type Section attached for a diagrammatical representation of the expected ground materials.
