41 Wallumatta Road, Newport

GEOTECHNICAL INVESTIGATION:

Alterations and Additions at 41 Wallumatta Road, Newport

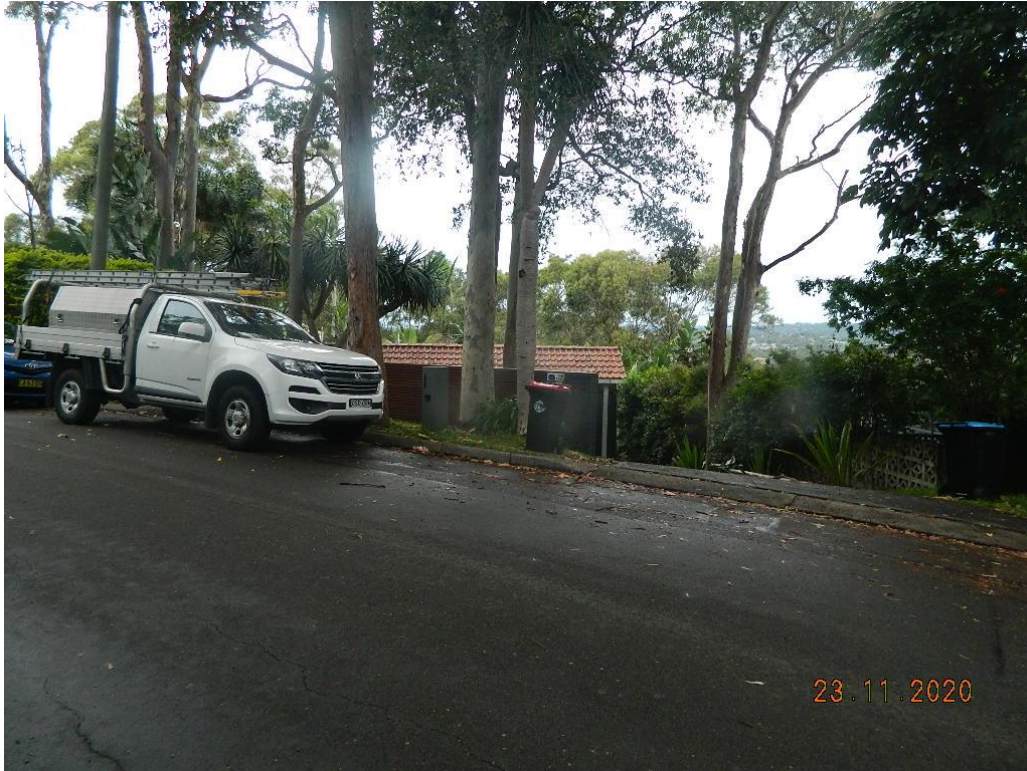
Photo 1

2.3 At the road frontage a concrete driveway runs down the slope to the house (Photos 1 & 2). Fill provides a level platform for a pavement next to the driveway (Photo 3). A stable rendered brick retaining wall up to ~2.1m high supports the fill. The two storey brick and timber clad house is supported by brick walls (Photos 2, 4 & 5). The external supporting walls show no significant signs of movement. A suspended deck supported by steel posts in good condition extends off the downhill side of the house (Photo 5). Fill provides a level lawn and pavement on the downhill side of the house (Photo 6). The fill is supported by stable sandstone flagging and rendered retaining walls up to ~1.3m high. A stable suspended timber deck supported by timber posts is located on the downhill side of the filled lawn (Photo 7). Medium Strength Hawkesbury Sandstone bedrock outcrops on the downhill side of the property (Photos 7 & 8). Stable sandstone joint blocks are embedded in the moderate slope on the downhill side of the property (Photos 9 & 10). No signs of slope instability that could have occurred since the site was developed were observed on the property. The adjoining neighbouring properties were observed to be in good order as seen from the street and subject property.

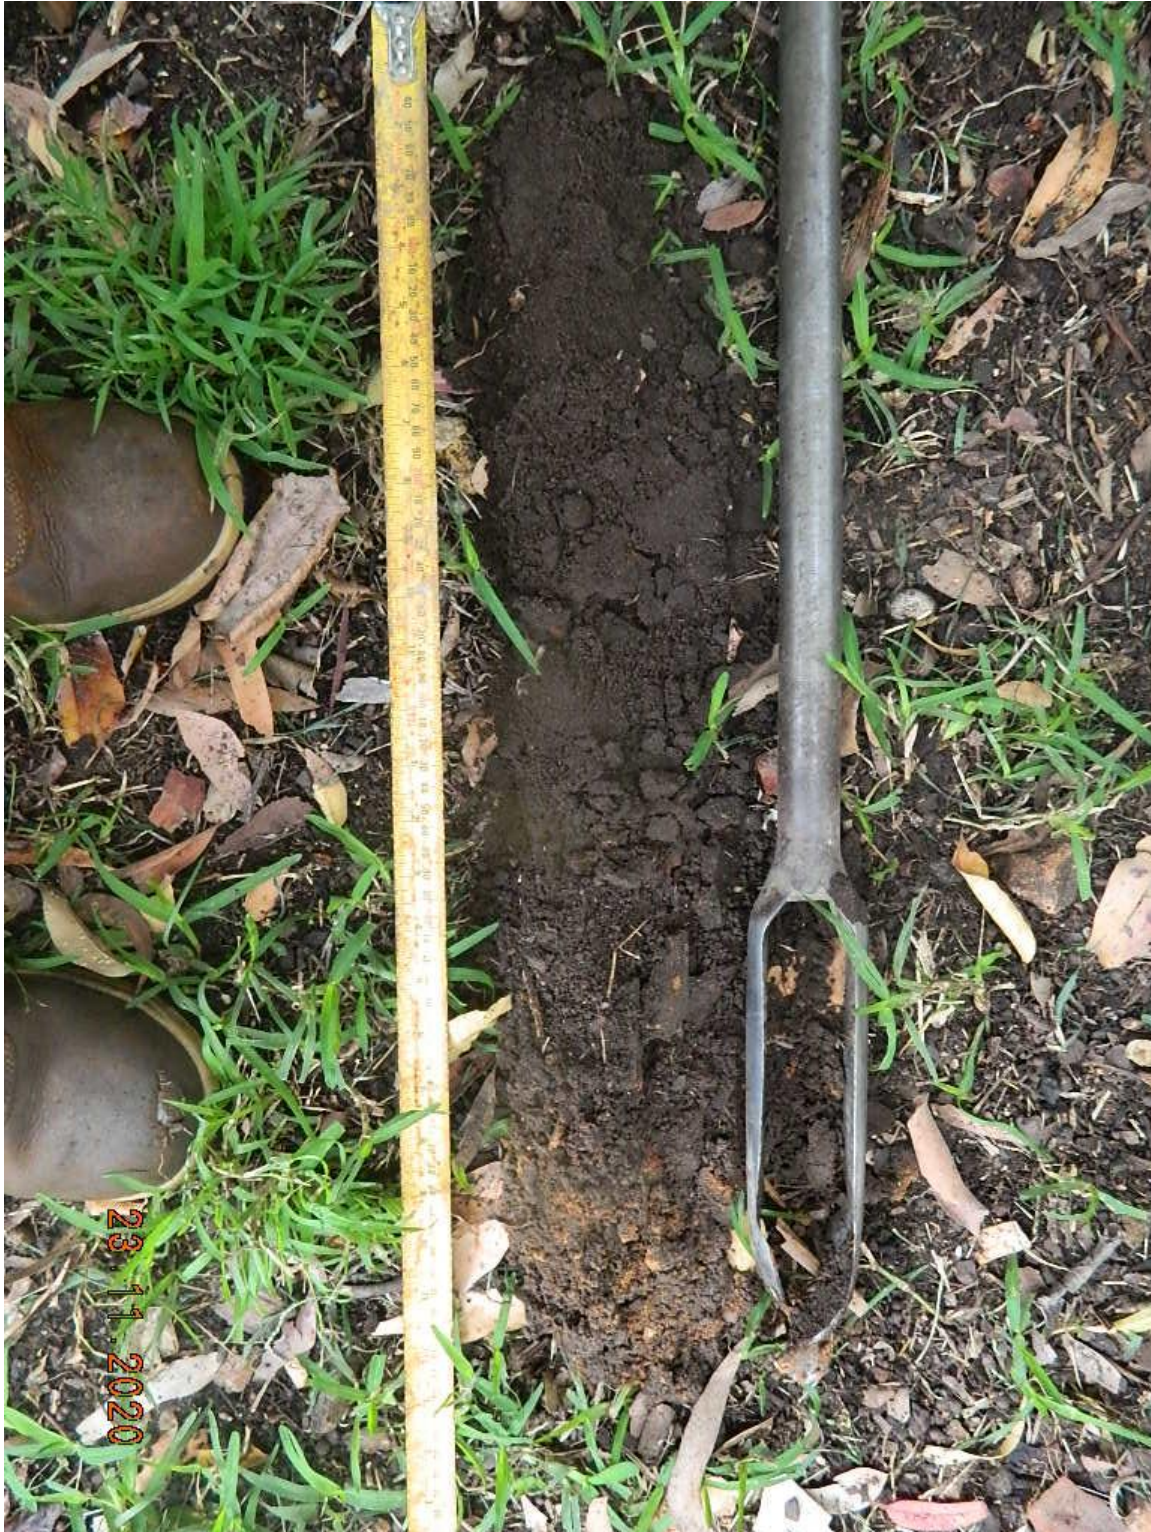
AUGER HOLE 1 (~RL50.1) – AH1 (photo 11)

Depth (m)	Material Encountered
0.0 to 0.5	TOPSOIL , sandy soil, dark brown, moist, fine to medium grained with fine trace organic matter.
0.5 to 0.6	CLAYEY SAND , grey and orange, damp.

Refusal @ 0.6m in clayey sand. No watertable encountered.

Photo 11: AH1 – Downhole is from top to bottom

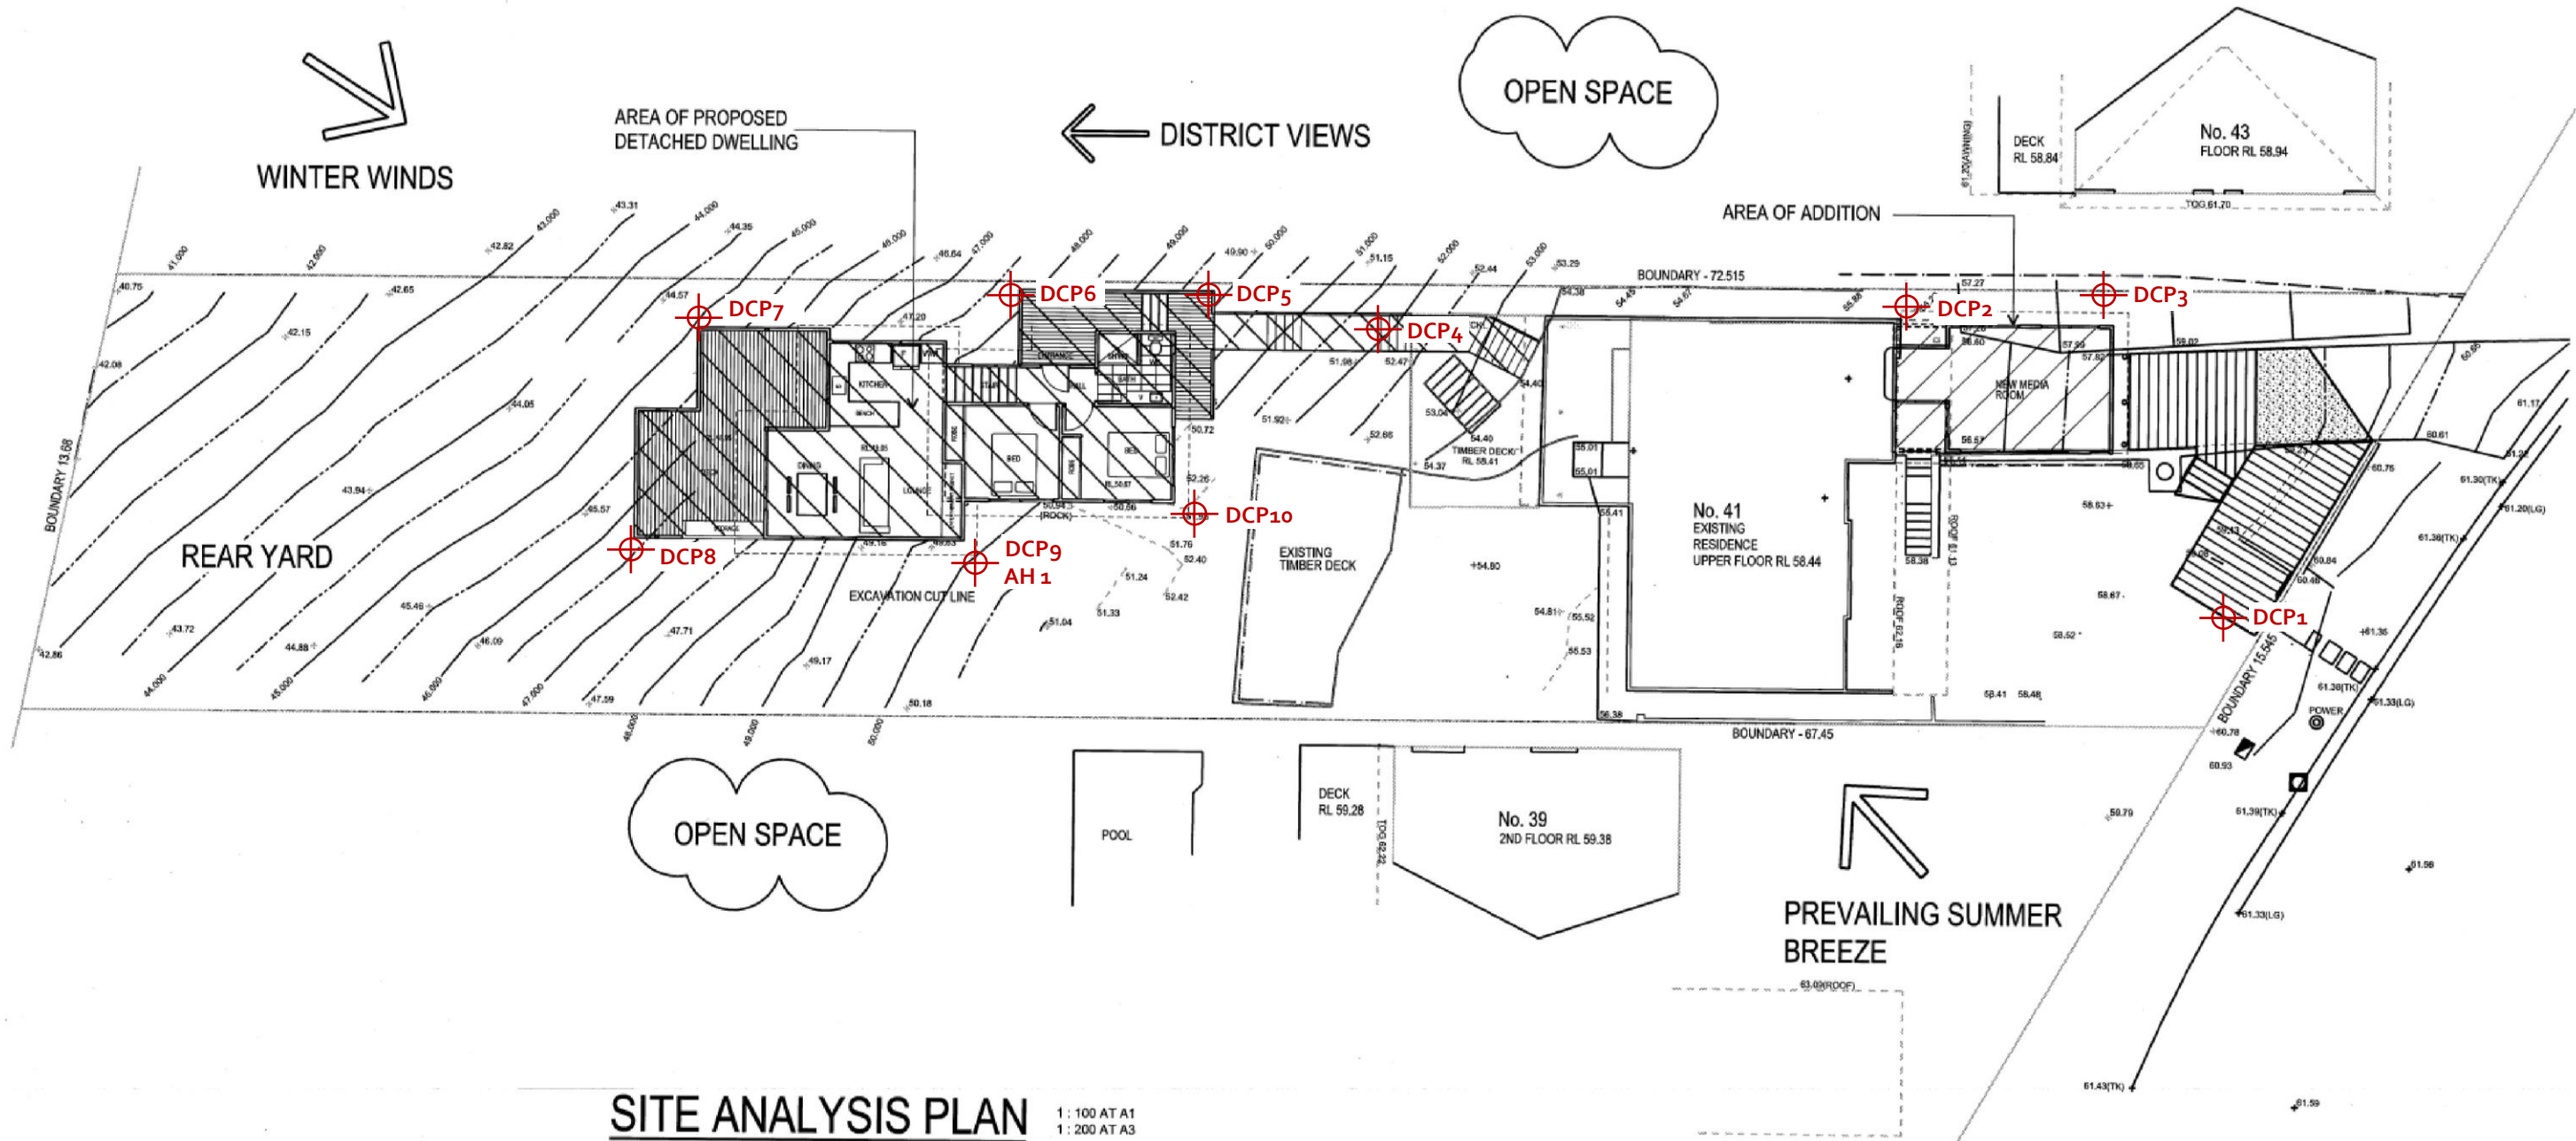
SITE PLAN – showing test locations

One auger hole was put down to identify the soil materials. Ten Dynamic Cone Penetrometer (DCP) tests were put down to determine the relative density of the overlying soil and the depth to weathered rock. The locations of the tests are shown on the site plan. It should be noted that a level of caution should be applied when interpreting DCP test results. The test will not pass through hard buried objects so in some instances it can be difficult to determine whether refusal has occurred on an obstruction in the profile or on the natural rock surface.
