## Preliminary Geotechnical Assessment

For Alterations & Additions at

**133 Owen Stanley Avenue, Allambie Heights NSW**

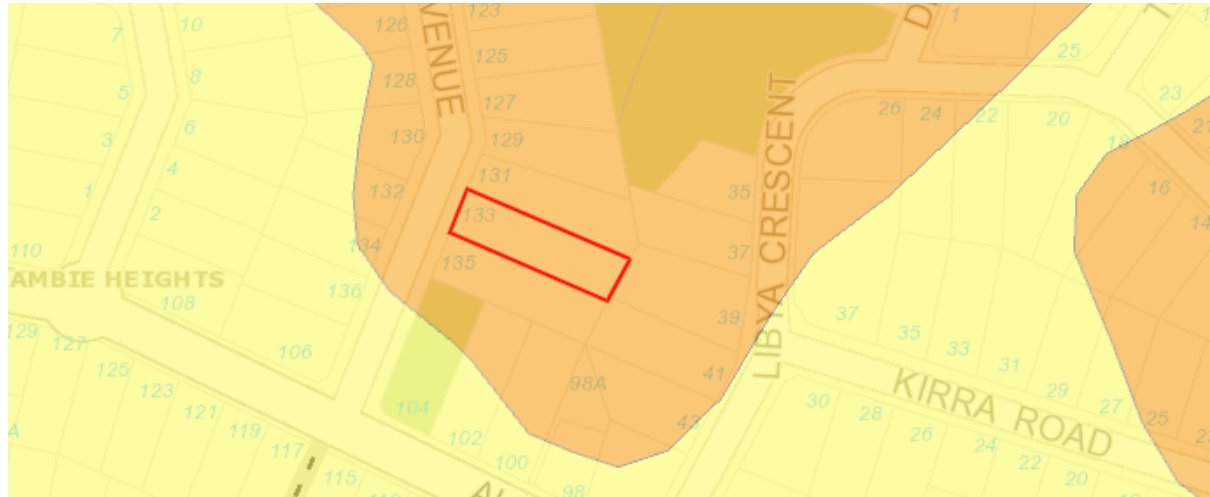
The site is mapped as **Area B** on the Landslip Risk Map WLEP 2011 (**Image 1**, below).
