J2527. 19th December, 2019. Page 1.

GEOTECHNICAL INVESTIGATION:

Alterations and Additions at 36 Watkins Road, Avalon

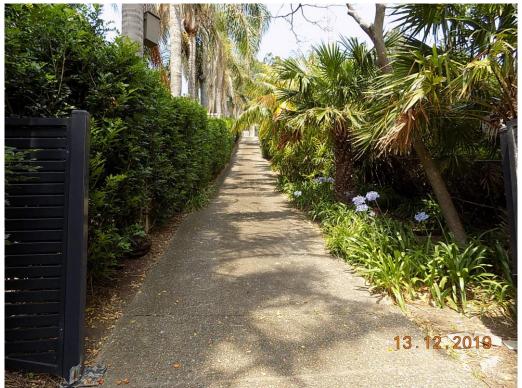
Photo 1

- 2.3 At the road frontage, a long concrete driveway runs up the slope to a garage on the lower ground floor of the house and to a partially suspended parking area on the downhill side of the house (Photos 1, 2, & 3). The parking area is supported by concrete columns that stand vertical (Photo 4). Filling has been placed on the slope between the lower common boundary and the parking area for a level lawn area. The

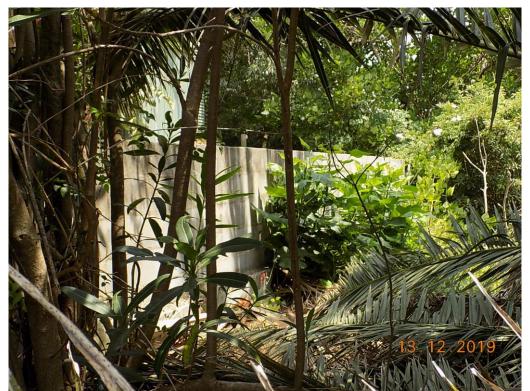
Photo 5

fill is supported by a ~1.3m high concrete block retaining wall (Photo 5). The wall displays some cracking through the blocks but no signs of deflection. Thus, the wall is considered stable. Two more fills above are supported by stable treated timber retaining walls ~1.0m high (Photo 6). The part three-storey brick house is supported on brick walls and brick piers (Photo 7). No significant signs of movement were observed in the supporting brick walls and the supporting brick piers stand vertical. Some of the supporting walls and piers were observed to be supported directly off outcropping competent Medium Strength Sandstone. A pool has been cut into the slope on the N side of the house (Photo 8). The water level of the pool indicates no ground movement has occurred in the shell of the pool since its construction. The cut for the pool area has been taken entirely through Medium Strength Sandstone. No significant geological defects were observed in the cut face and it is considered stable. The slope above the pool cut is terraced with two timber retaining walls that will be rebuilt as part of the proposed works (Photo 9). A small stable outbuilding and viewing platform has been constructed in the NE corner of the property (Photo 10). Denselyvegetated undisturbed bushland rises from above the upper boundary to the top of a ~70m high sea cliff (Photo 11). The sea cliff was observed from a distance (Photo 12). It consists of competent, alternating massively and thinly bedded sandstone and shale/laminite. The cliff face displays no significant undercutting or other significant geological defects that could affect its stability. The rock platform has a covering of dislodged sandstone boulders at the cliff base.

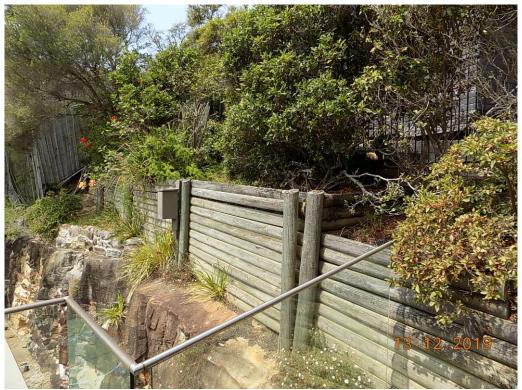
Photo 9

The existing timber retaining walls above the pool will be demolished and rebuilt as part of the proposed works (Photo 9). The walls is to be dismantled in an orderly manner and rebuilt following the requirements below.

All retaining walls are to have sufficient back-wall drainage and be backfilled immediately behind the wall with free-draining material (such as gravel). This material is to be wrapped in a non-woven Geotextile fabric (i.e. Bidim A34 or similar), to prevent the drainage from becoming clogged with silt and clay. If no back-wall drainage is installed in retaining walls, the likely hydrostatic pressures are to be accounted for in the structural design.

The proposed retaining walls above the existing pool will be founded on Medium Strength

Sandstone. This is a suitable bearing material for a concrete retaining wall footing or a gravity

wall. It is also suitable to support bar grouted into the rock to hold the wall in place.

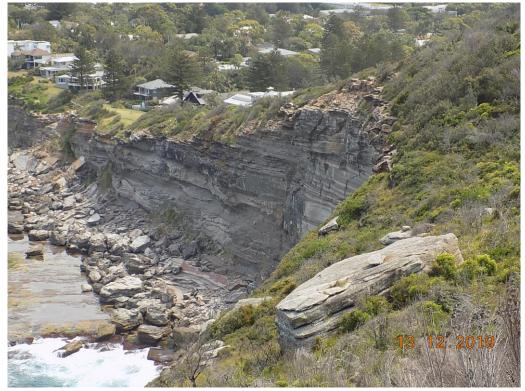
Photo 12

hazard (Hazard One). The sea cliff face that falls beyond the upper boundary is a potential

HAZARDS	Hazard One	Hazard Two	
TYPE	The moderate to steep slope that falls		
	across the property and continues	The sea cliff face failing and impacting	
	above and below failing and	on the proposed works (Photo 12).	
	impacting on the property.		
LIKELIHOOD	'Unlikely' (10 ⁻⁴)	'Rare' (10 ⁻⁵)	
CONSEQUENCES TO PROPERTY	'Medium' (20%)	'Major' (40%)	
RISK TO PROPERTY	'Low' (2 x 10 ⁻⁵)	'Low' (6 x 10 ⁻⁵)	
RISK TO LIFE 8.3 x 10 ⁻⁷ /annum		9.96 x 10 ⁻⁶ /annum	
COMMENTS	'ACCEPTABLE' level of risk to life &	'ACCEPTABLE' level of risk to life &	
	property.	property.
