GEOTECHNICAL INVESTIGATION:

Alterations and Additions at 10 Kookaburra Close, Bayview

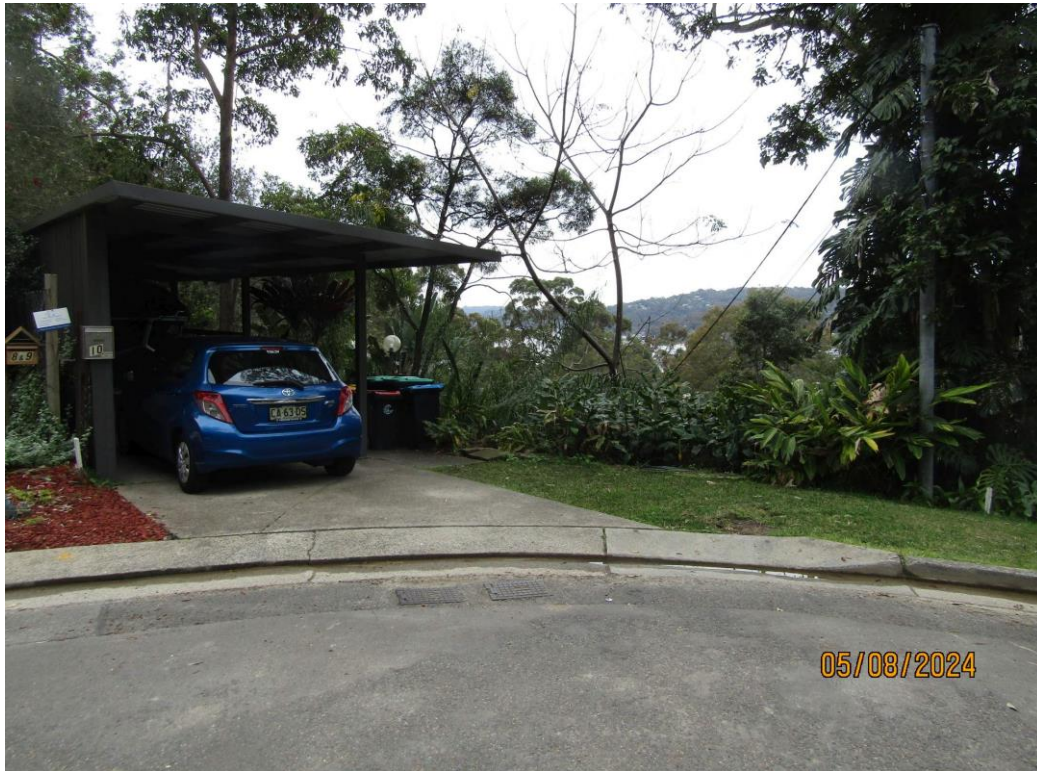
Photo 1

2.3 At the road frontage, a concrete driveway runs to a carport on the uphill side of the property (Photo 1). Fill to an unknown depth provides a level platform for the downhill side for the carport, entry pathway, and road reserve. The fill batter merges into the natural steep moderately-vegetated slope at the uphill side of the house (Photo 2). The SE side of the house has been terraced with a series of treated timber retaining walls. The uppermost wall is ~1.0m high and is tilting downslope significantly (Photo 3). See ‘**Section 16** Ongoing Maintenance’. The part two storey house is supported on brick walls (Photos 4 & 5). The external supporting walls show no significant signs of movement. A timber balcony with deck below extends off the downhill side of the house (Photo 5). The posts that support the balcony and deck stand vertical. The slope underneath and beside the deck has been terraced with a series of timber retaining walls up to ~1.5m high (Photos 6 to 8). One of the timber retaining walls is tilting downslope significantly (Photos 7 & 8). See ‘**Section 16** Ongoing Maintenance’.

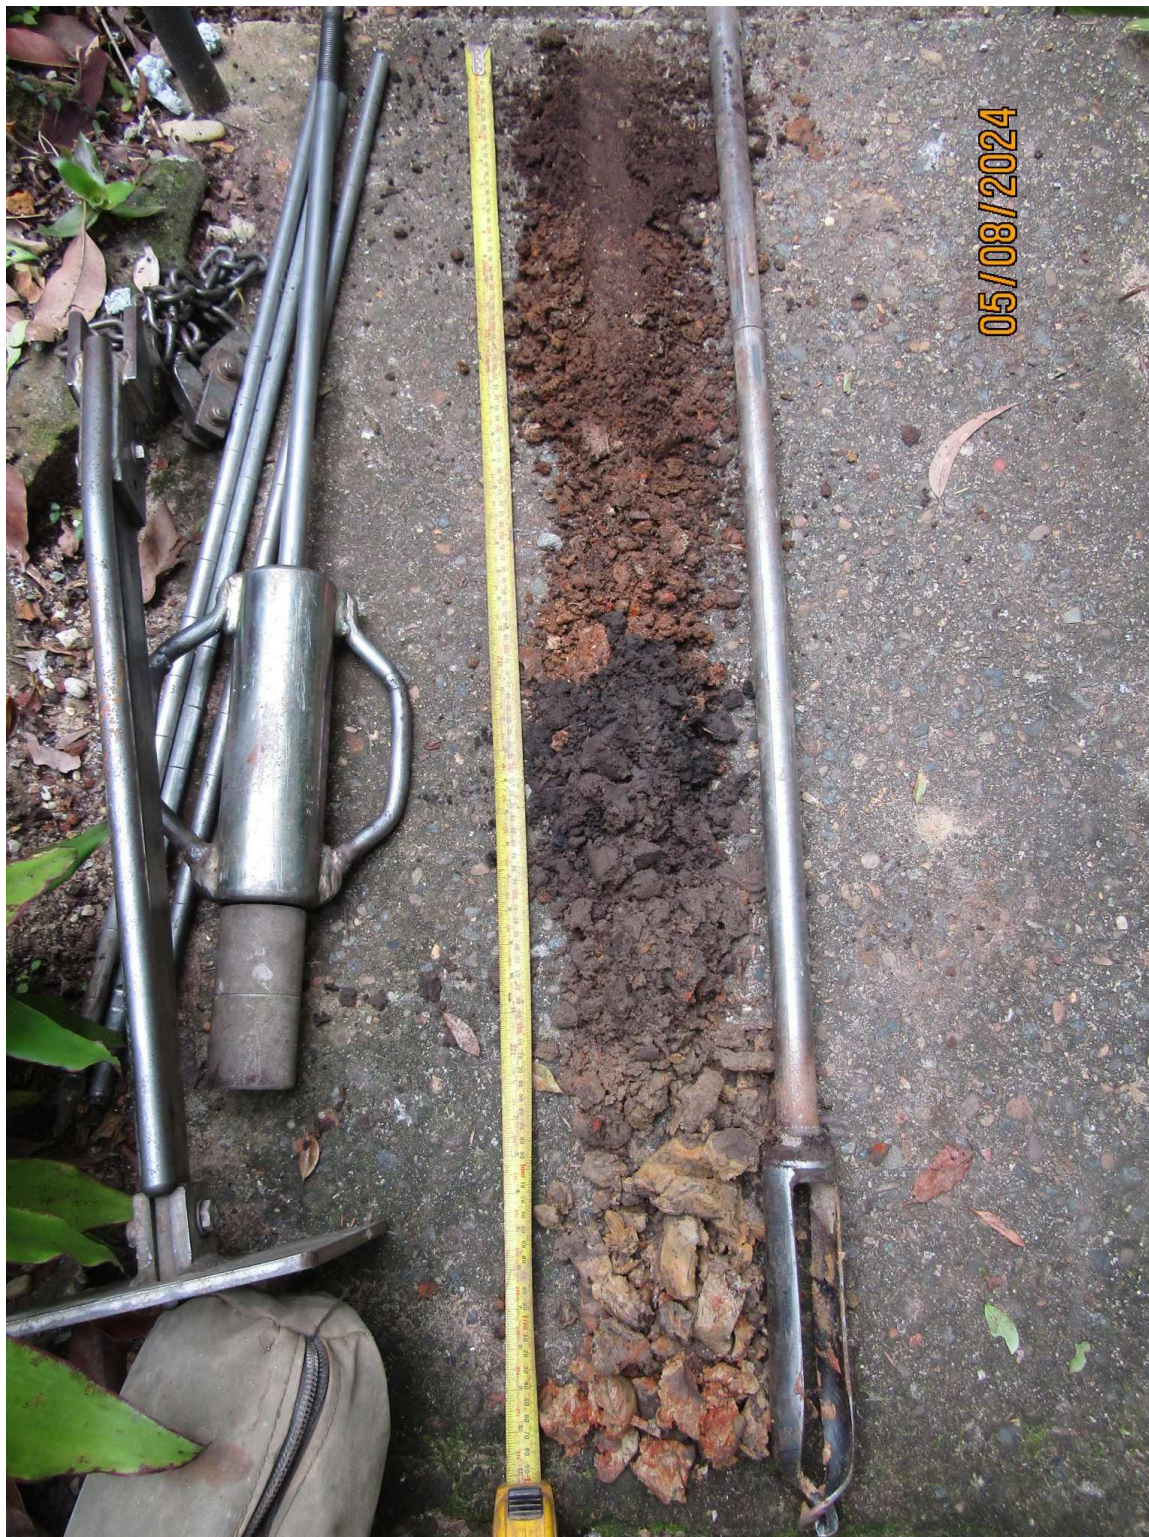
Photo 9: AH1 – Downhole is from top to bottom.

AUGER HOLE 1 (~RL52.9) – AH1 (Photo 9)

Depth (m)	Material Encountered
0.0 to 0.6	FILL , sandy soil and clay, with some rock fragments, dark brown, brown, orange, moist, fine to coarse grained.
0.6 to 1.0	TOPSOIL , sandy soil and silty sand, dark brown, brown, damp, fine to medium grained.
1.0 to 1.2	CLAY , light orange brown, grey, maroon, mottled, stiff, moist.

End of hole @ 1.2m in stiff clay. No water table encountered.

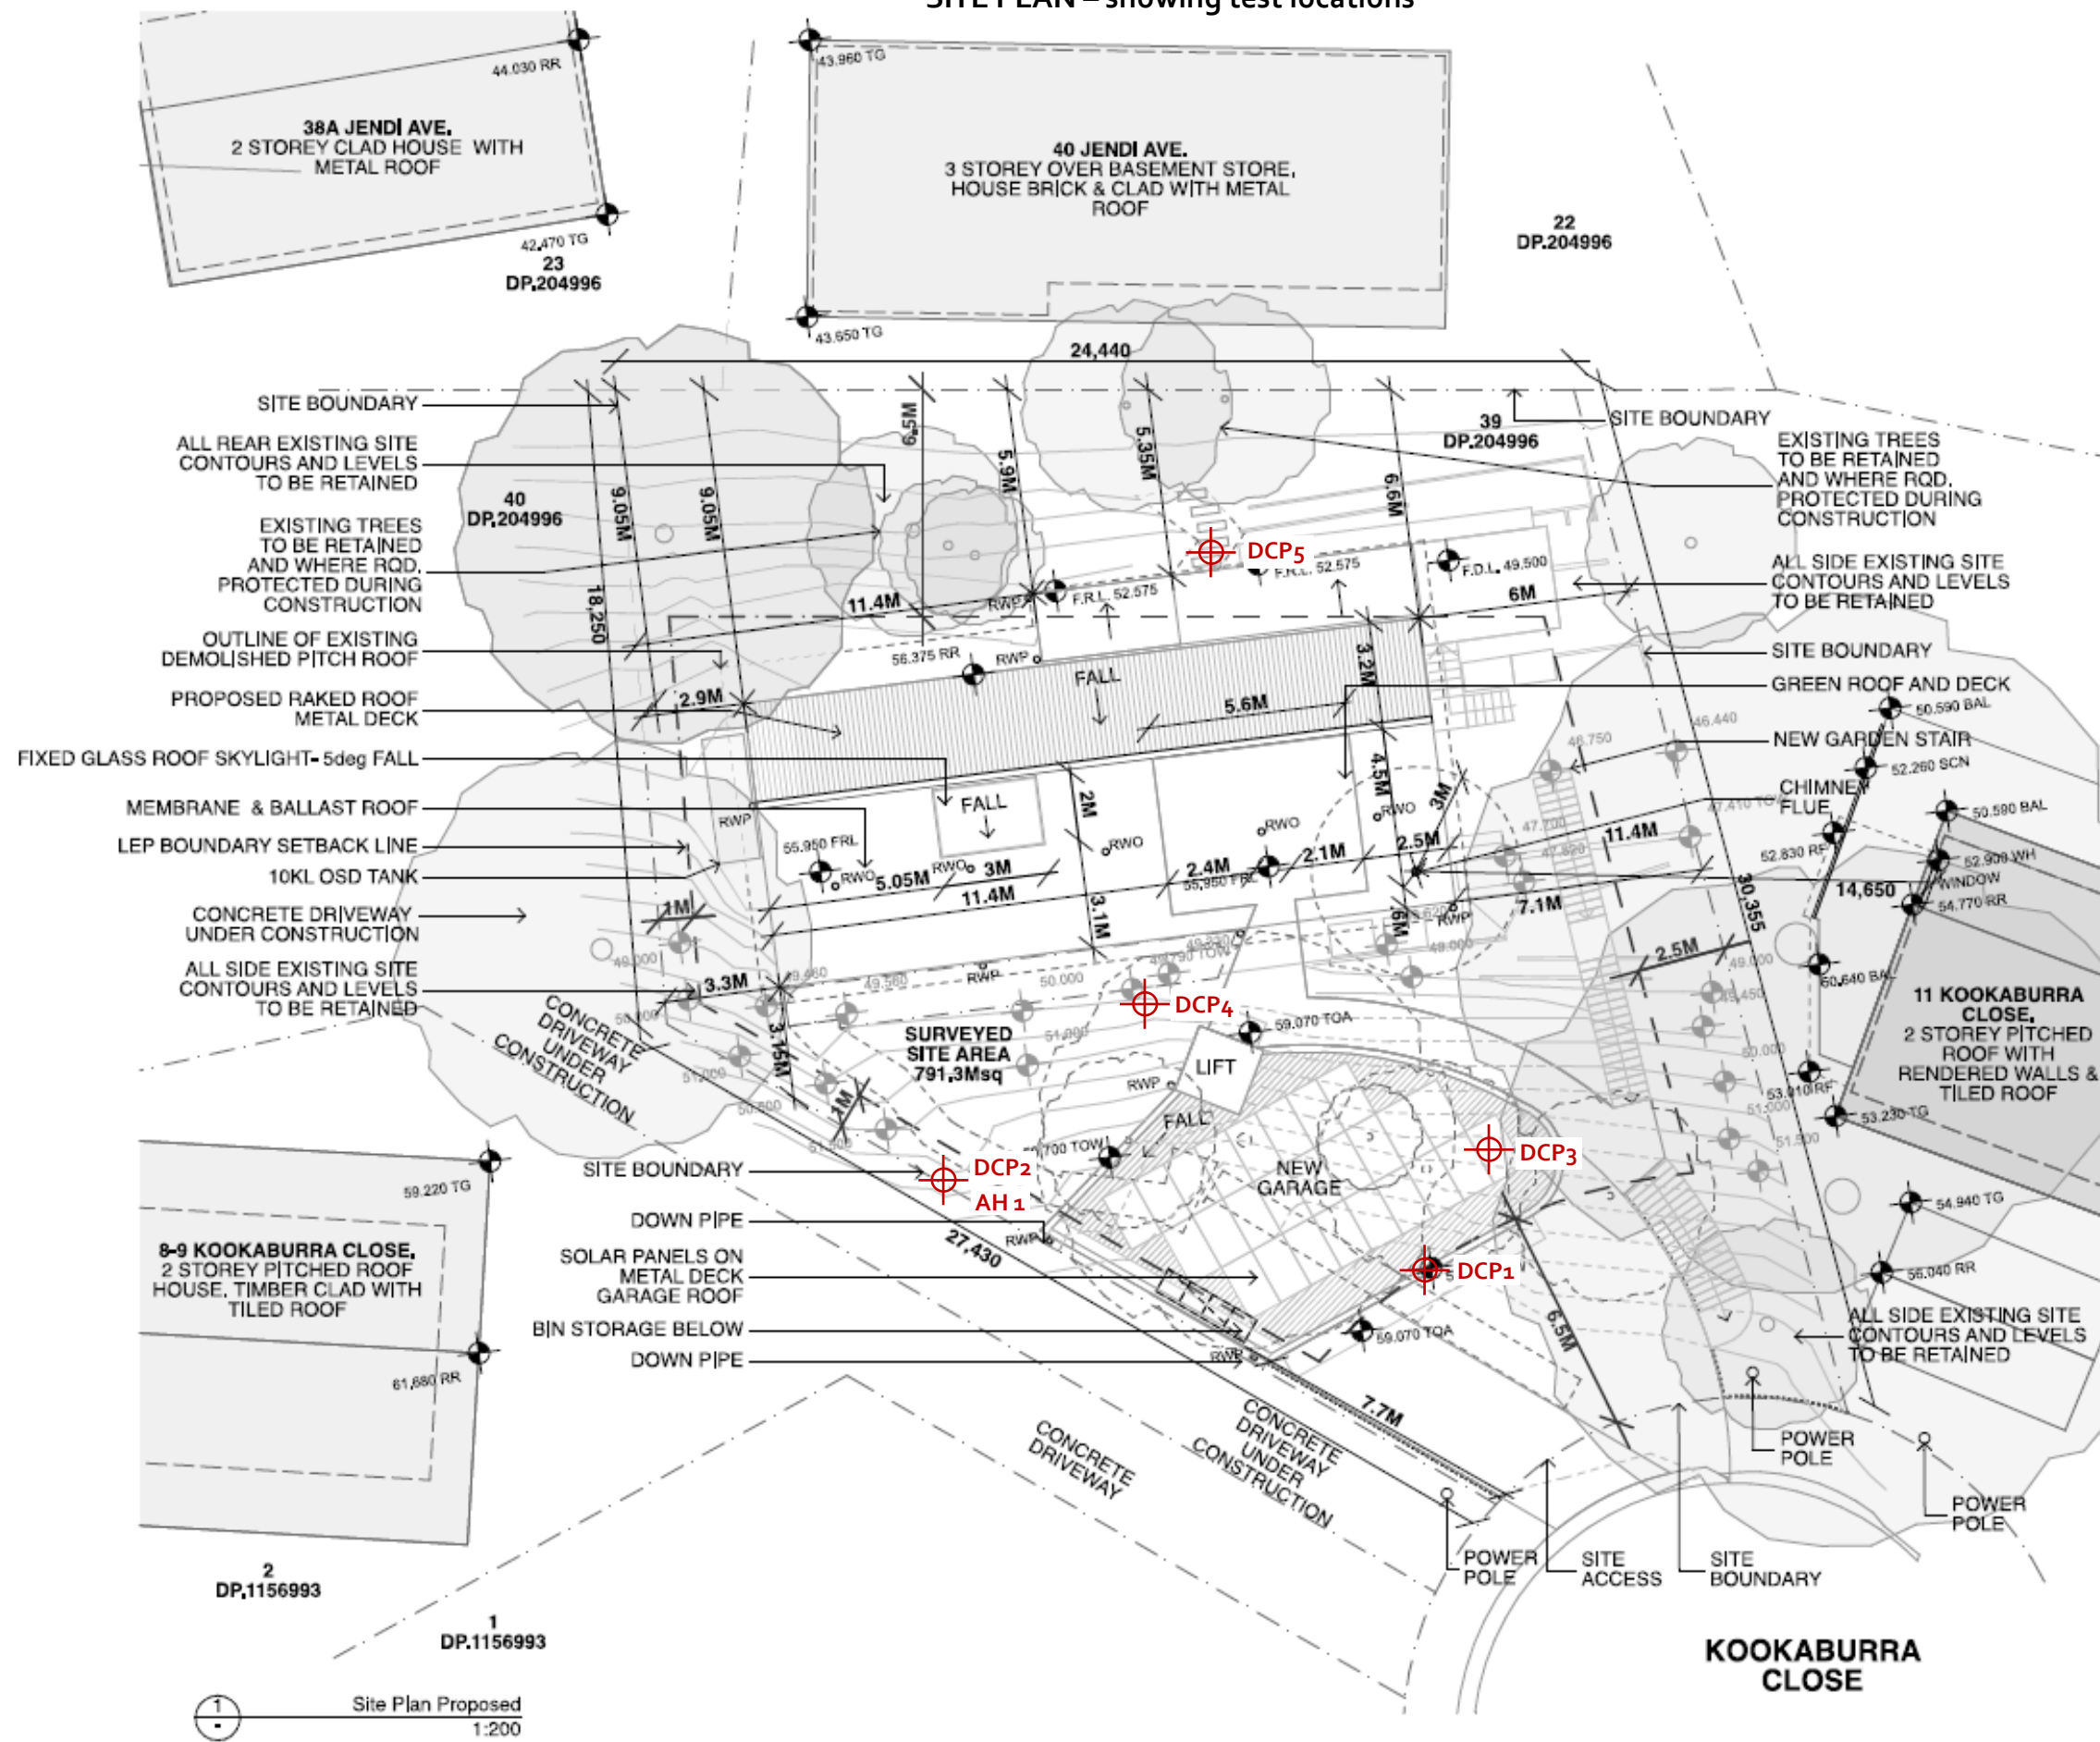
SITE PLAN – showing test locations

One hand Auger Hole (AH) was put down to identify the soil materials. Five Dynamic Cone Penetrometer (DCP) tests were put down to determine the relative density of the overlying soil and the depth to weathered rock. The locations of the tests are shown on the site plan attached. It should be noted that a level of caution should be applied when interpreting DCP test results. The test will not pass through hard buried objects so in some instances it can be

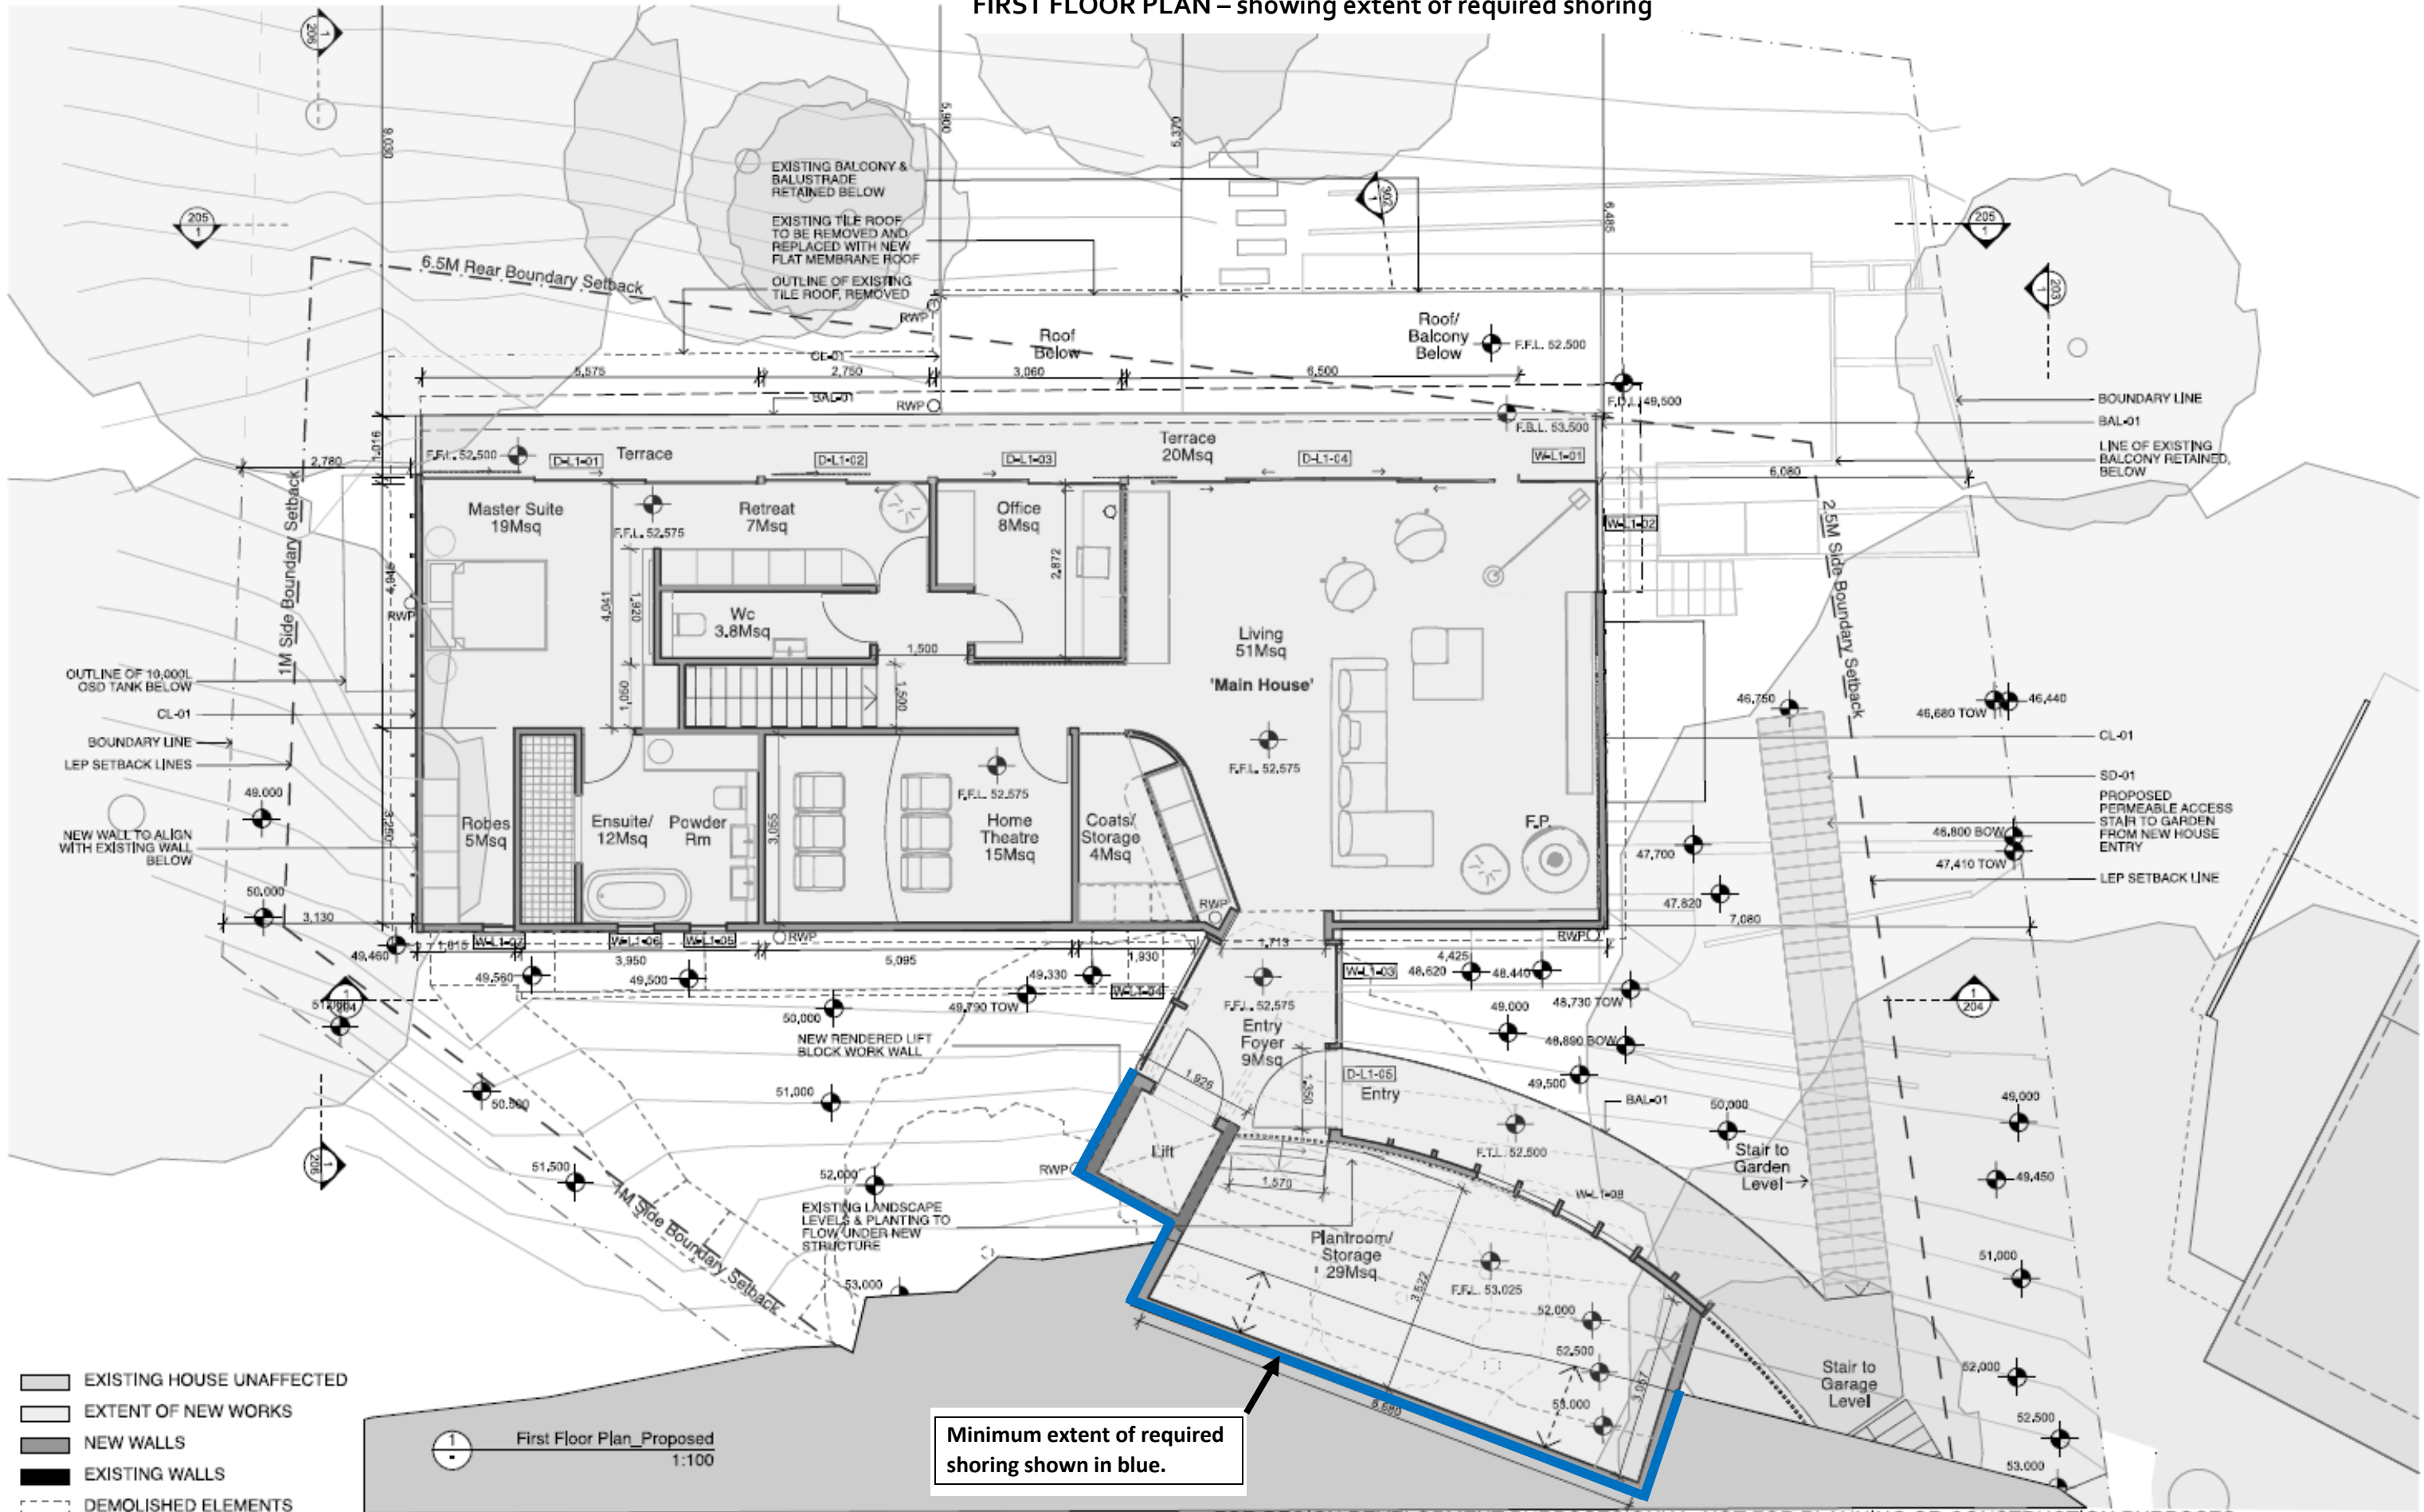
FIRST FLOOR PLAN – showing extent of required shoring

An excavation to a maximum depth of ~1.3m will be required to construct the proposed plantroom/storage and lift. The excavation is set back sufficiently from the surrounding structures and property boundaries. But due to the steep grade of the slope, the excavation will need to be temporarily or permanently supported prior to the commencement of the excavation, or during the excavation process in a staged manner, so cut batters are not left unsupported. The support will need to be designed by the structural engineer. See the site plan attached for the minimum extent of the required shoring shown in blue.

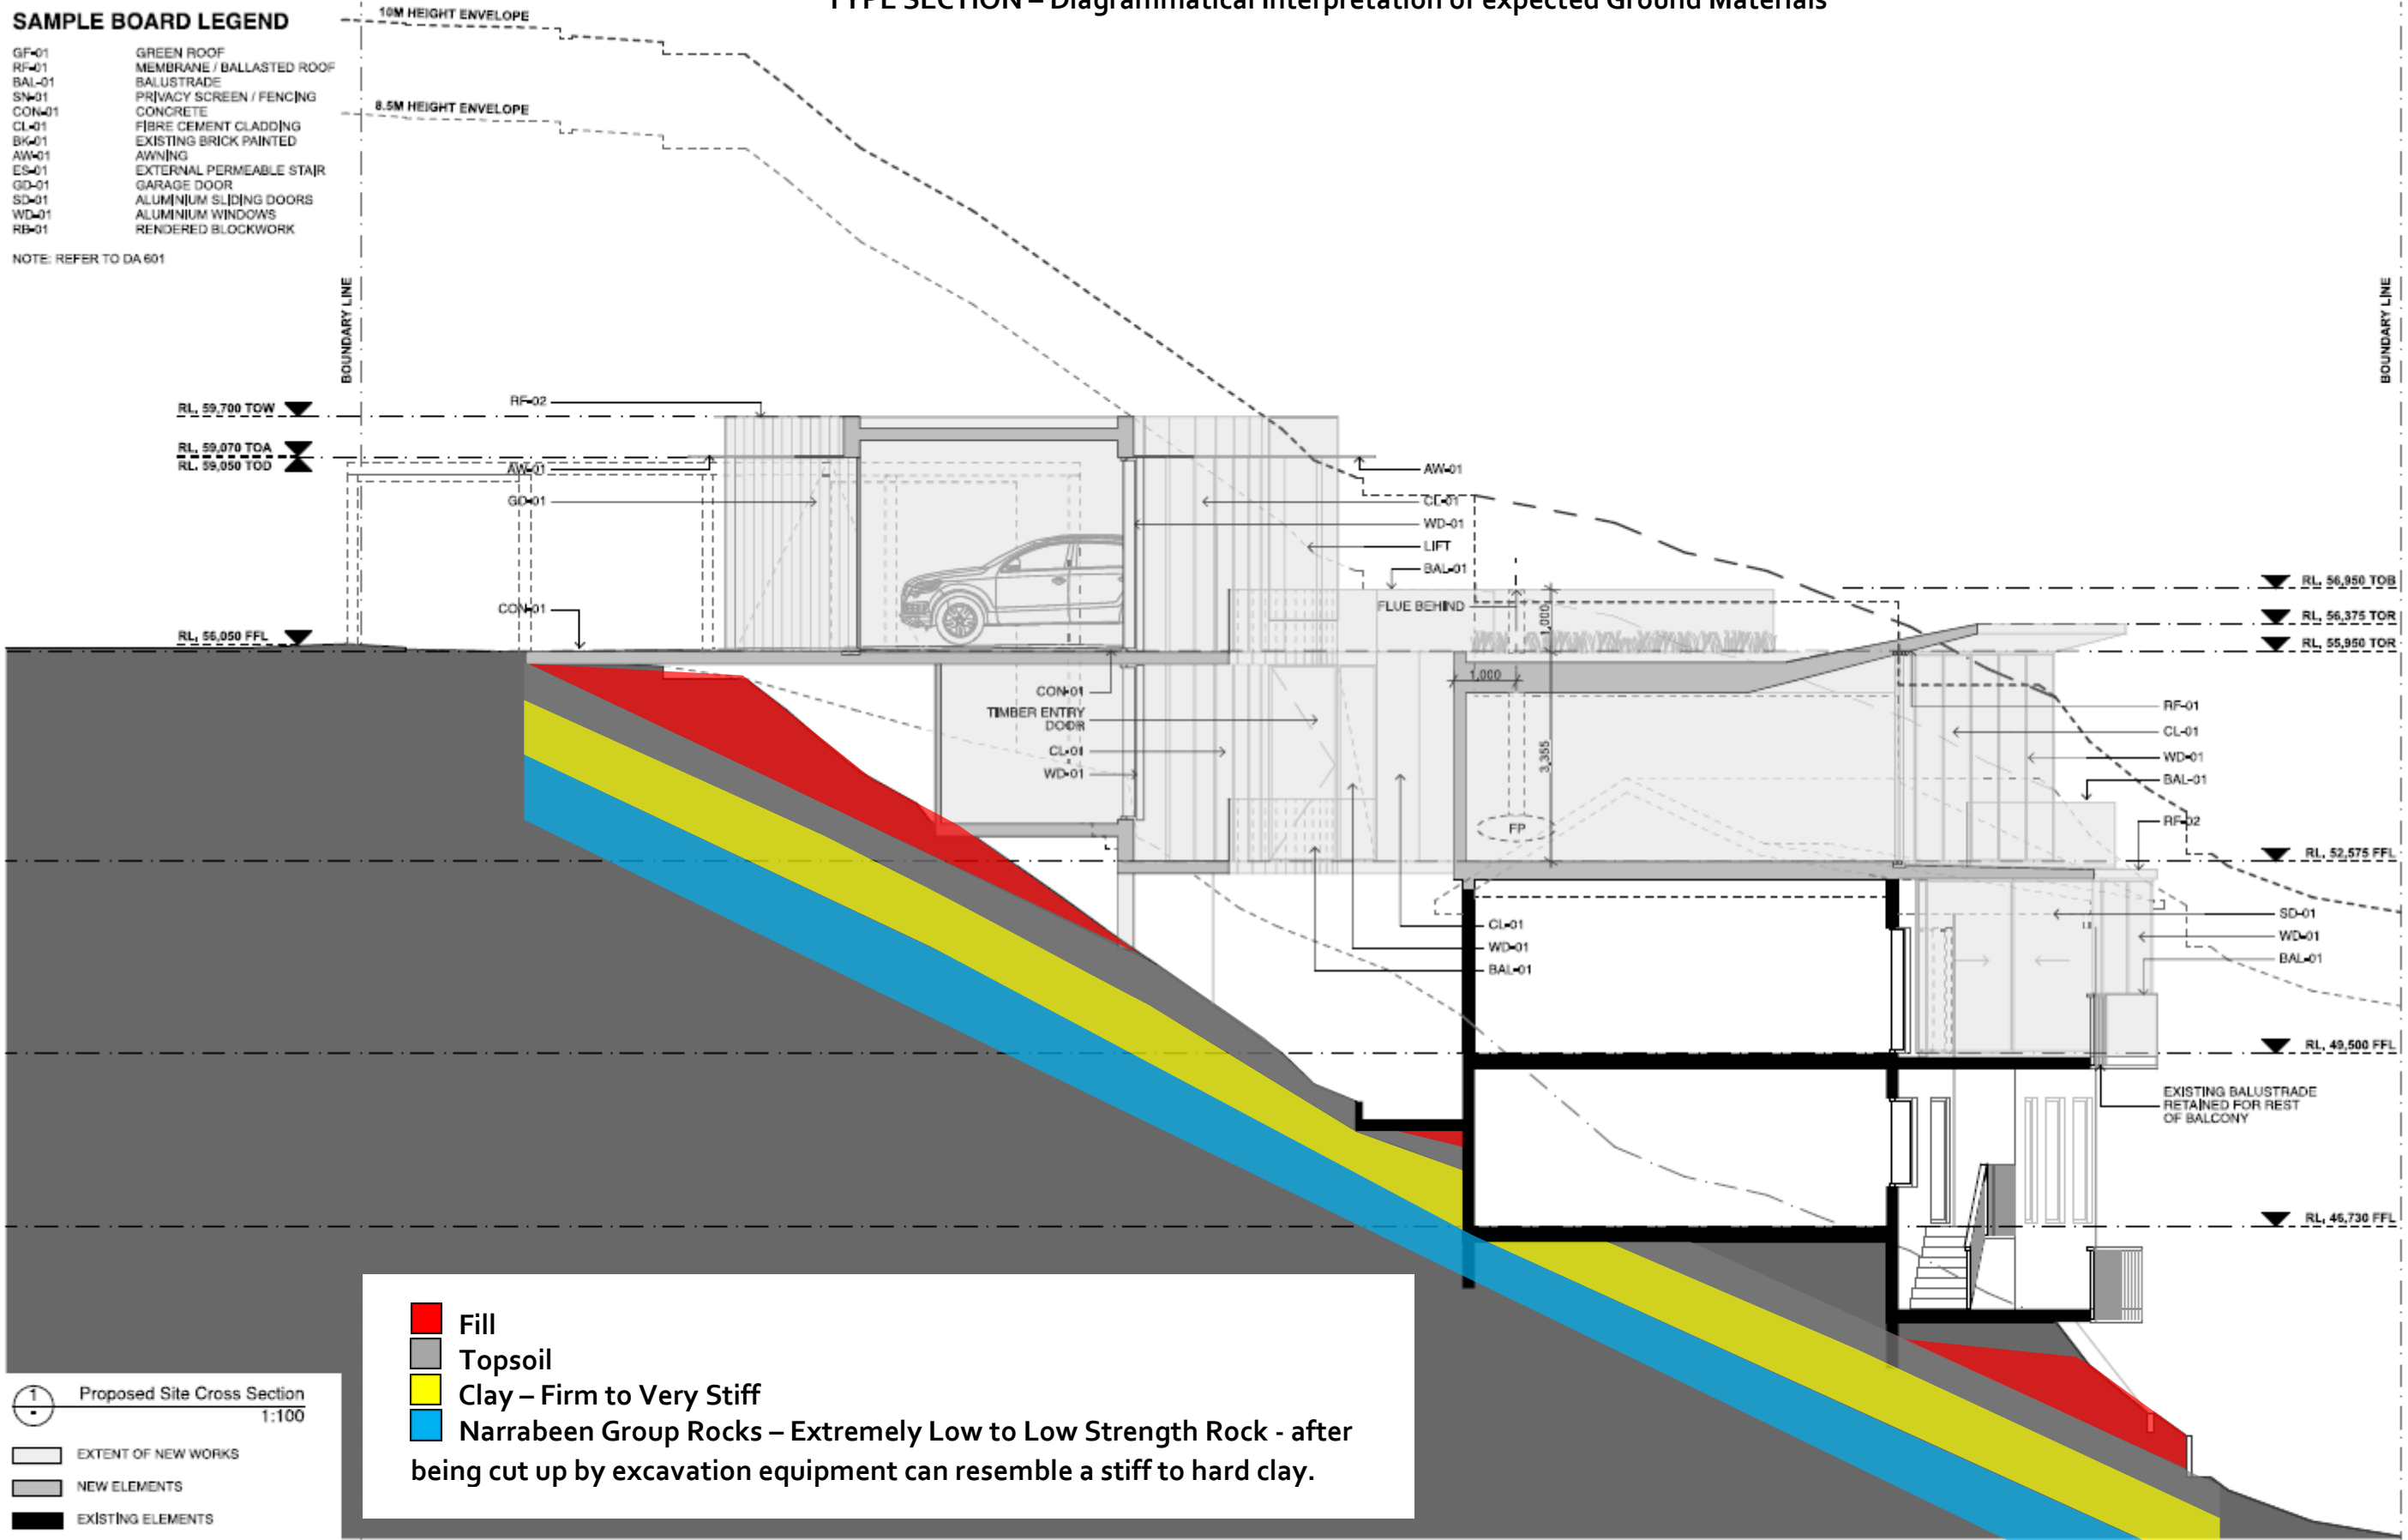
TYPE SECTION – Diagrammatical Interpretation of expected Ground Materials

The slope materials are colluvial at the near surface and residual at depth. In the test locations, the ground materials consist of fill and a thin sandy topsoil over Firm to Very Stiff Clays. Fill to an estimated maximum depth of ~1.5m provides level platforms for the road reserve, the carport, and for garden and paved areas across the property. In the test locations, the clays merge into the weathered zone of the underlying rock at depths of between ~0.9m to ~1.9m below the current surface, being deeper in the filled areas and slightly variable due to a variable weathering profile. The weathered zone of the underlying rock is interpreted as Extremely Low to Low Strength Rock. It is to be noted that this material is a soft rock and can appear as a mottled stiff clay when it is cut up by excavation equipment. See Type Section attached for a diagrammatical representation of the expected ground materials.

■ Fill
■ Topsoil
■ Clay – Firm to Very Stiff
■ Narrabeen Group Rocks – Extremely Low to Low Strength Rock - after being cut up by excavation equipment can resemble a stiff to hard clay.
