## **PRELIMINARY GEOTECHNICAL ASSESSMENT:**

### **63 Beacon Ave, Beacon Hill**

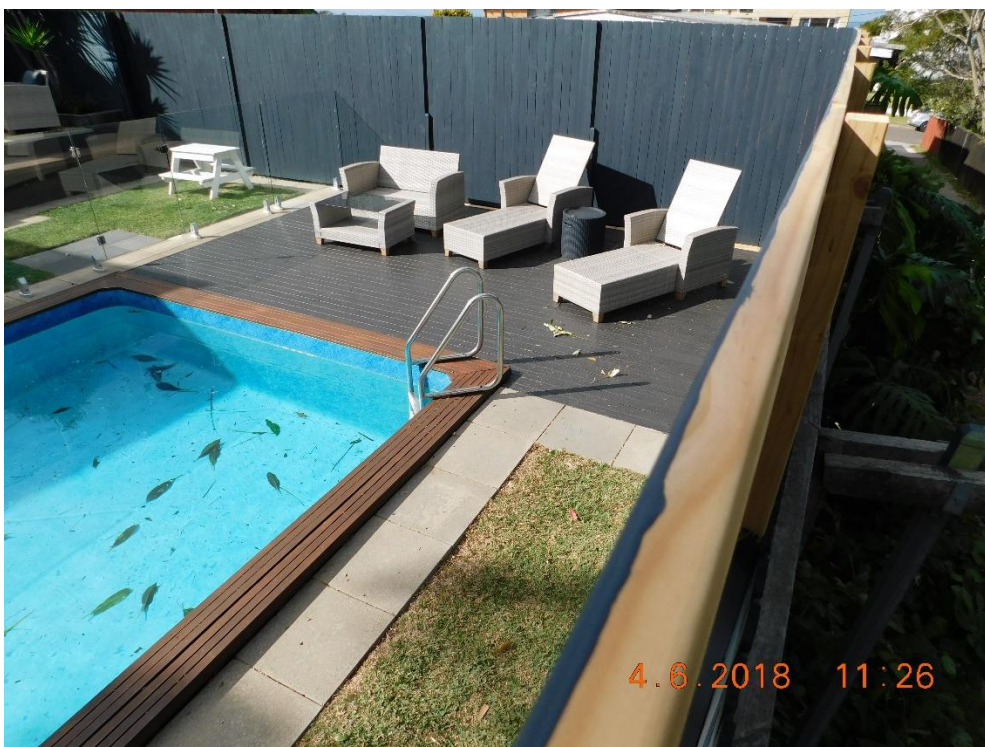
Photo 2- photo looking across the Western neighbour's yard to the Common Boundary fence beyond which is the proposed pool.

We could not see behind the neighbouring fence immediately to the West of the proposed pool to determine if rock outcrops or how large the neighbouring block retaining wall is in this location. As such we recommend ground testing be carried out over the proposed pool footprint to determine the depth to rock prior to any pool excavation commencing. Once the depth of rock is established a safe excavation plan for the proposed pool can be formulated by the Geotechnical Consultant, taking into consideration the close proximity of the proposed pool to the neighbouring wall and pool. We can carry out the testing and excavation plan upon request.
