J3948. 3rd March, 2022. Page 1.

GEOTECHNICAL INVESTIGATION:

Alterations and Additions and New Carport at 17 Corniche Road, Church Point

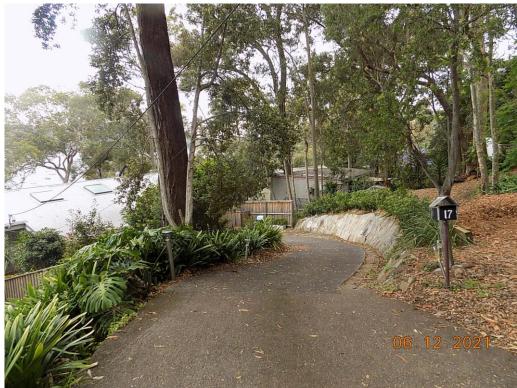
Photo 1 (date on ALL photos should read 7.12.2021)

2.3 At the road frontage, a concrete driveway runs to a parking area on the uphill side of the property (Photo 1). The cut batter for the driveway is lined with a ~1.0m high sandstone flagging wall. Between the road frontage and the house is a moderately sloping garden area (Photo 2). The part two-storey brick house is supported on brick walls (Photo 3). The external brick walls show no significant signs

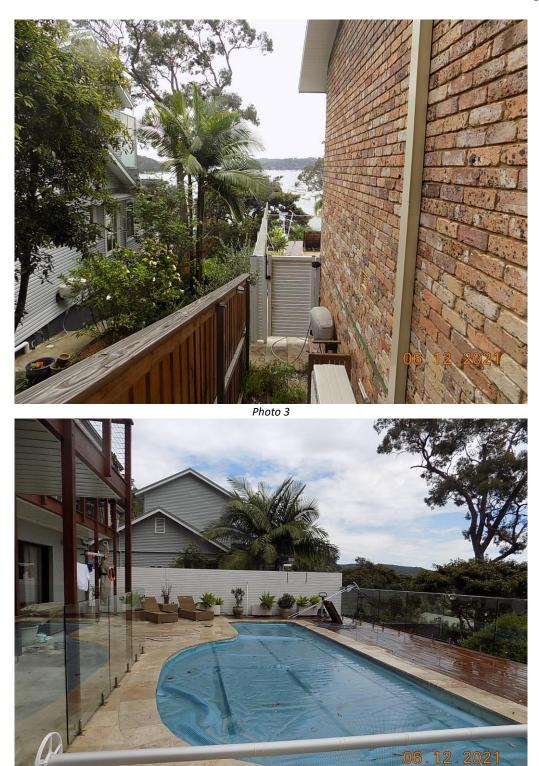
Photo 4

of movement. A pool has been partially cut into the slope on the downhill side of the property (Photo 4). No significant signs of movement were observed in the concrete shell of the pool. A fill for a level lawn area to the SE of the pool is supported by a ~1.5m high timber log retaining wall. This wall is to be demolished as part of the proposed works. In between the pool and the lower common boundary is a paved patio area. This patio area is to be demolished as part of the proposed works. A moderately sloping garden area falls to a level lawn area at the lower common boundary (Photo 5 & 6). The fill for the level lawn area is supported by a stable timber retaining wall reaching up to ~0.5m in height.

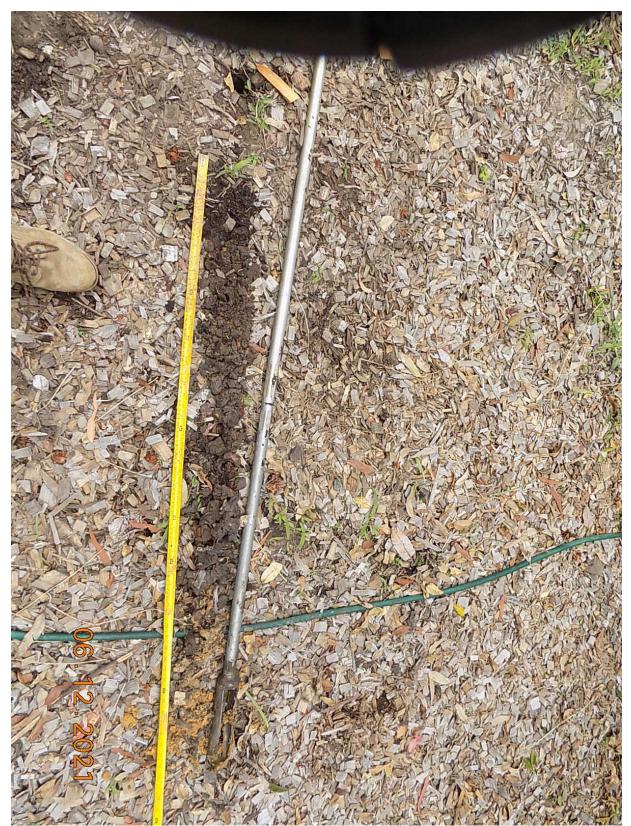
Photo 7 (Top to bottom)

AUGER HOLE 1 (~RL26.0) - AH1 (Photo 7)

Depth (m)	Material Encountered	
0.0 to 0.2	TOPSOIL , dark brown, medium grained, loose to medium dense, dry.	
0.2 to 0.4	0.2 to 0.4 FILL, dark brown clay, fine to medium grained, loose to medium dens	
	rock fragments, dry.	
0.4 to 1.0	CLAY , red and black, fine to medium grained, stiff to firm, damp to wet.	
1.0 to 1.2	CLAY, mottled yellow, grey, orange, red, fine grain, stiff to very stiff,	
	dry.	
1.2 to 1.5	SAND, yellow, coarse grained, very dense, dry.	
_

End of test @ 1.5m. No water table encountered.

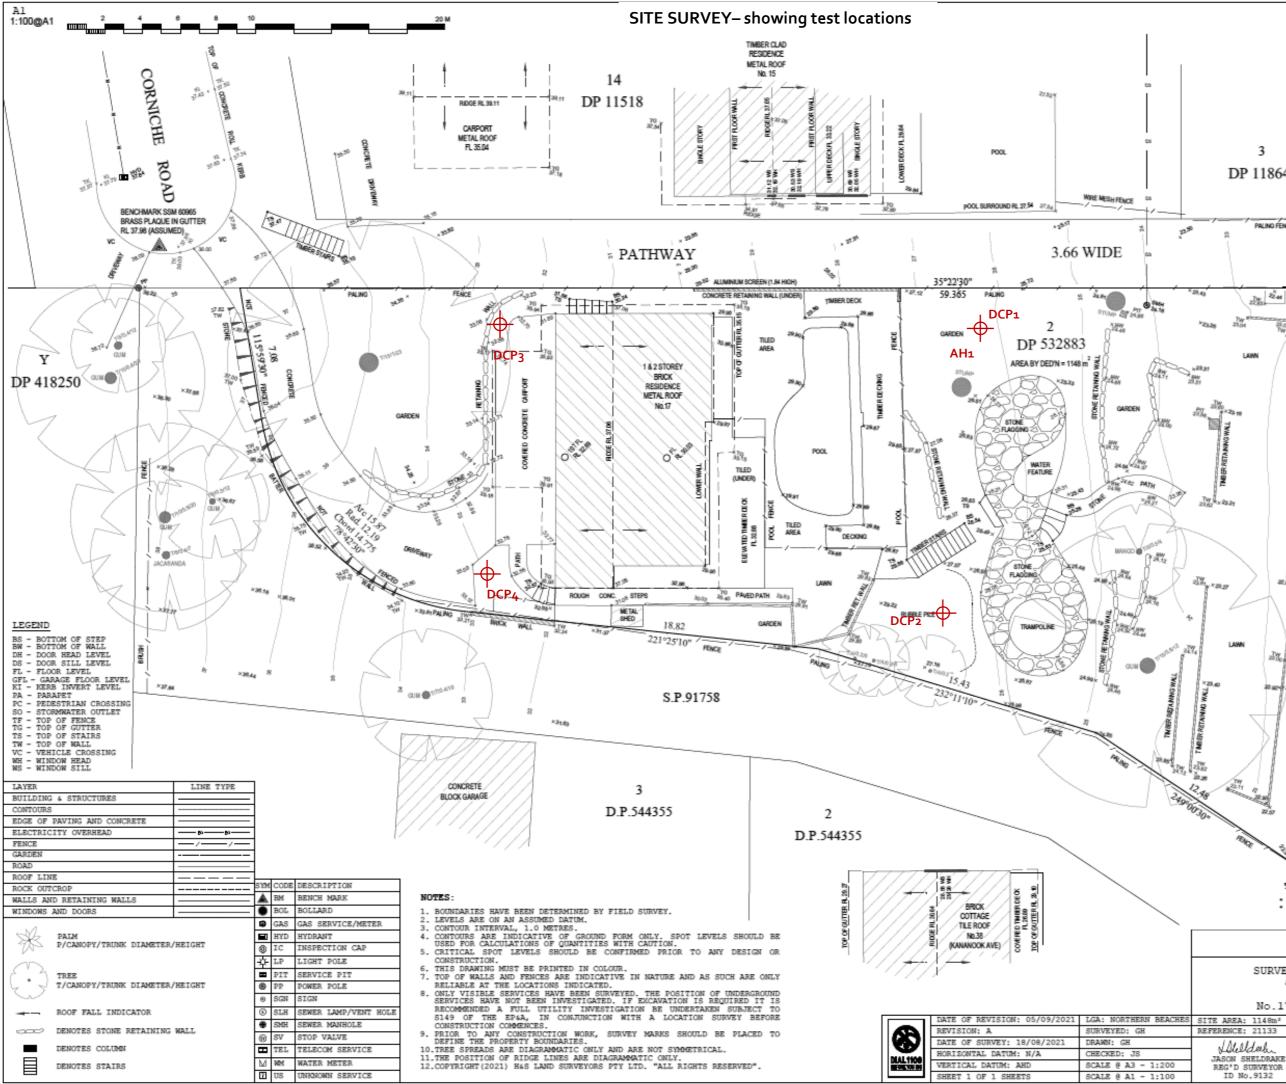
SITE PLAN – showing extent of minimum required shoring

As such, only the SE boundary will lie within the zone of influence of the cut for the extension to the uphill side of the house. In this instance, the zone of influence is the area above a theoretical 45° line from the base of the excavation towards the surrounding structures and boundaries. This line reduces to 30° through the fill and soil.

The SE boundary fence is to be braced prior to the excavation commencing.

The cut for the extension to the uphill side of the house is to be temporarily supported along the SE side with braced form ply or similar shoring. The shoring materials and labour are to be organised prior to the excavation commencing so it can be installed during the bulk excavation process. The shoring is to be designed/ approved by the structural engineer. The temporary shoring is to remain in place until permanent retaining walls are constructed. See site plan attached for extent of minimum required shoring.
