Date: 28 January 2022

Project No.: 2022-005

Vartkes Maulian,
39 Forest Way
Frenchs Forest, NSW
2086

Preliminary Landslip Assessment for 39 Forest Way, Frenchs Forest, NSW.

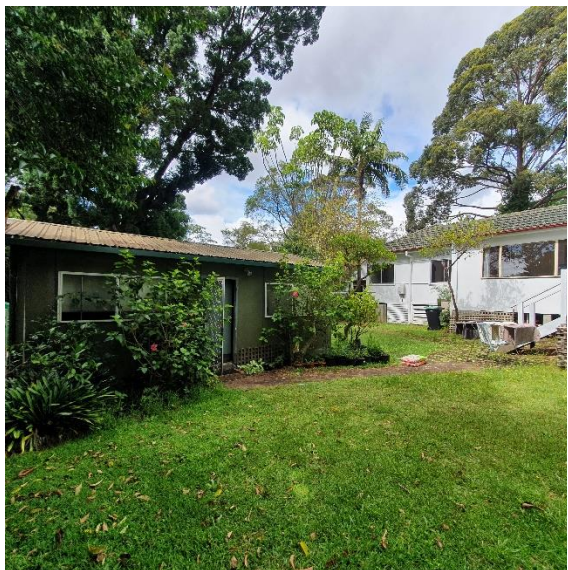
The rear of the site contains a fibro shed dwelling within the southern portion and is surrounded by a grass lawn that occupies most of the rear of the site (Photograph-1). Along the northern and eastern sides of the grass lawn is a low retained garden ($\leq 0.20\text{m}$ high) that contains several trees and dense vegetation. Approximately 2.5m south from the shed dwelling is a tree trunk (approximately 3.0m high and with a

Photograph-1: The rear of the site. View looking west.

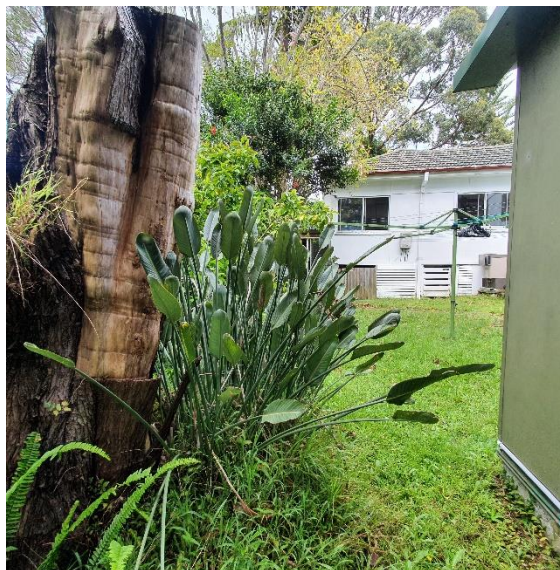
diameter of approximately 0.70m wide) (Photograph-2). Excessive ground movement, structure defects, unstable ground or signs of underlying geotechnical issues were not observed within the rear of the site and appeared in good condition.

Photograph-2: A tree trunk located approximately 2.0m from the rear fibro shed. View looking west.
