ARBORICULTURAL IMPACT REPORT

PROPOSED DWELLING (PROPOSED) LOT 81 - 122 RIVERVIEW ROAD AVALON BEACH NSW

PREPARED FOR TIM AND NIKKI HILL

REVISED REPORT 22ND DECEMBER 2021

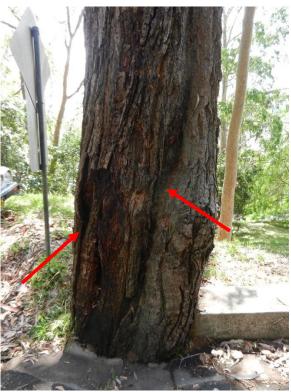
Photograph 1: Tree # 8 - Illustrating the past tissue loss and mechanical injury.

As noted above, tree numbers 8 and 14 will need to be very carefully managed during construction with trunk and ground protection installed (in accordance with Fig. 4 of AS4970-2009) prior to commencement of works with this protection maintained in good working order through the entire construction period.

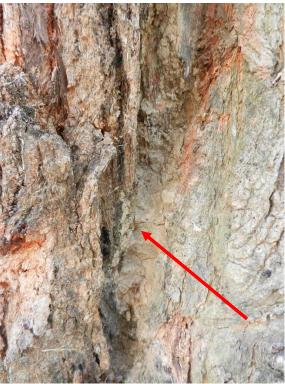
Photograph 2: Tree # 8 – Illustrating the termite mudding in the lower trunk.

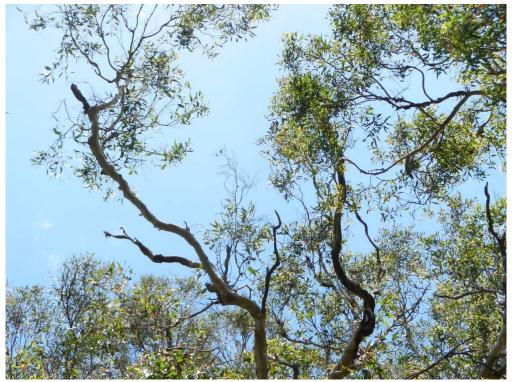
Photograph 3: Tree # 5 – Illustrating the moderate levels of dieback.

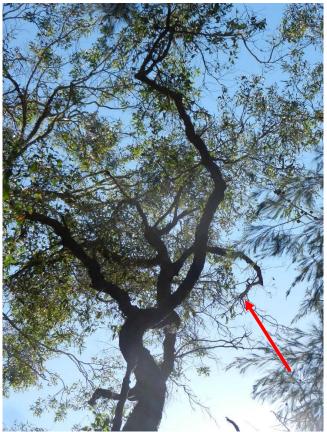
Photograph 4: Tree # 10 – Illustrating the dieback.

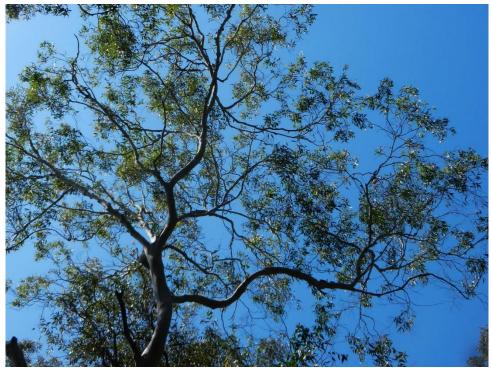
Photograph 5: Tree # 12 – Illustrating the reduced foliage density and moderate dieback.

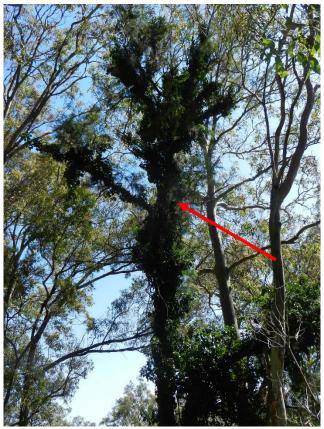
Photograph 6: Tree # 15 – Illustrating the high levels of English Ivy growth on the tree.

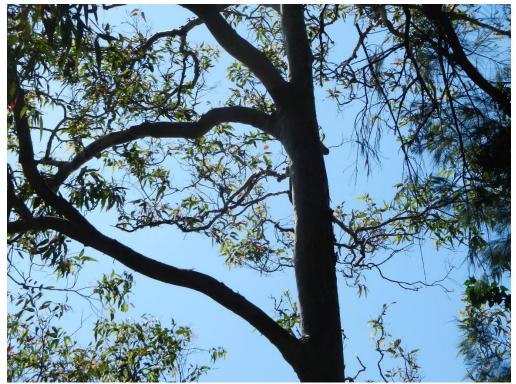
Photograph 7: Tree # 16 – Illustrating the reduced foliage density and low to moderate dieback.
