PRELIMINARY GEOTECHNICAL ASSESSMENT:

26 Wabash Avenue, Cromer

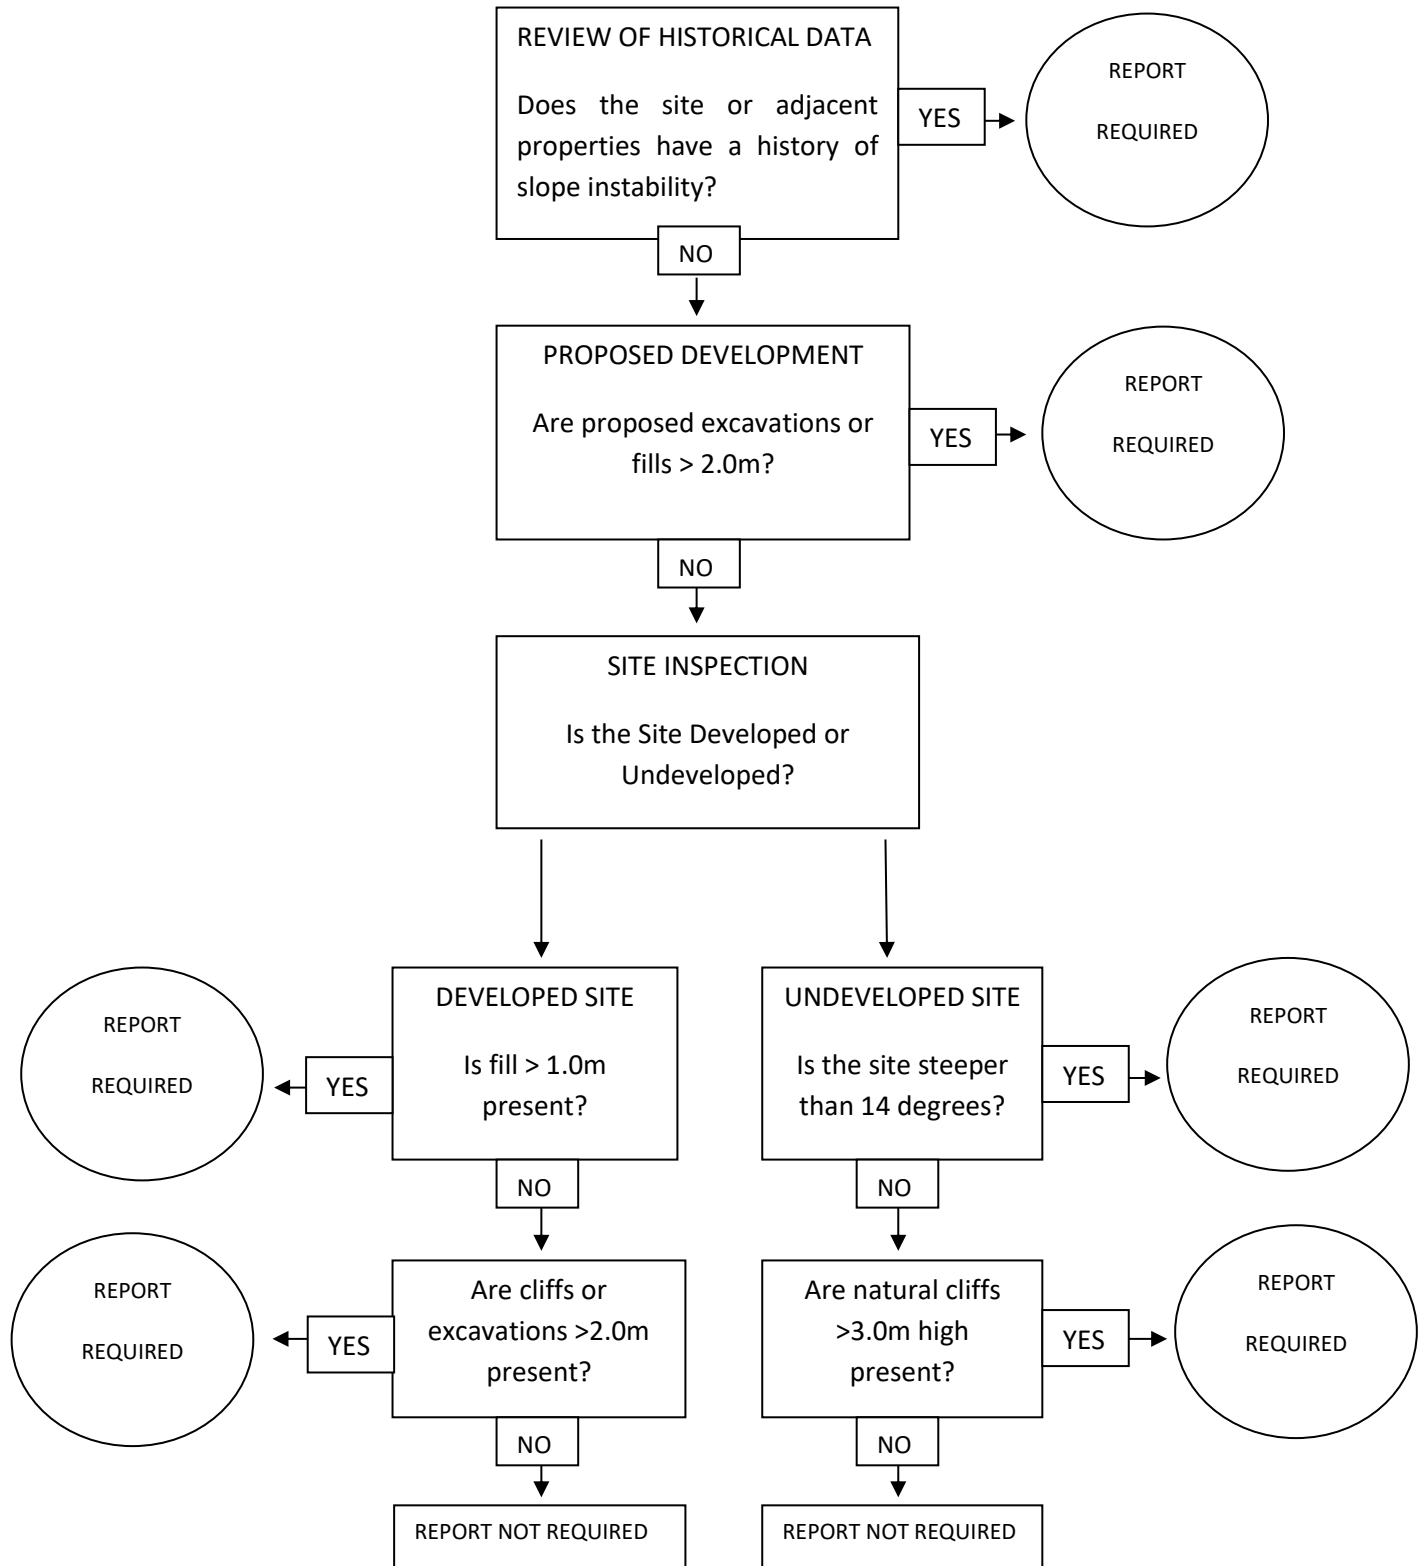
Preliminary Assessment Flow Chart – Northern Beaches Council (Warringah)

The proposed development and site conditions were considered and applied to the Council Flow Chart.

Provided good engineering and building practice are followed, no further Geotechnical assessment is recommended for the proposed development.
