Geotechnical Assessment

Project: Alterations & Additions
1 Suncrest Avenue, Newport NSW

Ref: AG 25173
5 May 2025

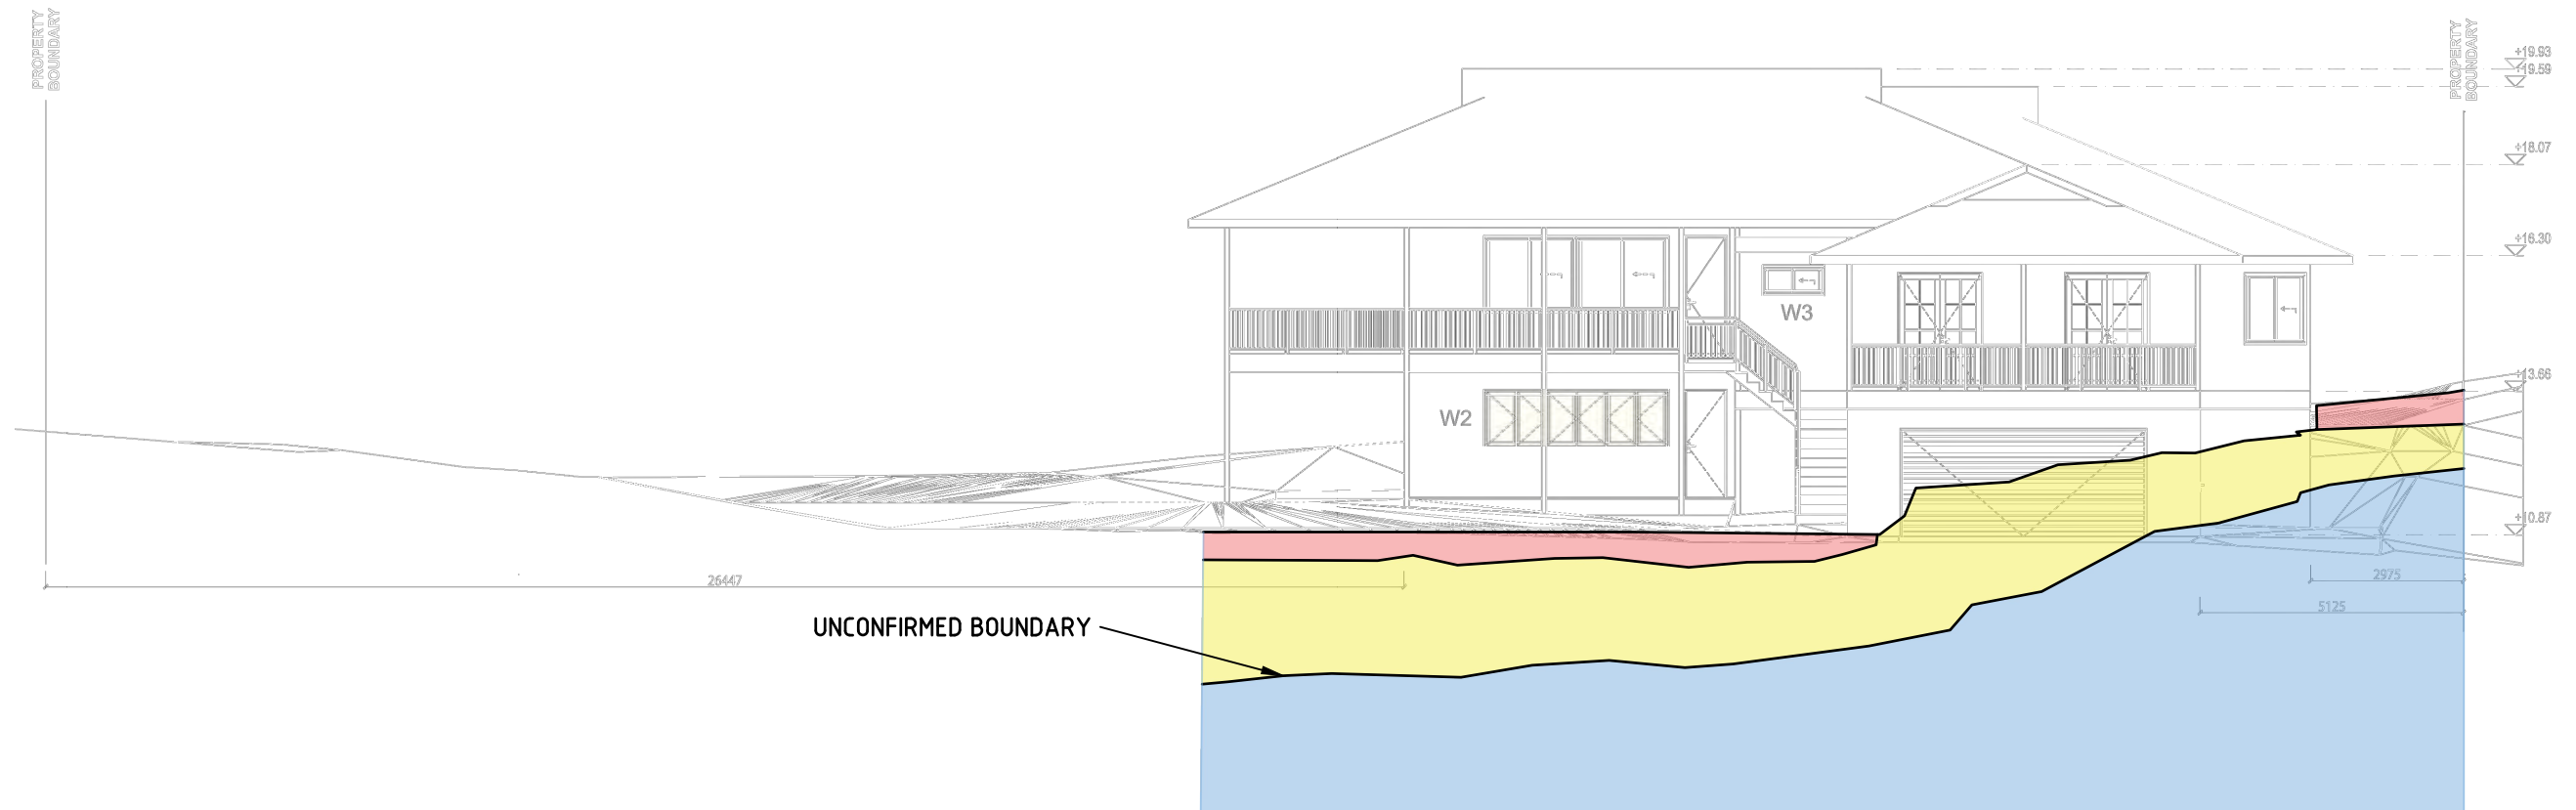
INFERRED GEOLOGICAL SECTION
SCALE NTS

Unit	Material	Comments
1	Topsoil / Fill	Silty topsoil and fill material. Unit 1 is inferred to be uncontrolled and poorly compacted.
2	Clayey Sand	Loose to medium dense clayey sand. Unit 2 is inferred as colluvium.
3	Clay	Medium plasticity clay. Unit 3 is interpreted to represent a thin residual layer and may not be present across much of the site
4	Shale	Generally, highly weathered, very low-low strength (Class V–IV*) interbedded shale and sandstone.

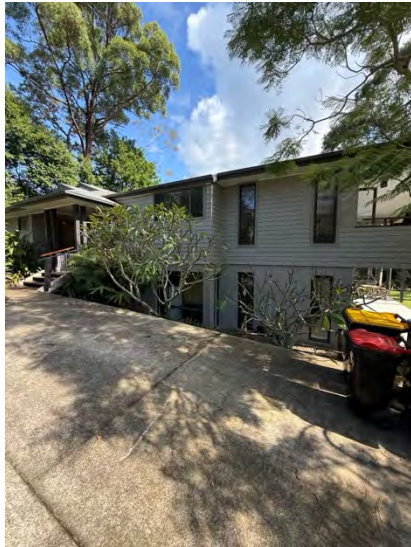
Photo 1: Front of residence.

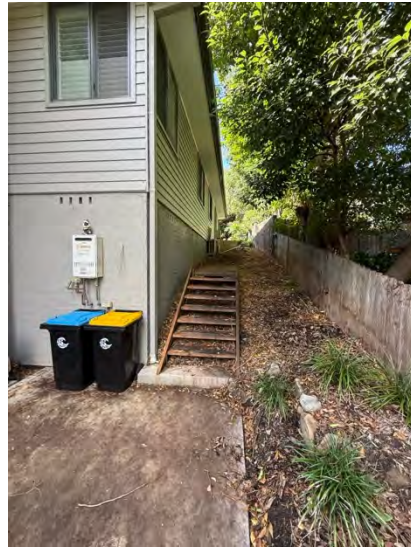
Photo 2: Southern side of residence.

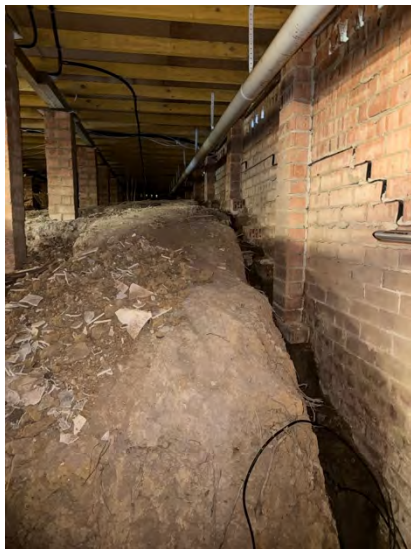
Photo 3: Location of proposed extension
– southern end.

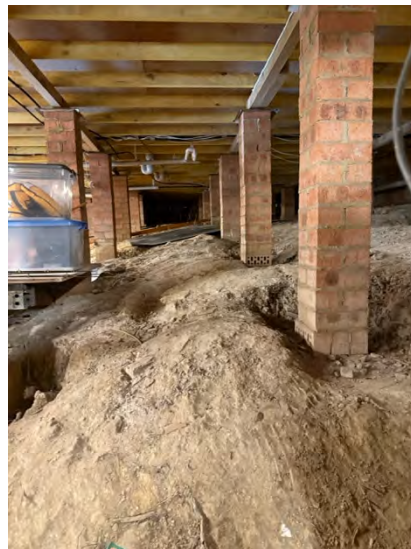
Photo 4: Location of proposed extension
– typical condition.
