GEOTECHNICAL INVESTIGATION:

New Garage and Pool at 88 Quirk Street, Dee Why

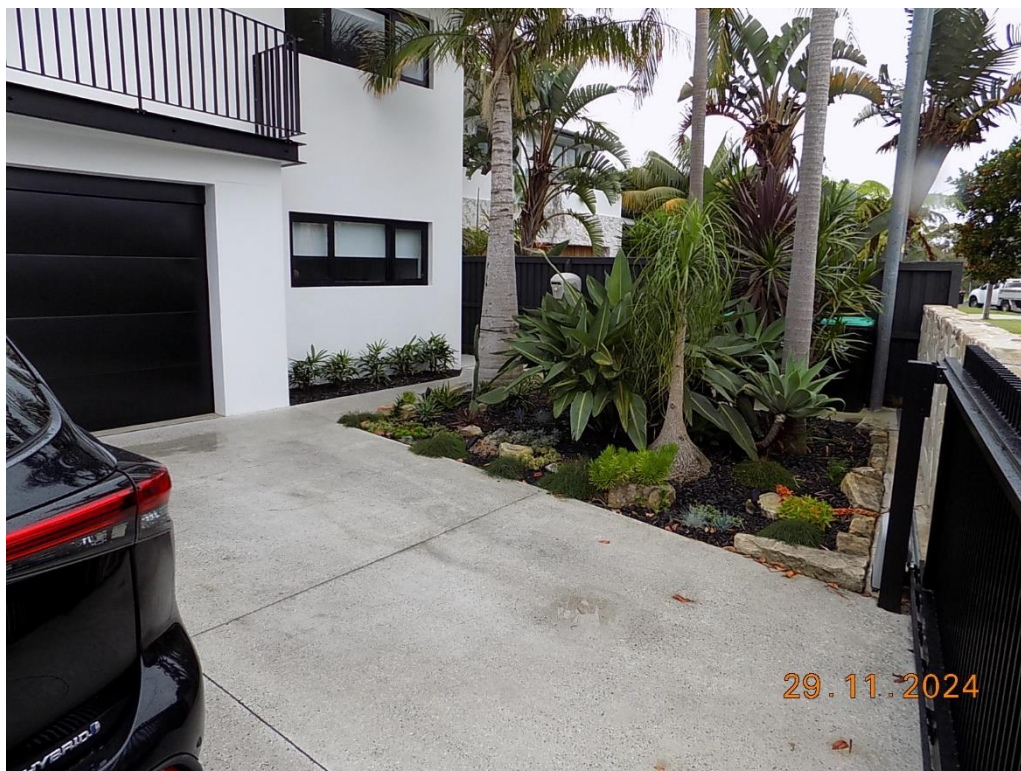
Photo 1

- 2.3** At the Quirk Street frontage, a concrete driveway runs to a garage on the ground floor of the house. Between the road frontage and the house is near level garden bedding (Photo 1). The part three-story rendered brick house is supported on brick walls. No significant signs of movement were observed in the visible supporting walls of the house. Fill for a level lawn and garden below the house (Photo 2) has been

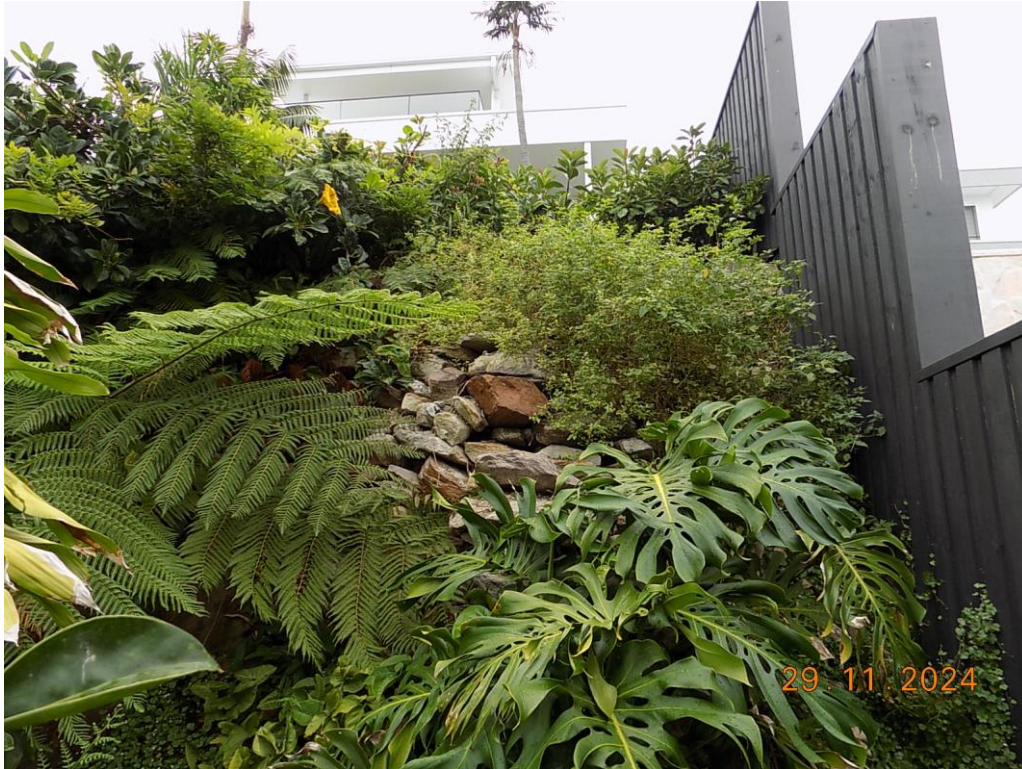
Photo 3

laid over exposed competent Medium Strength Sandstone which steps down the property below the house. Where the fill is deeper towards the W common boundary, it has been supported by a loose stack stone retaining wall (Photo 3). This wall will be demolished as part of the proposed works. The outcrop steps ~2.0m down the slope below the fill (Photo 4). A portion of the outcropping rock to the E is undercut up to ~1.0m (Photo 5). However, the undercut portion has a relatively thick cantilever arm in relation to its overhang length, and displays no horizontal cracking when viewed from above or below. No other significant geological defects were observed in the rock face. As such, it is considered stable. A detached joint block immediately below this outcrop is resting in a stable position (Photo 6). The remainder of the outcropping rock across the property was observed to be free from significant geological defects that could affect its stability. A low cut has been made at the Bushey Place frontage for a parking space (Photo 7). The cut is supported by a low concrete block retaining wall which will be demolished as part of the proposed works.

- ~Flush with the loose stack stone retaining wall near the W common boundary (Photo 3).
- ~Flush with a detached joint block below the ~2.0m outcrop (Photo 6)

As such, the loose stack stone retaining wall and detached joint block will lie within the zone of influence of the proposed excavation. In this instance, the zone of influence is the area above a theoretical 45° line (from horizontal) from the base of the excavation or top of Medium Strength Rock, whichever is encountered first, towards the surrounding structures and boundaries. This line reduces to 30° through the fill and soil.

The excavation requires the removal of the loose stack stone retaining wall which supports fill on the W side of the ~2.0m outcrop. The wall is to be demolished from the top down in an orderly manner prior to the excavation commencing. The fill, soil, and clay behind the walls, and at the location of any new excavation is to be battered temporarily at 1.0 Vertical to 1.7 Horizontal (30°) until retaining structures are in place.

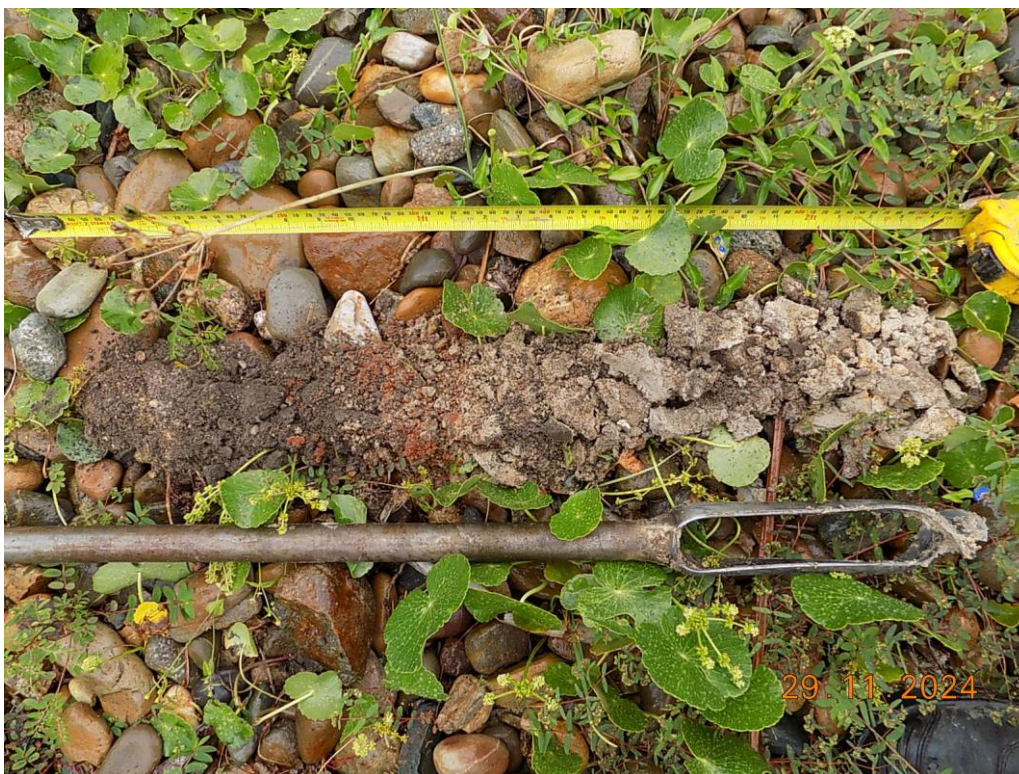
Photo 8 – downhole is left to right

AUGER HOLE 1 (~RL57.6) – AH1 (Photo 8)

Depth (m)	Material Encountered
0.0 to 0.3	TOPSOIL , sandy soil, brown, Medium Dense, dry, Fine to Medium grained.
0.3 to 0.7	RESIDUAL CLAY , sandy clay, derived from weathered sandstone, mottled orange, grey, and maroon, Soft to Stiff, dry, Fine to Medium grained.

End of Hole @ 0.7m in Residual Clay. No water table encountered.

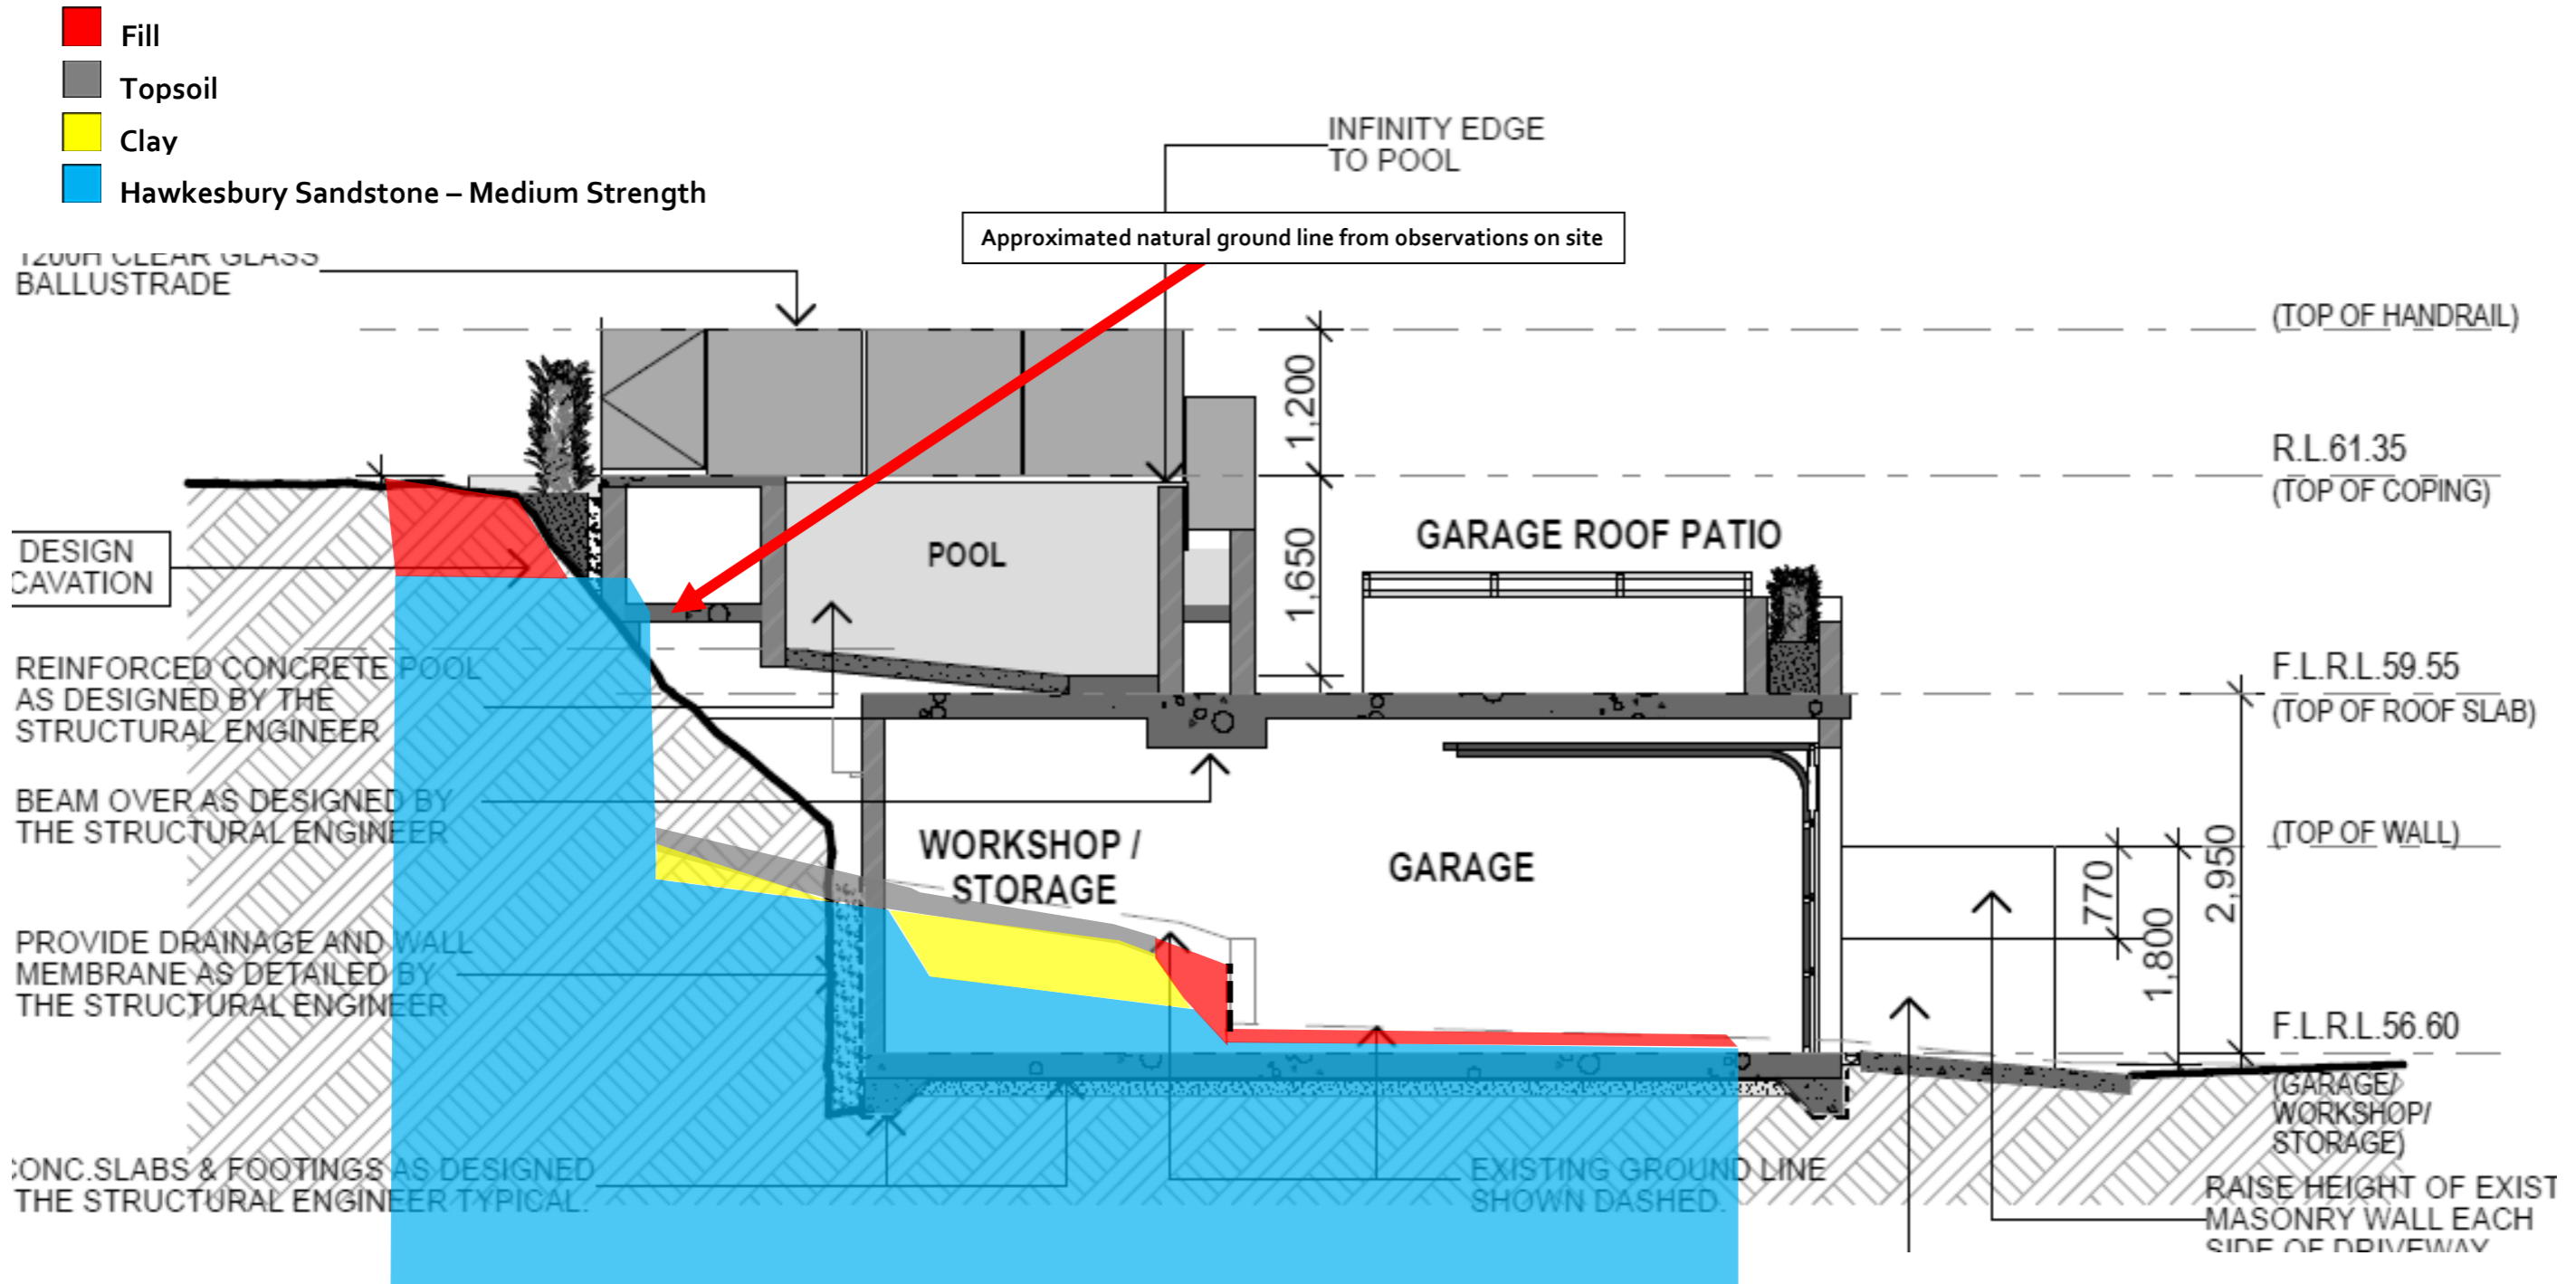
TYPE SECTION – Diagrammatical Interpretation of expected Ground Materials

The surface features of the block are controlled by the outcropping and underlying sandstone bedrock that steps down the property forming sub-horizontal benches between the steps. Where the grade is steeper, the steps are larger and the benches narrower. Where the slope eases, the opposite is true. Where the rock is not exposed, it is overlain by shallow soils over clays that fill the bench step formation. Filling has been placed below the house for landscaping. In the test locations, where the rock is not exposed, it was encountered at depths of between 0.2 to 1.4m below the current surface, being slightly deeper due to the presence of fill and the stepped nature of the underlying bedrock. The outcropping sandstone on the property is estimated to be Medium Strength or better and similar strength rock is expected to underlie the entire site as all the DCP tests bounced at refusal. See Type Section attached for a diagrammatical representation of the expected ground materials.
