Report Title: Geotechnical Assessment 44 Nareen Parade, North Narrabeen
Report Date: 11/03/21
Author : BEN WHITE
Author's Company/Organisation : WHITE GEOTECHNICAL GROUP PTY LTD

GEOTECHNICAL INVESTIGATION:

New Granny Flat at 44 Nareen Parade, North Narrabeen

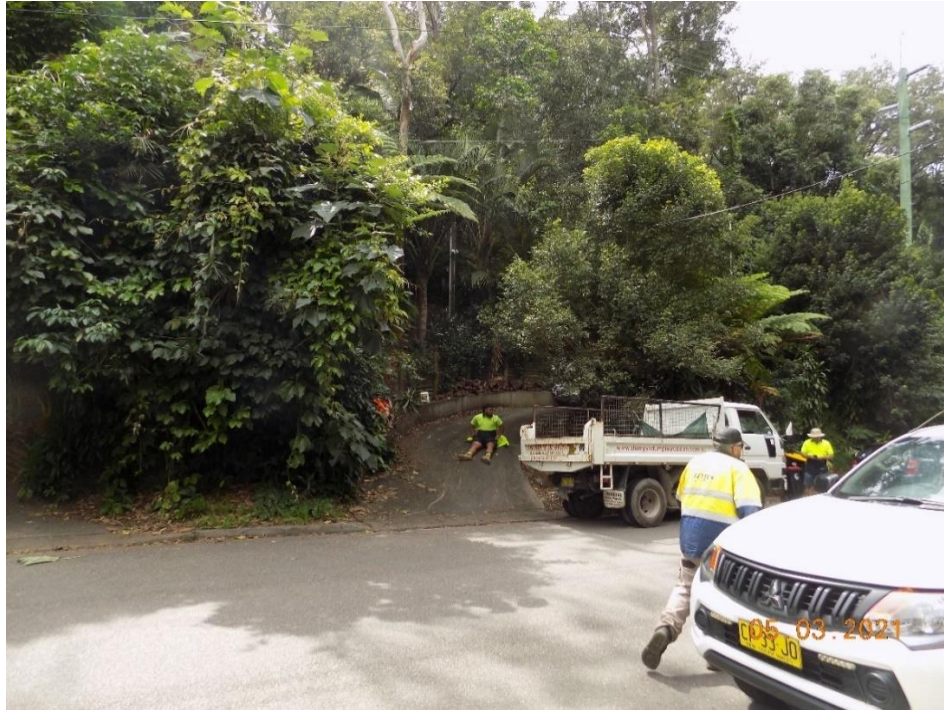
Photo 1

- 2.3** At the road frontage a concrete driveway runs up the slope to a parking area (Photo 1). The driveway has been partially cut into the slope. The cut is supported by a stable timber retaining wall ~1.5m high. A narrow timber pathway runs across the slope above this wall, and is supported by a stable keystone block retaining wall, ~1.2m high (Photo 3). The slope between the car space and the house is terraced with a series of timber retaining walls between ~1.0 and ~1.5m high. One of these retaining walls is tilting at a maximum angle of 18° downslope from vertical and will require remediation works (**see section 13**) (Photo 6). The two-storey timber framed and clad house is supported on steel posts and brick piers which appear to stand vertical. An excavation has been made through fill under the downhill side of the house for a storage area. The ~1.3m high cut face is unsupported. See **section 13** for

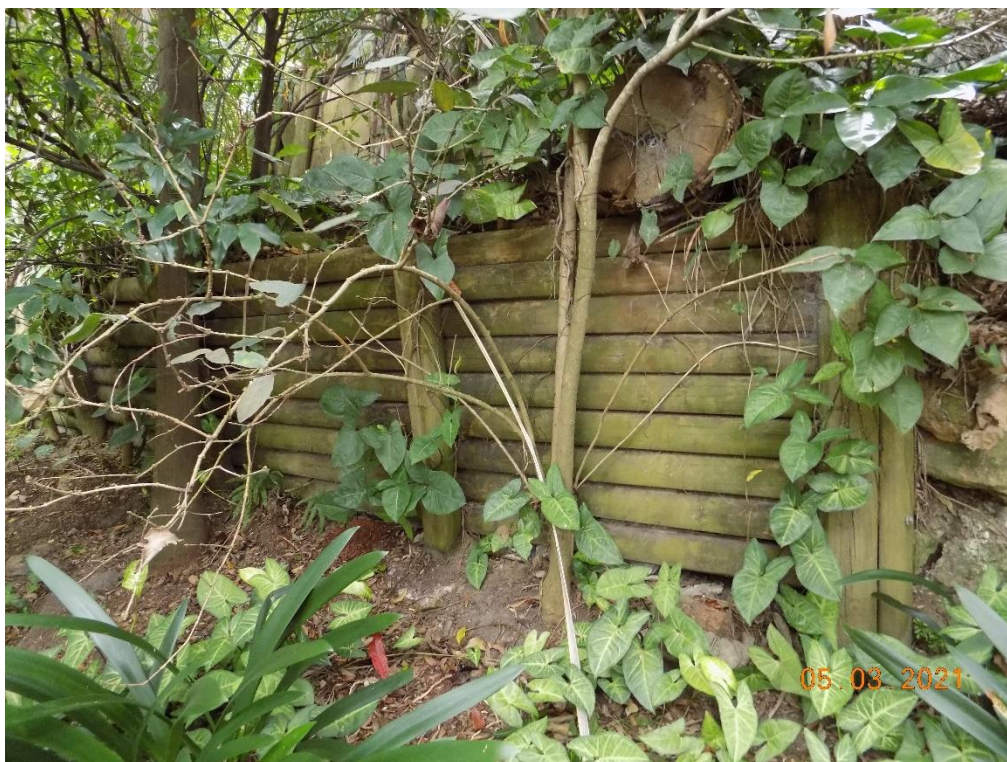
Photo 6

No geotechnical hazards were observed below or beside the property. The timber retaining wall that is tilting below the house is a potential hazard (**Hazard One**). The steep land surface that falls across the property and continues above is a potential hazard (**Hazard Two**).

HAZARDS	Hazard One	Hazard Two
TYPE	Further movement of the timber retaining wall below the house that causes failure (Photo 6).	The steep slope that falls across the property and continues above failing and impacting on the property.
LIKELIHOOD	'Likely' (10^{-2})	'Unlikely' (10^{-4})
CONSEQUENCES TO PROPERTY	'Medium' (15%)	'Medium' (12%)
RISK TO PROPERTY	'High' (2×10^{-3})	'Low' (2×10^{-5})
RISK TO LIFE	1.3×10^{-5} /annum	9.1×10^{-7} /annum
COMMENTS	This level of risk to life and property is 'UNACCEPTABLE'. To move the risk to 'ACCEPTABLE' levels, the recommendations in Section 13 are to be followed.	'ACCEPTABLE' level of risk, provided the recommendations in section 13 are followed.

A timber retaining wall between the parking area and the house (Photo 6) is tilting downslope to a maximum angle of ~18°. Should this wall collapse, it would pose a threat to the proposed works and any inhabitants. As such, we recommend the retaining wall be rebuilt or remediated to current engineering standards as part of the proposed construction.
