Arboricultural Impact Assessment

Client Name: Vanessa Lucas
Site Address: 6 Coronation Street Mona Vale NSW
Authors Details: Hugh Millington
Email: hugh@hughtheArborist.com.au
Phone: 0426836701
Date Prepared: 2nd November 2024

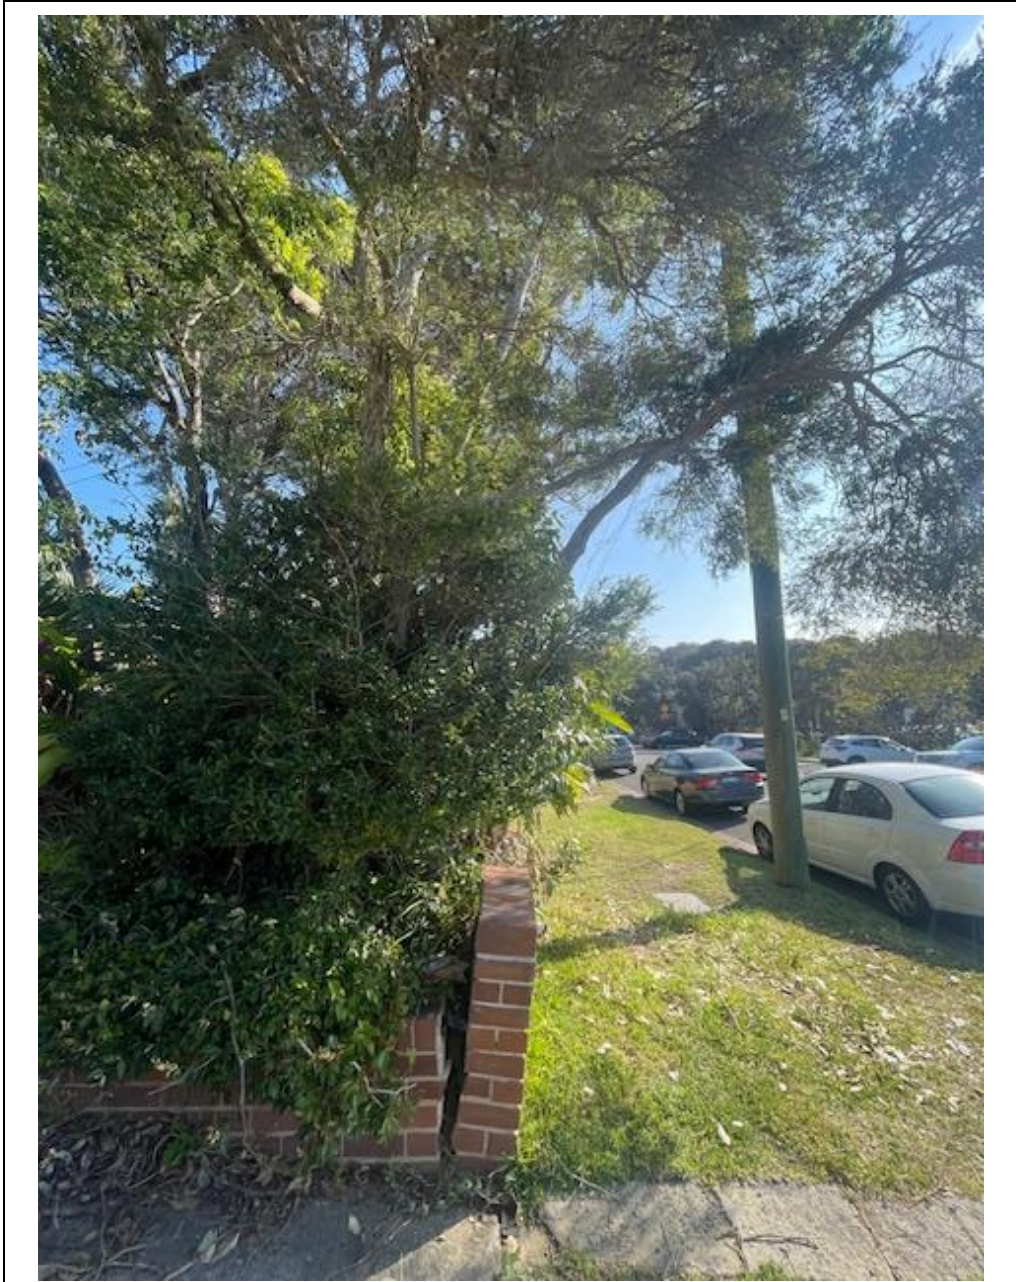
3	<i>Eucalyptus robusta</i>	A1	10.0	3.2	Major	The proposed excavations and level changes for the new driveway and carport will encroach into the TPZ but not the SRZ by up to 9%. The existing front boundary retaining wall is in the process of failing and is assumed to be replaced. The existing wall transects through the TPZ and the SRZ indicating that a new wall will be of major encroachment potentially affecting the condition and stability of the tree. Unless it can be demonstrated that the new wall can be constructed at a greater setback than the existing to avoid excavation into the front setback the tree is not considered to be retainable under the proposal.	Remove
4	<i>Eucalyptus robusta</i>	A1	8.8	2.9	Major	The proposed excavations and level changes for the carport and new driveway will encroach into the TPZ and the SRZ by up to 35% which is a major encroachment that is likely to affect the condition and stability of the tree.	Remove

Photo A: The front boundary retaining wall is in a state of disrepair.
