AS2870-2011 SITE CLASSIFICATION

Nason Atai

Lot 1, No 35 Blackbutts Road

Our REF: AWT 84605

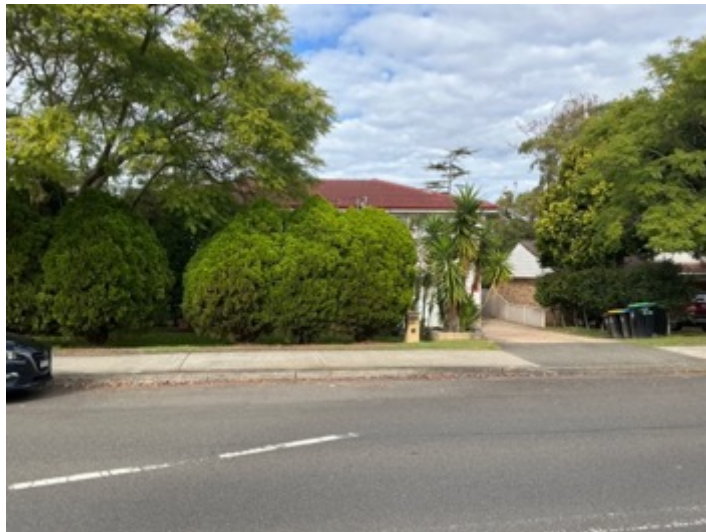
SITE PHOTO:

Site Features:	Existing Dwelling with grass
Site Drainage:	Poor to Fair (At time of testing)
Ground Slope	Flat to Slight
Water Table/Seepage:	Not present
Fill:	Yes
Rock:	Yes (inferred at TS1)
Slope Instability Assessment:	Not commissioned
Exposure Classification:	Not Commissioned
