PRELIMINARY GEOTECHNICAL ASSESSMENT:

5 Yallumba Close, Forestville

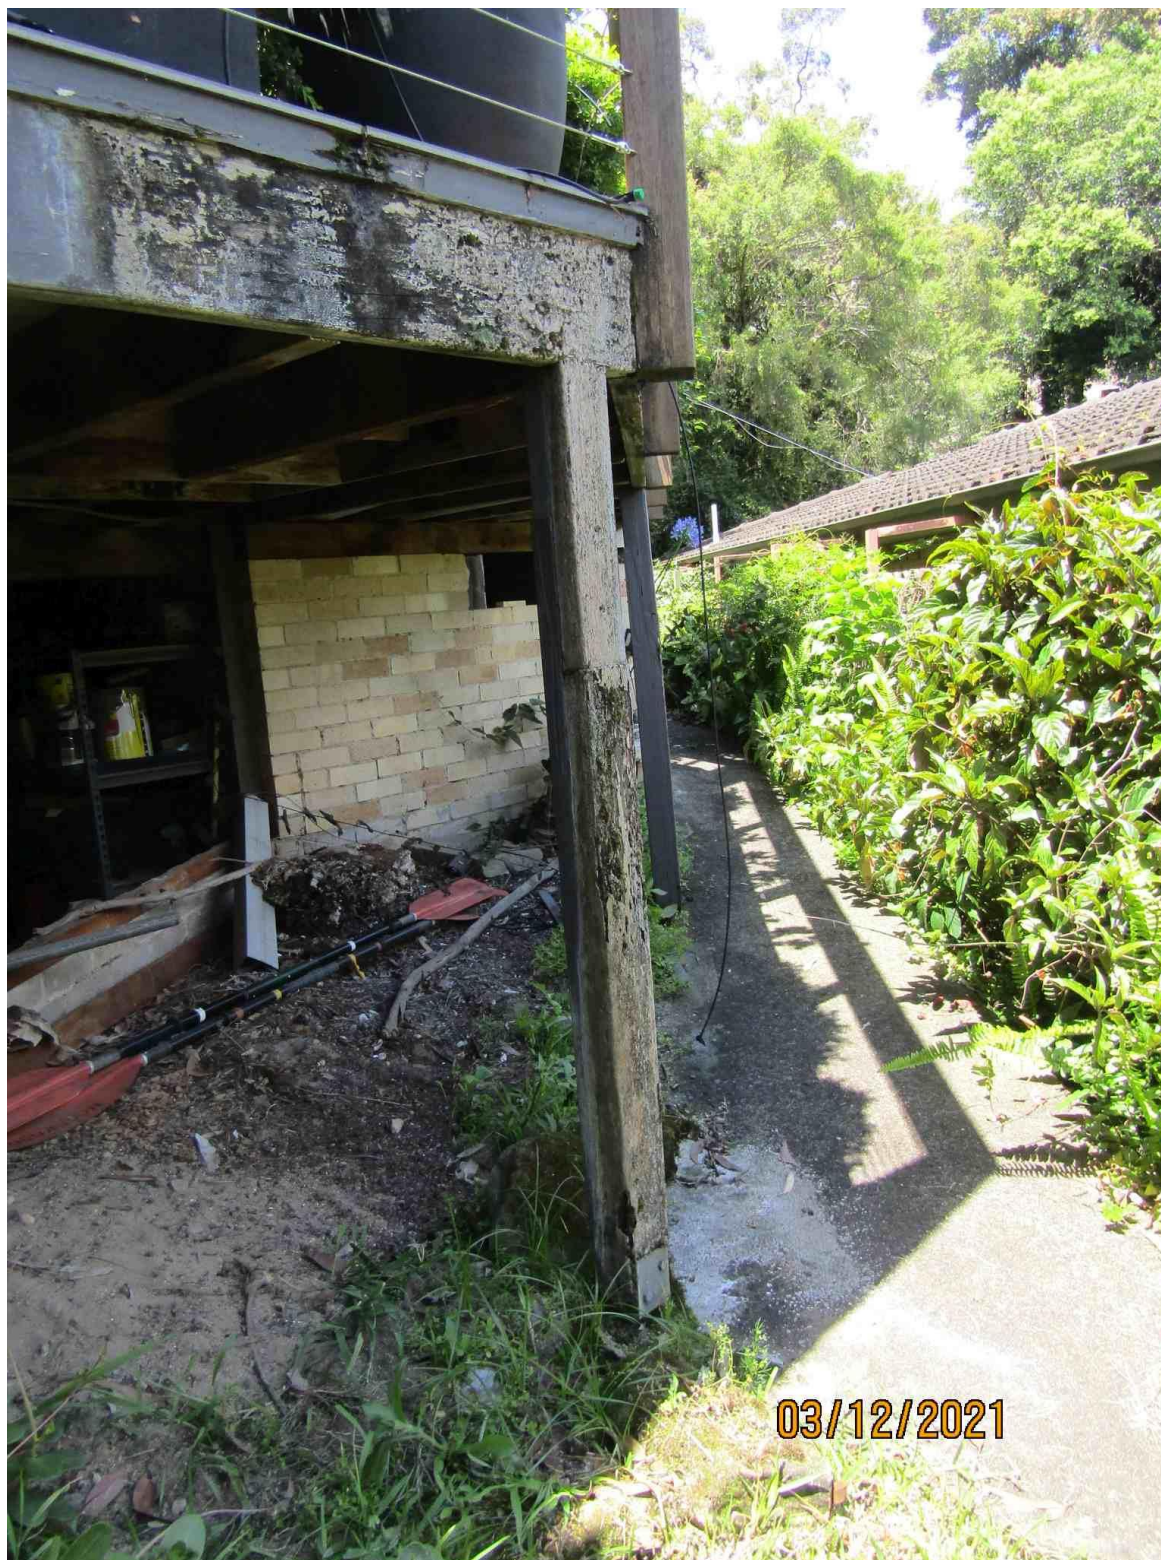
Photo 1

The rotting timber posts and beams supporting the outer edge of the deck (Photo 1) are to be assessed for stability by a structural engineer.
