Report Title: Geotechnical Report 40 Maxwell Street, Mona Vale  
Report Date: 24/6/19  
Author: BEN WHITE  
Author's Company/Organisation: WHITE GEOTECHNICAL GROUP PTY LTD

## **GEOTECHNICAL INVESTIGATION:**

Alterations & Additions and New Secondary Dwelling at **40 Maxwell Street, Mona Vale**

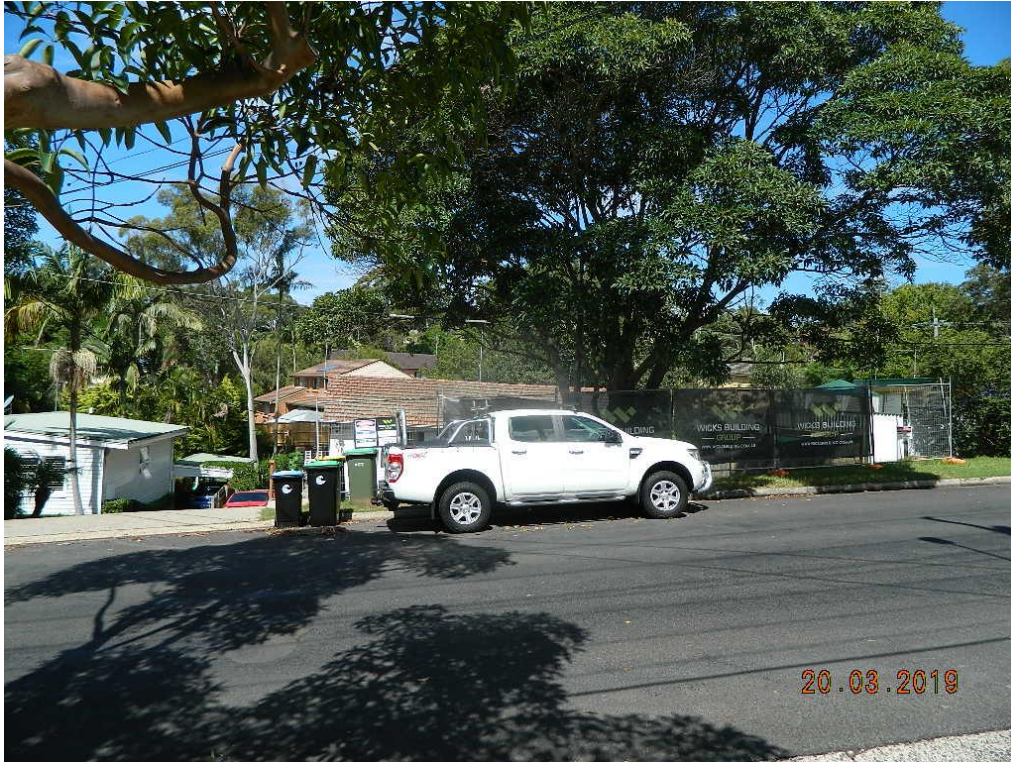
Photo 1

- 2.1** The site was inspected on the 20<sup>th</sup> March, 2019.
- 2.2** This residential property is on the low side of the road and, in the location of the house, has a SE aspect. The block is located within a gently graded gully between two hillslopes. At the road frontage, the slope falls at an average angle of ~8° to the base of the gully where a stormwater easement contains a stormwater pipe that is partially exposed at the surface (Photo 10). This was likely installed through the path of the original creek channel and has been backfilled during the development of the block. The slope begins to rise again on the other side of the easement. The slopes above the property continue at gentle angles.
- 2.3** At the road frontage, a concrete driveway runs down the slope to a gravel parking area on the NE side of the house (Photos 1 & 2). A cut and fill has been made

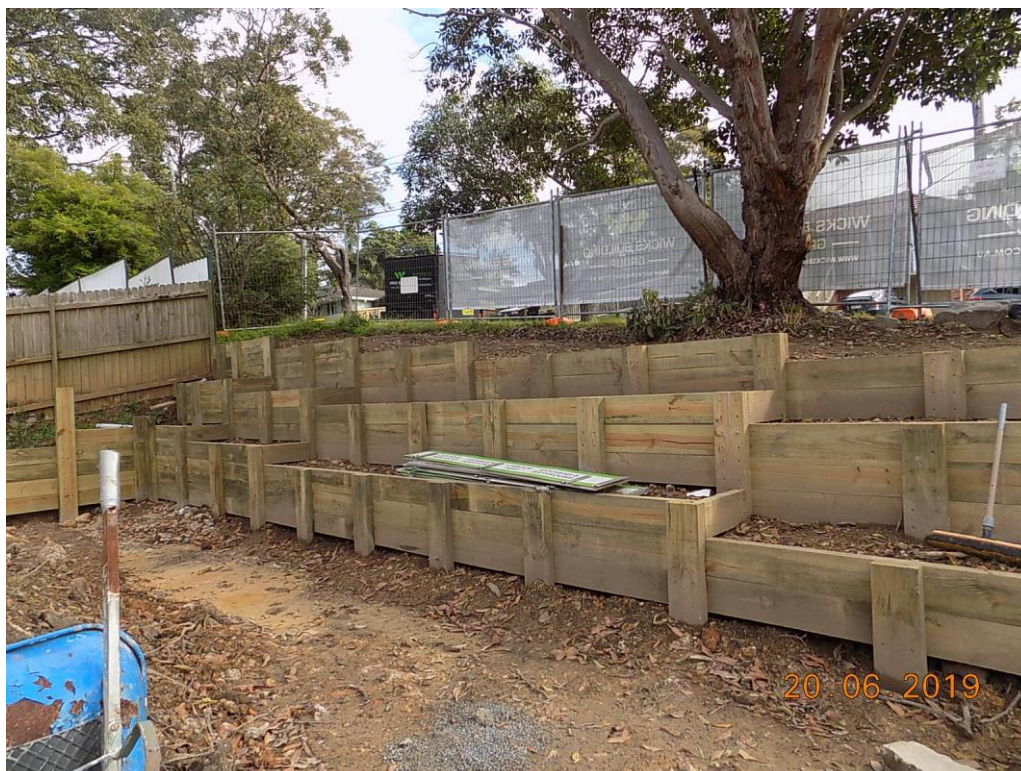
Photo 3

in the slope between the road frontage and the house (Photos 3 & 4). Both the cut and fill are supported by new stable timber retaining walls. The single-storey brick and timber framed and clad house is supported on brick walls and brick piers (Photo 5). No significant signs of movement or cracking were observed in the external supporting walls of the house. Two of the brick piers were observed to be tilting to a maximum angle of  $\sim 6^\circ$  (Photos 6 & 7). We recommend these piers be replaced as part of the proposed works and note an assessment of the structural adequacy of the house will need to be undertaken by the structural engineer. A gently sloping lawn extends from the downhill side of the house to the SE common boundary (Photo 8). A stable  $\sim 1.5\text{m}$  high timber retaining wall along the SE common boundary supports a fill that levels the SE neighbouring property (Photo 9). No significant signs of movement were observed on the property. No geotechnical hazards that could impact on the subject property were observed on the neighbouring properties as seen from the subject property and the road.

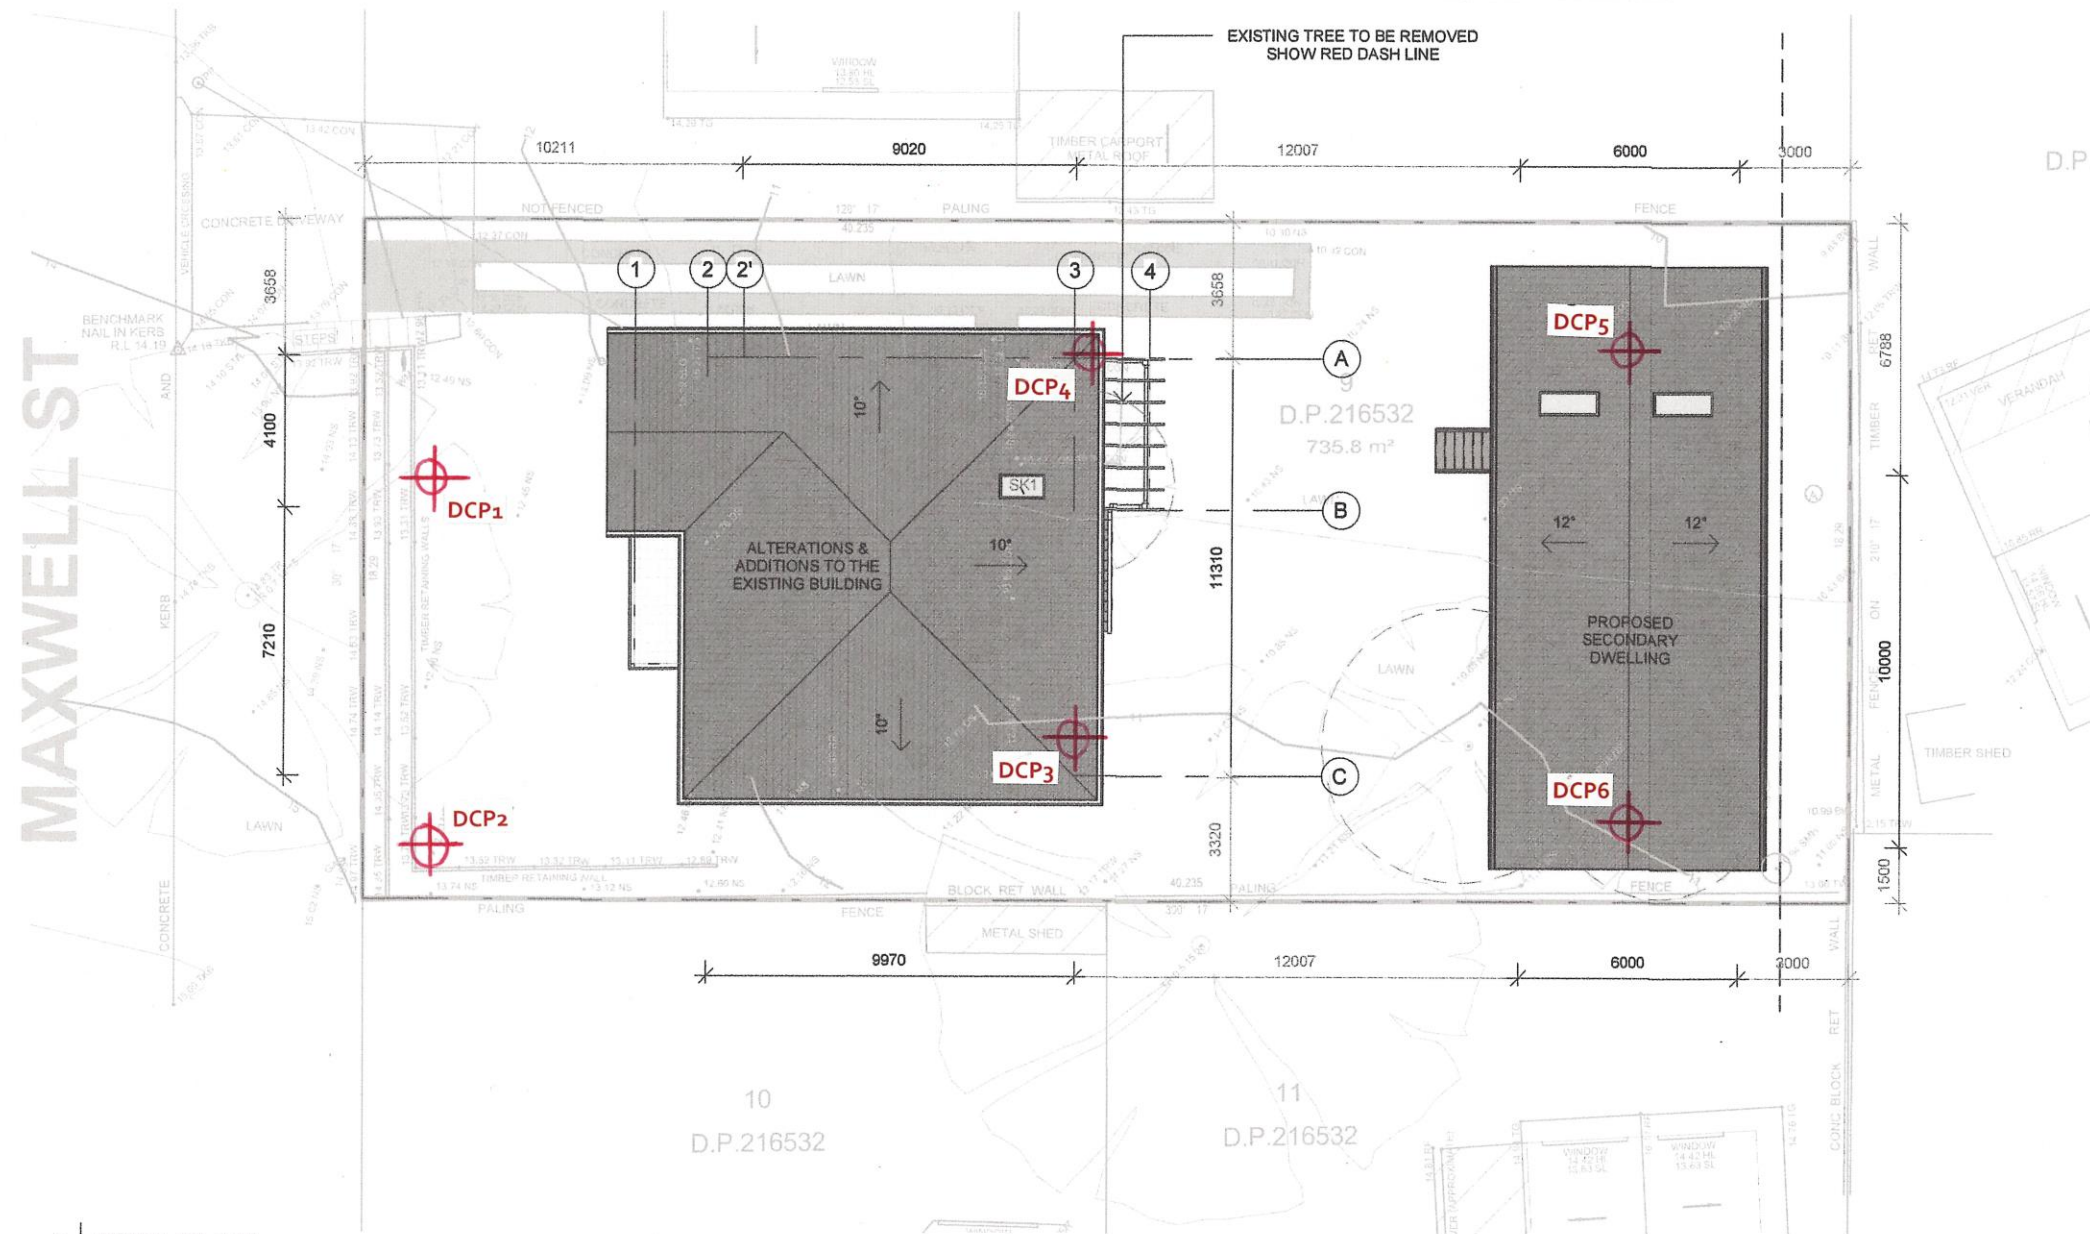
# SITE PLAN – showing test locations

Six DCP (Dynamic Cone Penetrometer) tests were put down to determine the relative density of the overlying soil and the depth to weathered rock. The locations of the tests are shown on the site plan. It should be noted that a level of caution should be applied when interpreting DCP test results. The test will not pass through hard buried objects so in some instances it can be difficult to determine whether refusal has occurred on an obstruction in the profile or on the natural rock surface. It is likely DCP1 refused on a boulder/rock in the profile, this is not expected to be an issue for the remaining tests on this site and the results are as follows:

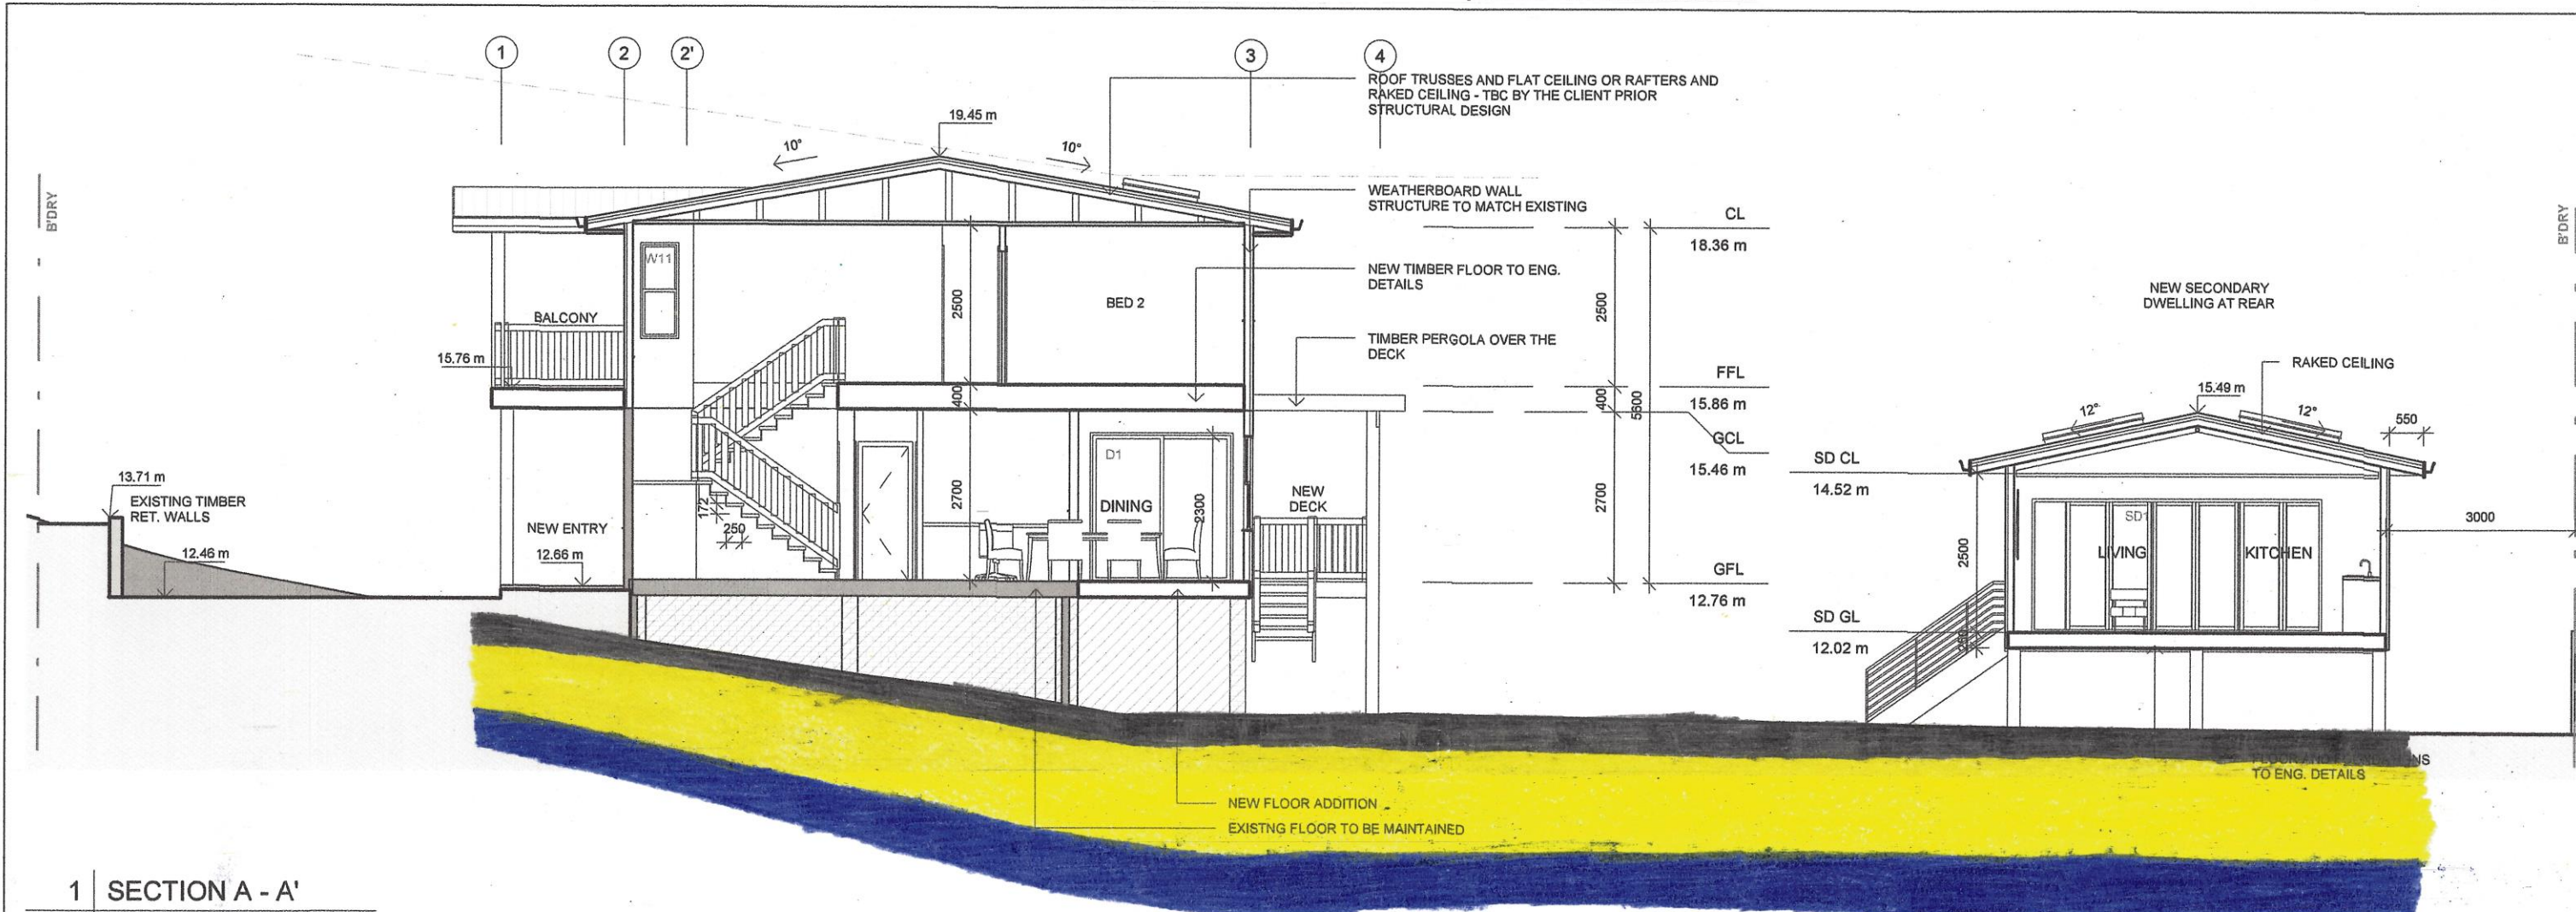
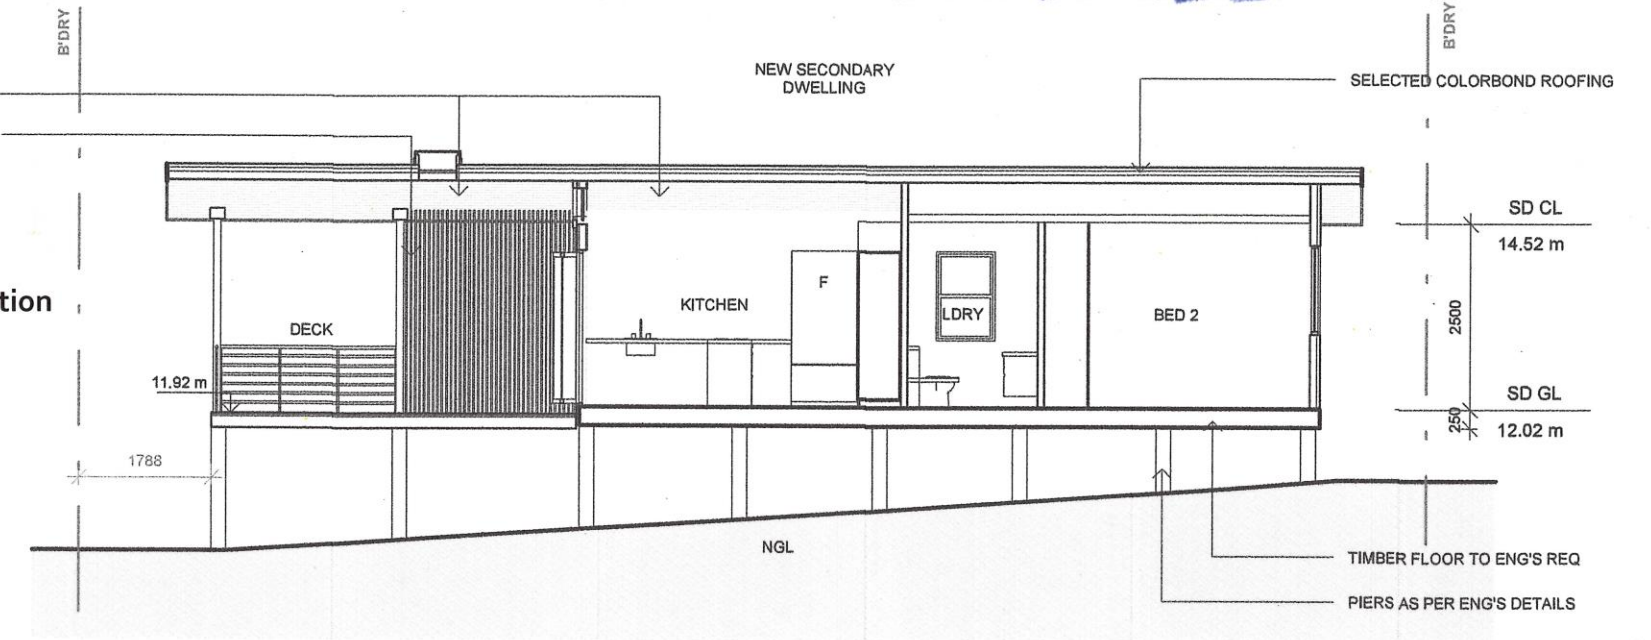
# TYPE SECTION – Diagrammatical Interpretation of expected Ground Materials

below the current ground surface, being variable due to the weathered nature of the rock. Extremely Low to Very Low Strength Shale is expected to underlie the entire site. It is to be noted that this material can appear as a mottled stiff clay when it is cut up by excavation equipment. The original creek channel has likely been infilled during the initial development of the property. No other fills were observed during the testing on the site. See Type Section attached for a diagrammatical representation of the expected ground materials.

- Fill
- Topsoil
- Silty Clay – Firm to Stiff
- Narrabeen Group Rocks – Extremely Low Strength Shale - after being cut up by excavation equipment can resemble a stiff to hard clay.
