# Geotechnical Assessment

**Project:** Alterations & Additions  
15 Lakeside Crescent, North Manly NSW

**Ref:** AG 25044  
11 February 2025

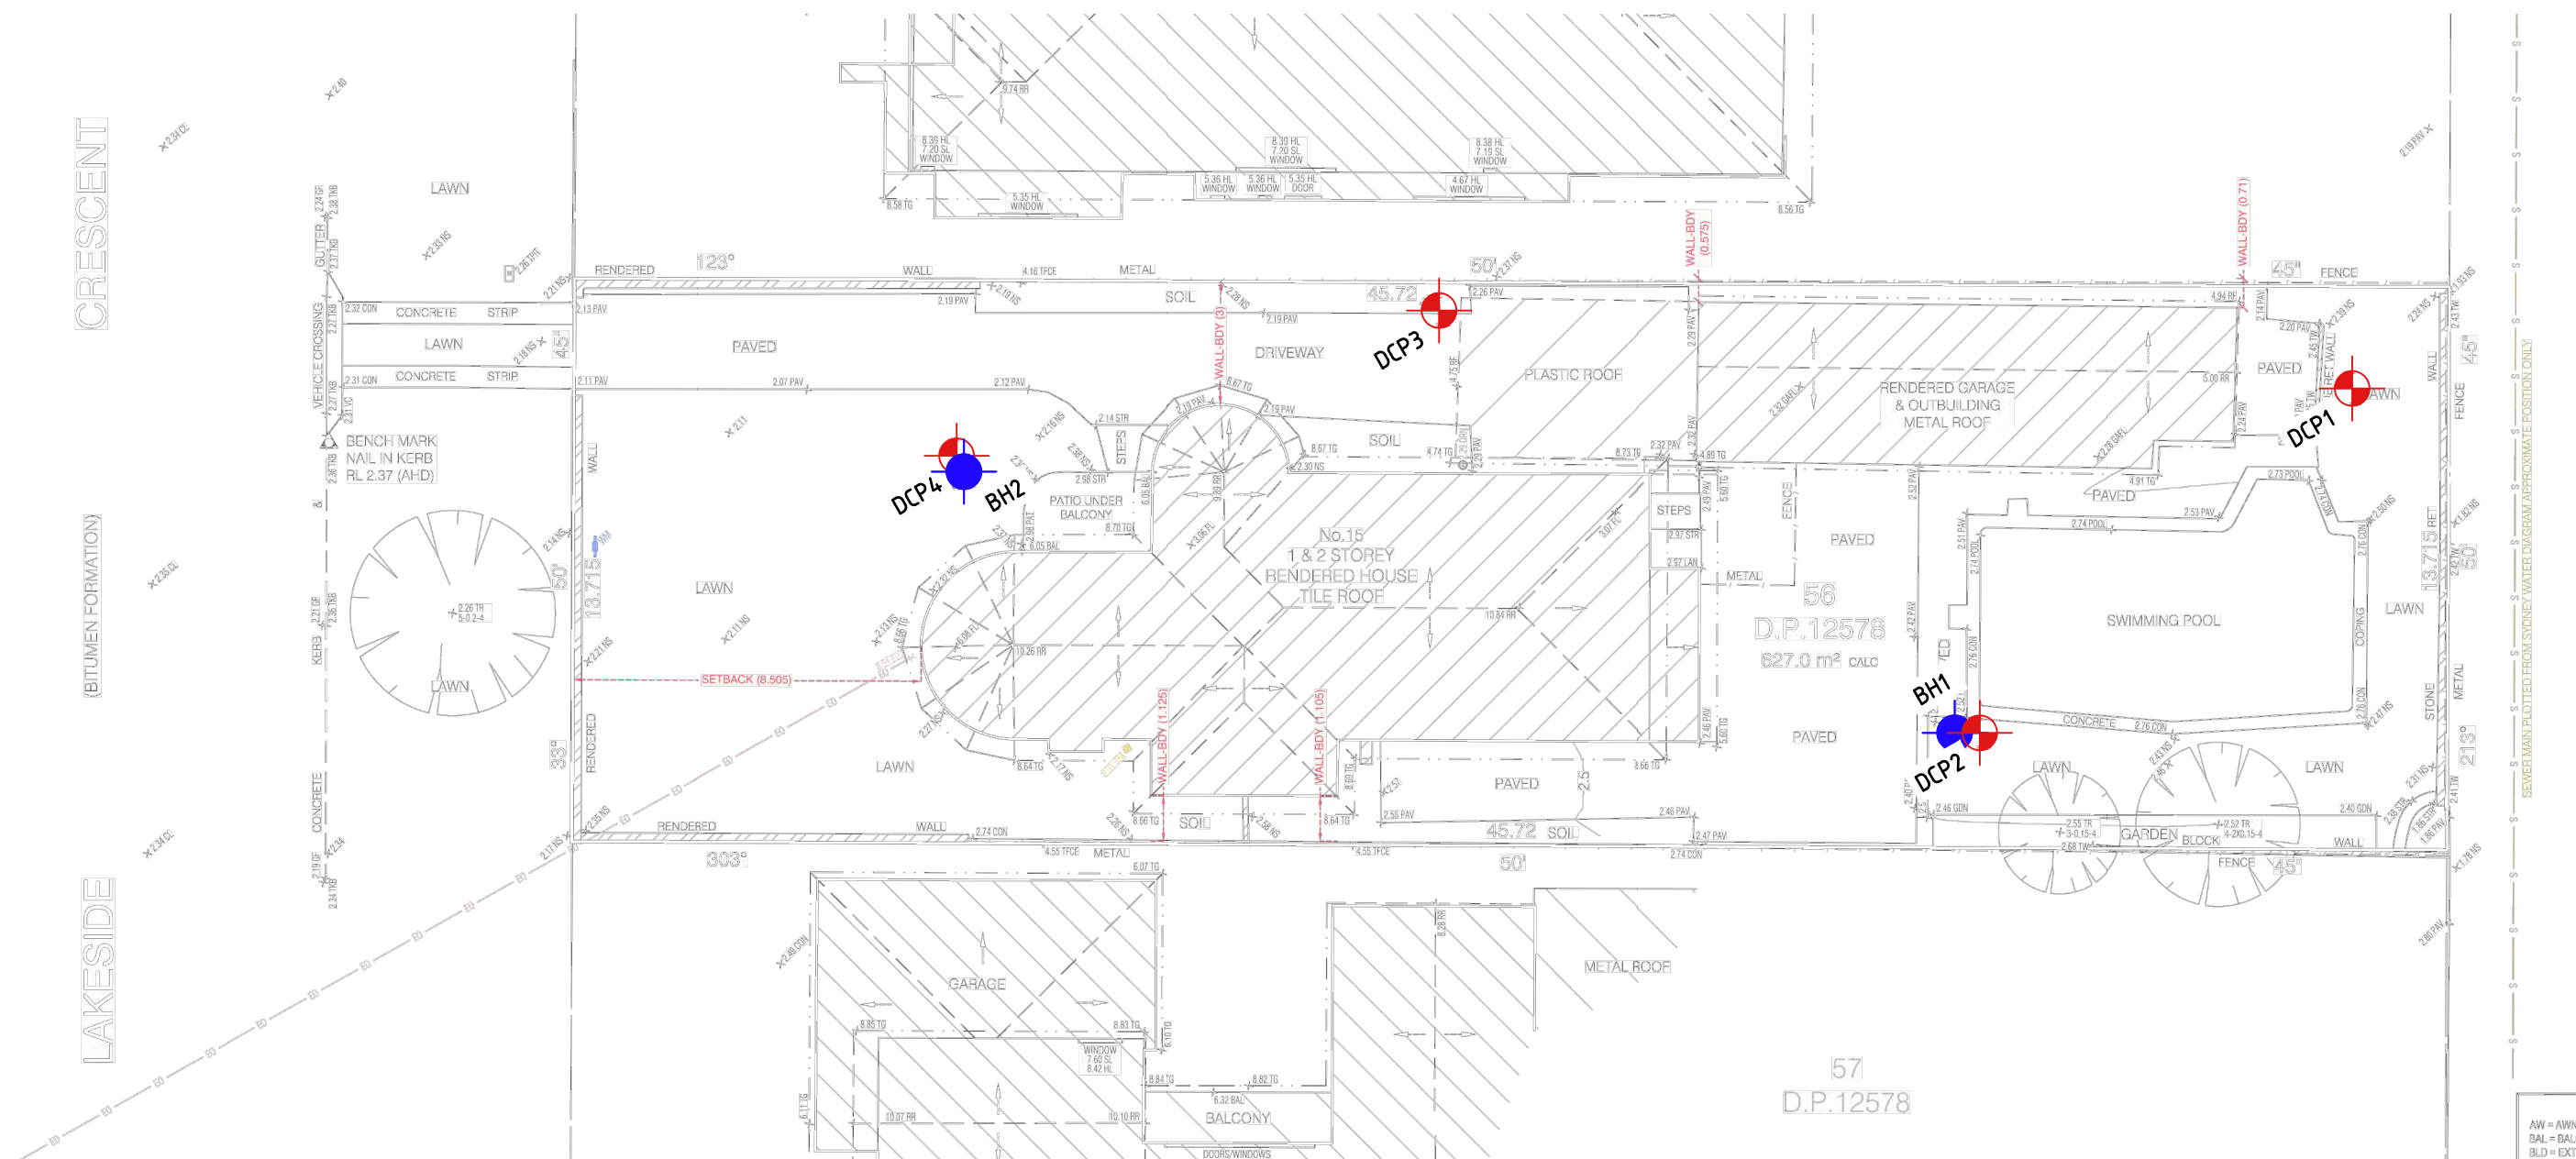
DATE:	09/02/2025
SCALE:	AS SHOWN @ A3
DRAWING TITLE:	SITE PLAN
DRAWING NO:	AG 25044- S1

SITE PLAN/GROUND TEST LOCATIONS  
SCALE NTS

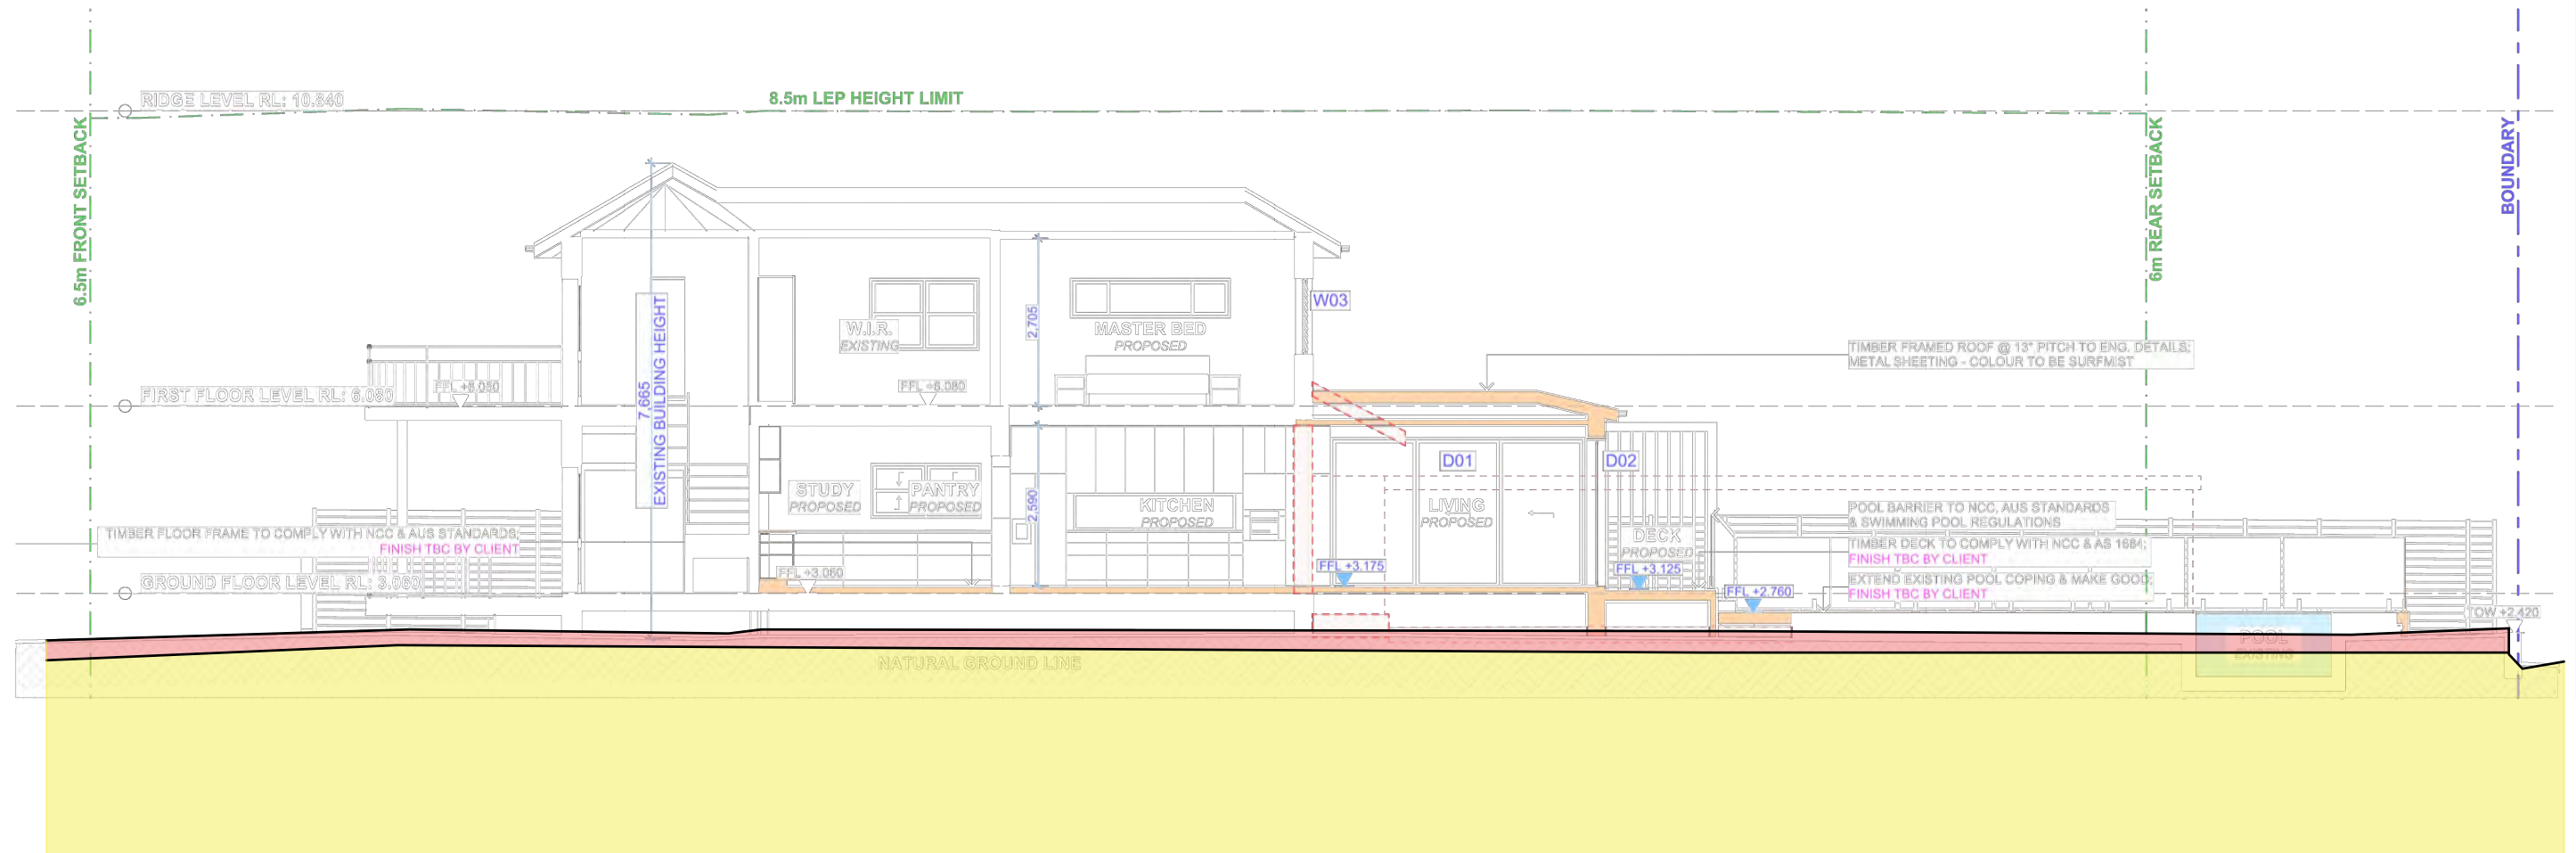
**INFERRED GEOLOGICAL SECTION**  
SCALE NTS

INTERPRETED SUBSURFACE SECTION ONLY.  
ACTUAL GROUND CONDITIONS MAY VARY.

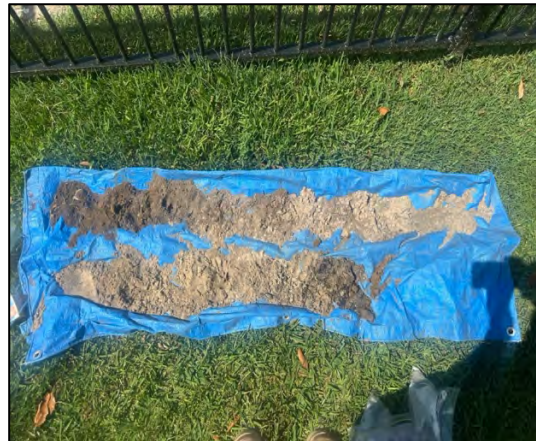
**Photo 4:** Subsurface soil profile of BH01.

0.25	Fill	Fill Silty SAND SM: poorly compacted, dark brown, fine to coarse grained, with fine to coarse sized gravel, moist.	SM		PC	M	
		0.50							
		0.75							
		1	Natural	Silty SAND SM: loose to medium dense, grey light brown, fine to medium grained, trace fine sized gravel, natural moist, trace of shells.	SM		L-MD

1.25							
		1.50							
		1.75		Silty SAND SM: loose to medium dense, grey light brown, fine to medium grained, trace fine sized gravel, natural moist, trace of shells.	SM			W-M	
				BH1 Terminated at 1.8m (Practical limit of hand held equipment)					
<div>METHOD</div> <div>EX Excavator bucket</div> <div>R Ripper</div> <div>HA Hand auger</div> <div>PT Push tube</div> <div>SON Sonic drilling</div> <div>AH Air hammer</div> <div>PS Percussion sampler</div> <div>AS Short spiral auger</div> <div>AD/V Solid flight auger:V-Bit</div> <div>AD/T Solid flight auger:TC-Bit</div> <div>HFA Hollow flight auger</div> <div>WB Washbore drilling</div> <div>RR Rock roller</div>		<div>PENETRATION</div> <div>VE Very Easy(No Resistance)</div> <div>E Easy</div> <div>F Firm</div> <div>H Hard</div> <div>VH Very Hard(Refusal)</div> <div>WATER</div> <div> Water Level on Date</div> <div> Water inflow</div> <div> Water outflow</div>		<div>FIELD TESTS</div> <div>SPT - Standard Penetration Test</div> <div>PP - Hand/Pocket Penetrometer</div> <div>DCP - Dynamic Cone Penetrometer</div> <div>PSP - Perth Sand Penetrometer</div> <div>MC - Moisture Content</div> <div>PBT - Plate Bearing Test</div> <div>IMP - Borehole Impression Test</div> <div>PID - Photo Ionisation Detector</div> <div>VS - Vane Shear; P=Peak, R=residual (unconnected kPa)</div>		<div>SAMPLES</div> <div>B - Bulk disturbed sample</div> <div>D - Disturbed sample</div> <div>ES - Environmental sample</div> <div>U - Thin wall tube "undisturbed"</div> <div>MOISTURE</div> <div>D - Dry</div> <div>M - Moist</div> <div>W - Wet</div> <div>PL - plastic limit</div> <div>LL - liquid limit</div> <div>W - Moisture content</div>		<div>SOIL CONSISTENCY</div> <div>VS - Very soft</div> <div>S - Soft</div> <div>F - Firm</div> <div>St - Stiff</div> <div>VSt - Very stiff</div> <div>H - Hard</div> <div>RELATIVE DENSITY</div> <div>VL - Very loose</div> <div>L - Loose</div> <div>MD - Medium dense</div> <div>D - Dense</div> <div>VD - Very dense</div>
