**RISK ANALYSIS &
MANAGEMENT
FOR
PROPOSED ADDITIONS
AND ALTERATIONS
AT
55 ROBERTSON ROAD,
SCOTLAND ISLAND**

VS 24417.
2nd July, 2013.
Page 1.

RISK ANALYSIS & MANAGEMENT FOR PROPOSED ADDITIONS & ALTERATIONS AT 55 ROBERTSON ROAD, SCOTLAND ISLAND

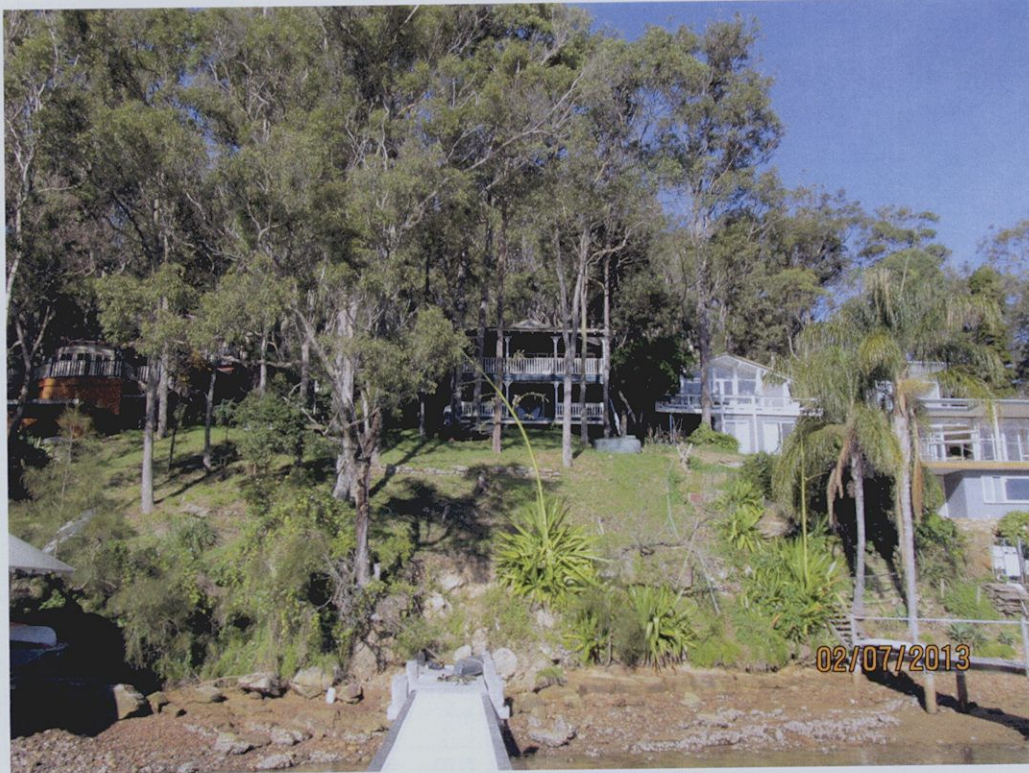
Photo 1

3.3 A jetty in good condition extends into Pittwater from the middle of the block (Photo 1). Sandstone bedrock outcrops along the waterfront and shows no geological defects that could affect its stability (Photo 2). An embankment rises steeply from the water's edge before easing at the house. Slumping has occurred near the middle of this bank (Photo 3). The slump is approximately 1.2 metres deep and 3.5 metres wide. A tree is located beside the slump and soil erosion has occurred beside the tree trunk (Photo 4). The tree appears to be dying and if it falls it will destabilize the surrounding area. Further investigation is to be undertaken to determine the condition of the tree. Access to the house is provided by a path that extends along the eastern side of the property. The slope is planted with deep rooted gum trees that stand vertical (Photo 5). A cut has been made underneath the house to accommodate a storage area. It is supported by a stable timber wall. The western side of the cut is unsupported but the batter angles appear stable (Photo 6). A paved area has been cut into the slope on the uphill side of the house. It is supported by a stable concrete block wall (Photo 7). A shed is located near the upper boundary. The cut batter to accommodate this shed rises to a maximum of approximately 0.6 metres. The cut batter stands at near vertical angles and is unsupported. We recommend a retaining wall be installed.

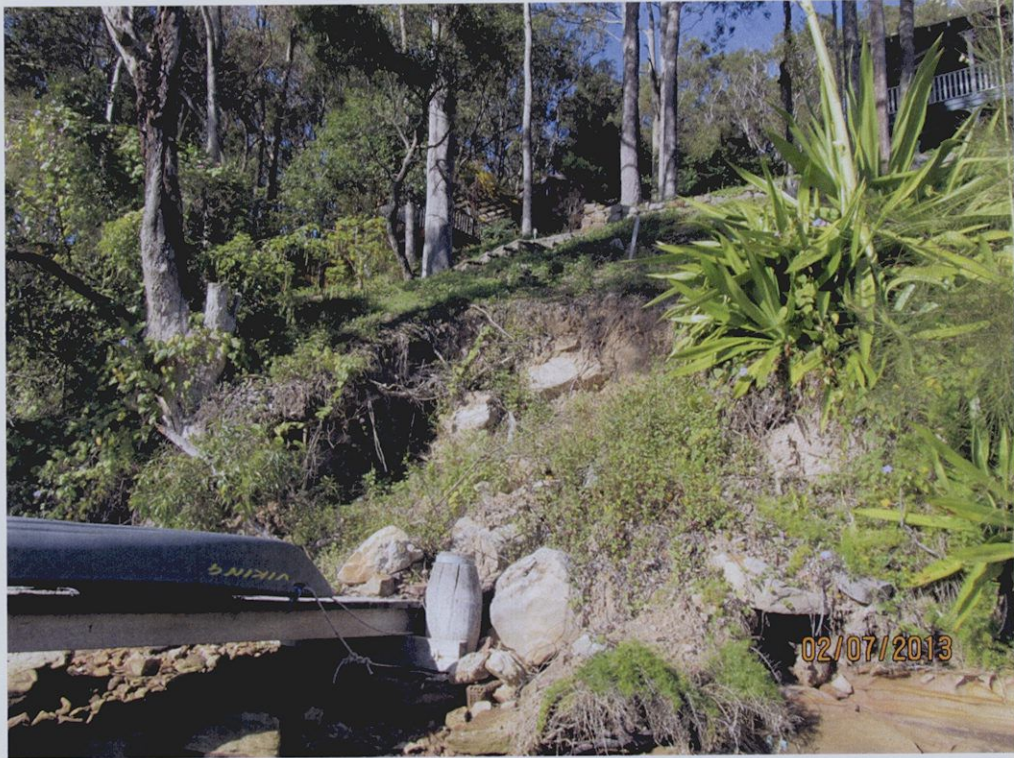
Photo 3

An embankment rises steeply from the water's edge. Slumping has occurred near the middle of this bank. The slump is approximately 1.2 metres deep and 3.5 metres wide. The soil profile consists of 0.2m of organic topsoil over firm clay with bedrock encountered at ~ 1.0m. A tree is located beside the slump and soil erosion has occurred underneath the tree trunk. The tree appears to be dying and if it falls it will destabilize the surrounding area. The likelihood of further slumping impacting on the jetty is assessed as 'Likely' (10^{-2}). The consequences to property of such a failure are assessed as 'Minor' (5%). The risk to property is 'Medium' (5×10^{-4}).

HAZARDS	Hazard One
TYPE	The land slump that has occurred along the waterfront bank is a potential hazard (Photo 3 & 4)
LIKELIHOOD	'Likely' (10^{-2})
CONSEQUENCES TO PROPERTY	'Minor' (5%)
RISK TO PROPERTY	'Medium' (5×10^{-4}).
RISK TO LIFE	2.08×10^{-5} /annum
COMMENTS	NOTE: This level of risk is ' UNACCEPTABLE '. This level of risk can be brought to ' ACCEPTABLE ' if further investigation is undertaken to determine the condition of the tree and large boulders are placed across the base of the slump and stepped up the slope.

$R_{(Lol)} = 2.08 \times 10^{-5}/\text{annum}$ **NOTE:** This level of risk is 'UNACCEPTABLE'. This level of risk can be brought to 'ACCEPTABLE' if further investigation is undertaken to determine the condition of the tree and large boulders are placed across the base of the slump and stepped up the slope to stabilize this area.

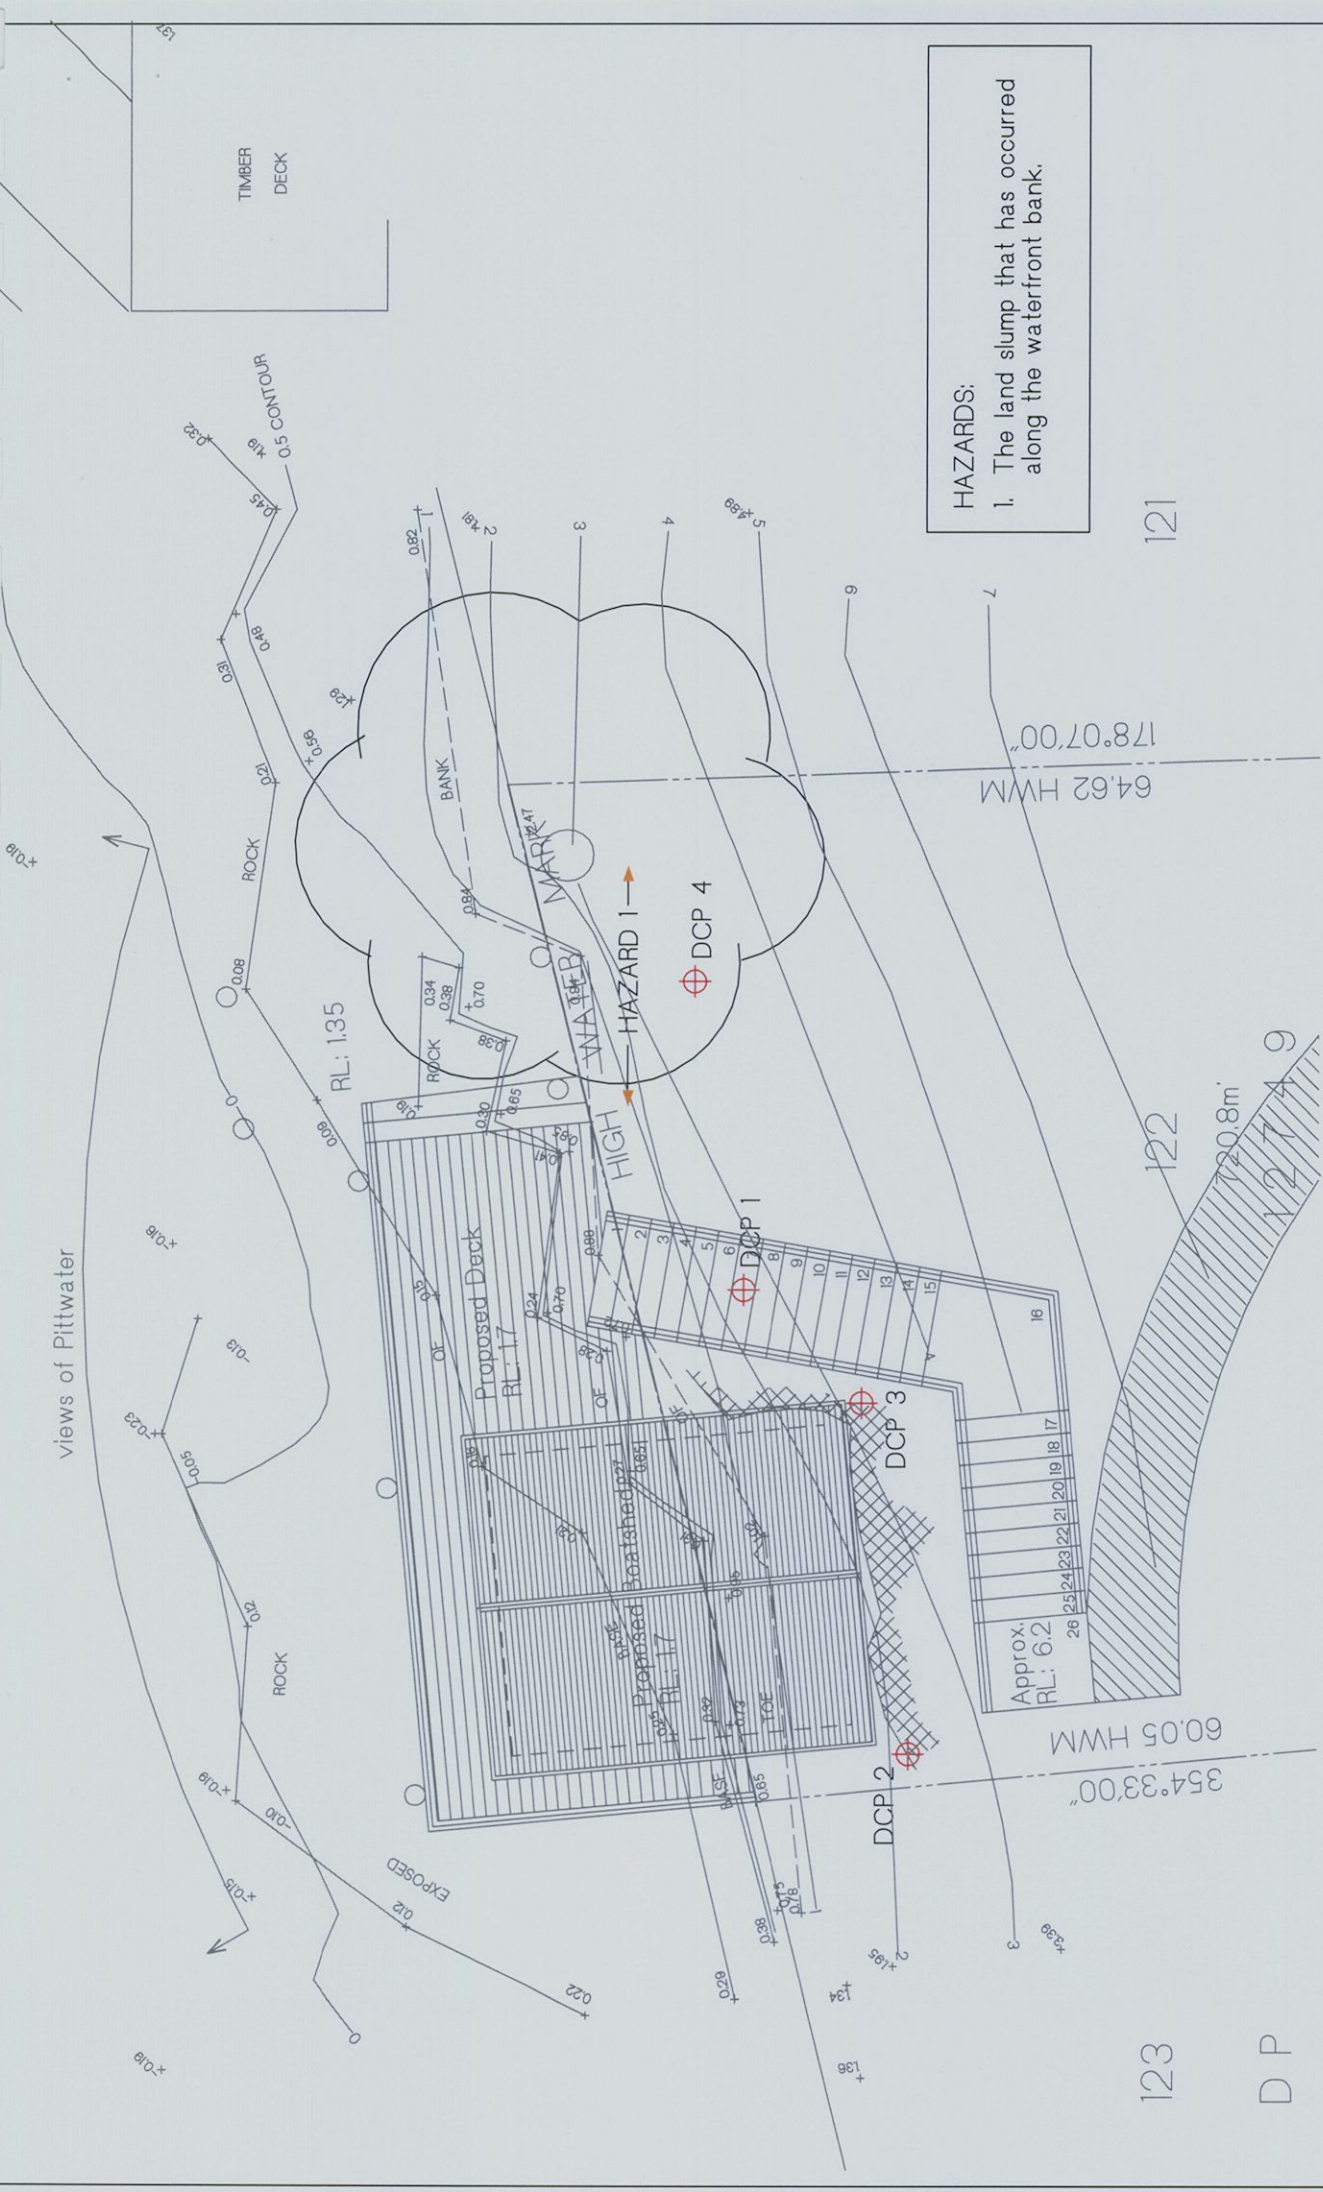
<p>SITE PLAN - DCP LOCATIONS</p>		<p>Job No VS 24417</p>	<p>Address 55 ROBERTSON ROAD SCOTLAND ISLAND NSW</p>
		<p>Scale 1:100</p>

Four Dynamic Cone Penetrometer (DCP) tests were conducted in the approximate locations shown on the Site Plan. The results of these tests are as follows:

HAZARDS:
 1. The land slump that has occurred along the waterfront bank.
