Arboricultural Impact Assessment

15 Dress Circle Avalon

Prepared by Alex Austin

David Tory July 2020

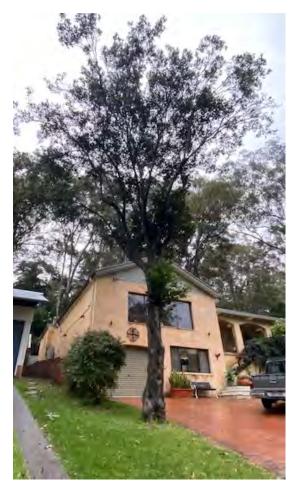
Tree 1 is located at on the boundary between 15 & 17 Dress Circle Road. The boundary is not fenced at the tree location. The tree is to be retained. No works are planned in the TPZ, however, Tree 1 is vulnerable to construction damage due to its proximity to the works and must be protected from damage.

Figure 7: Tree 1 in the landscape. (Source: Austin 1/5/2020)

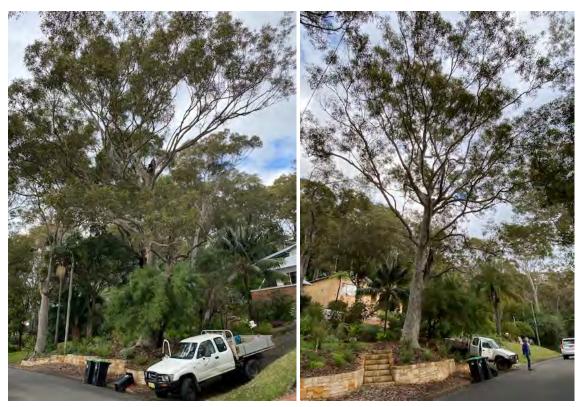
Tree number 3 appears to be located on the council verge. A large stem failure has previously occurred in the upper canopy which has created a cavity. The previous failure appears to be storm related and has resulted in fair structure. A cavity and excessive end weight over the driveway were observed. A comms cable is attached to the trunk. The tree is to be retained. Minor driveway expansion works are planned within the TPZ. The required excavation works are to be completed by hand and must not damage roots larger than 40mm.

Figure 8 (Left): The cavity and previous failure wound in Tree 3 can be observed.. (Source: Austin 1/5/2020)

Figure 9 (Right): Tree 3 in the landscape. (Source: Austin 1/5/2020)

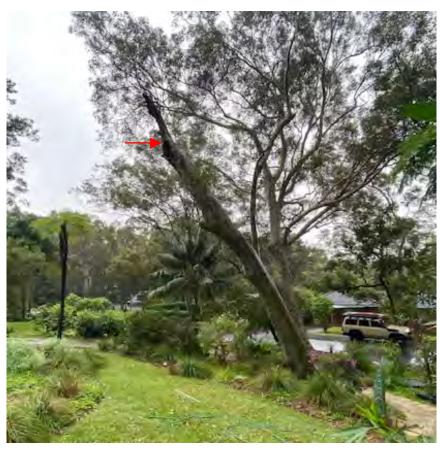
Tree 2 has had a previous major stem failure that has resulted is a cavity and a significantly reduced canopy volume. The tree receives a C retention value due to its poor remaining structure. Active fauna nesting was observed in the hollow. The tree is to be retained. No works are planned in the TPZ, however, Tree 1 is vulnerable to construction damage due to its proximity to the works and must be protected from the works.

Figure 10. Tree 2 in the landscape. The previous failure wounds, cavity and reduced size due to previous failures can be observed. (Source: Austin 1/5/2020)

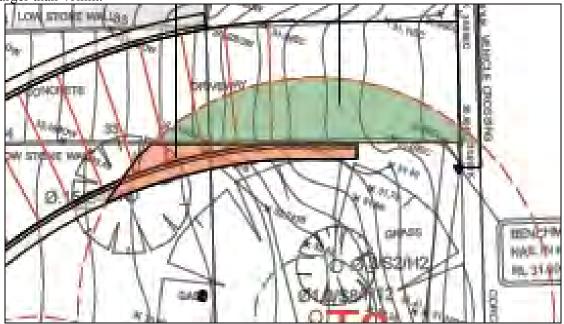
The existing drive levels are to stay the same. The alignment of the driveway is to expand to the east and into the TPZ. All required excavation works are to be completed by hand. The orange area in the figure below represents the new encroachment into the TPZ of Tree 3. The orange area is 3.5 square metres, representing 3.06% of the 115m TPZ. Considering the need for over excavation, a total of a 5% encroachment is considered to be necessary. This is considered a minor encroachment under Australian Standard 4970–2009: *Protection of trees on development sites*. The required excavation works are to be completed by hand and must not damage roots larger than 40mm.

Figure 11: The site plan indicating the location of the encroachment into Tree 3. (Source: Site plan, Titled 'PROPOSED NEW WORKS IN RELATION TO EXISTING TREES', by David Tory Architect, dated 13/07/20)
