# Geotechnical Assessment

**Project:** Alterations & Additions  
181 McCarrs Creek Road, Church Point NSW

## Geotechnical Assessment

**181 McCarrs Creek Road, Church Point NSW**

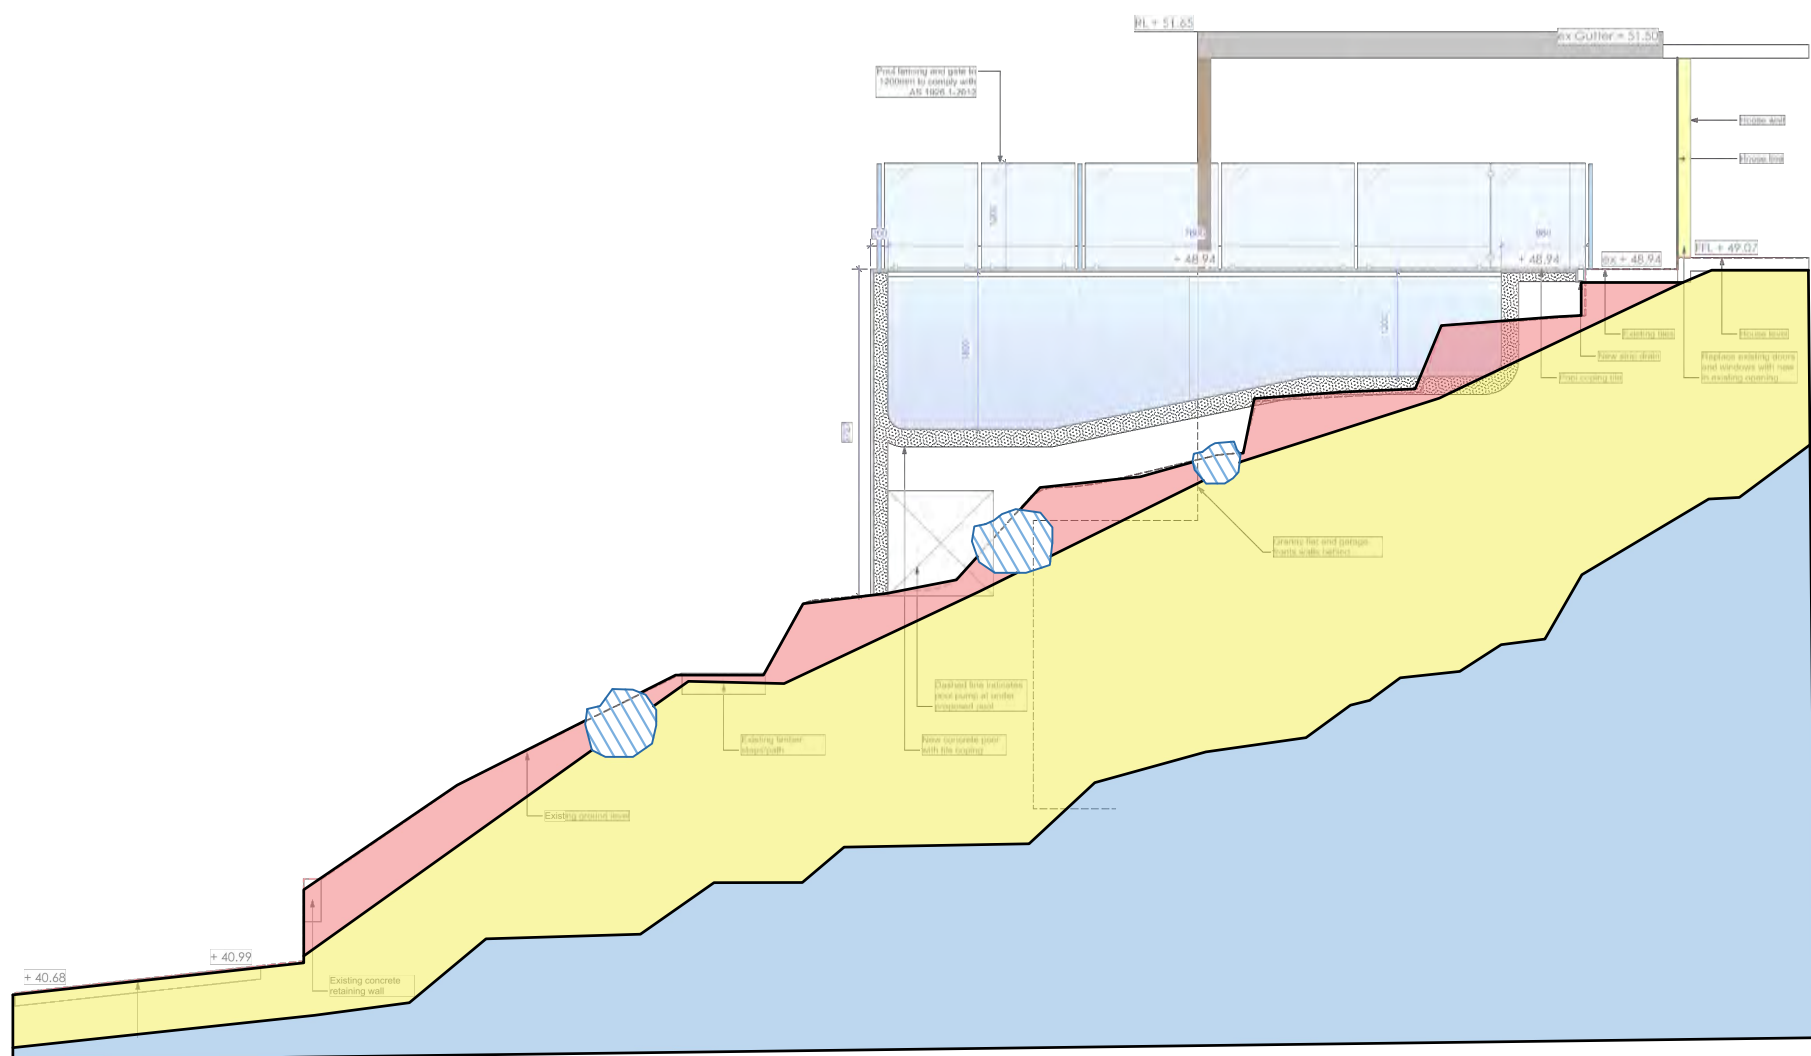
**INFERRED GEOLOGICAL SECTION  
AT 181 MCCARRS CREEK ROAD  
CHURCH POINT NSW**

The soil profile consists of shallow uncontrolled silty fill and silty topsoil (O & A Horizons), silty clay (B Horizon) and weathered low strength bedrock (C Horizon). Detached sandstone floaters are also expected on sand within the soil profile on site. Based on our observations and the results of testing on site, we would expect weathered low strength bedrock to be found within 1.0 to 4.0 metres below current surface levels across the area of the proposed works, and deeper where filling has been carried out.

INTERPRETED SUBSURFACE SECTION ONLY.  
ACTUAL GROUND CONDITIONS MAY VARY.
