Address of site 23-25 Bassett Street, Mona Vale

GEOTECHNICAL INVESTIGATION:

Proposed Aged Care Centre at 23-25 Bassett Street, Mona Vale

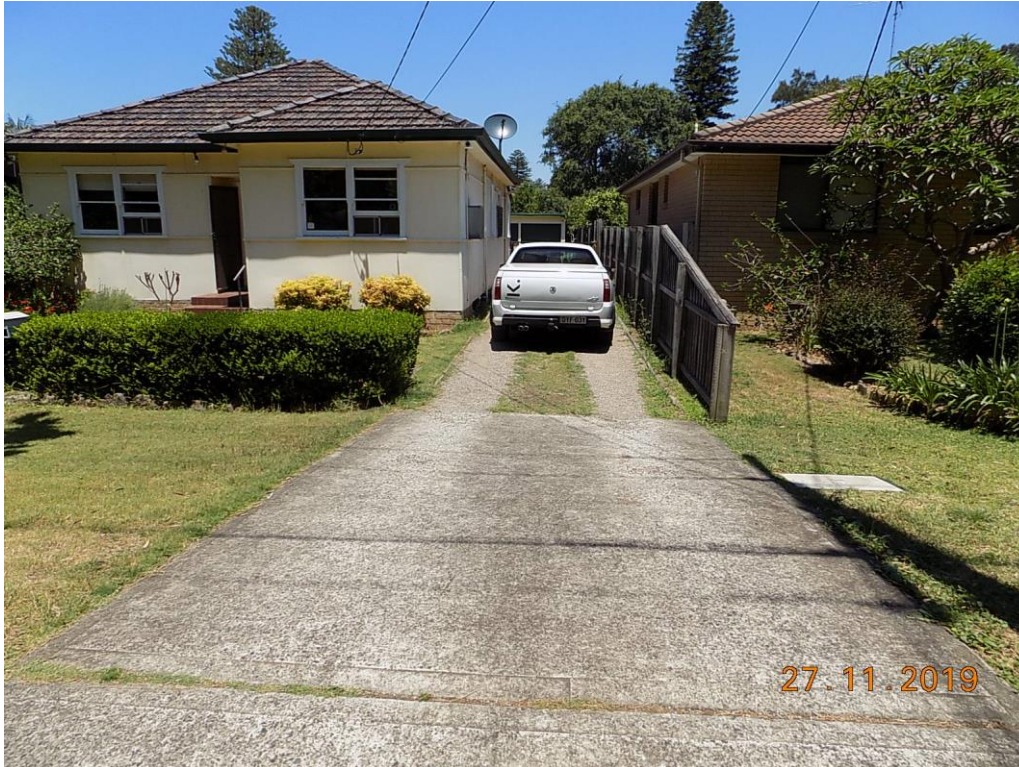
Photo 1

- 2.3** **23 Bassett Street** - At the road frontage, a concrete and gravel driveway runs to a parking area on the W side of the house (Photo 1). Between the road frontage and the house is a near-level lawn (Photo 2). Another near-level lawn extends off the S side of the house, past two garages, to the S common boundary (Photos 3, 4, and 5). The house and both garages will be demolished and the site will be cleared as part of the proposed works.

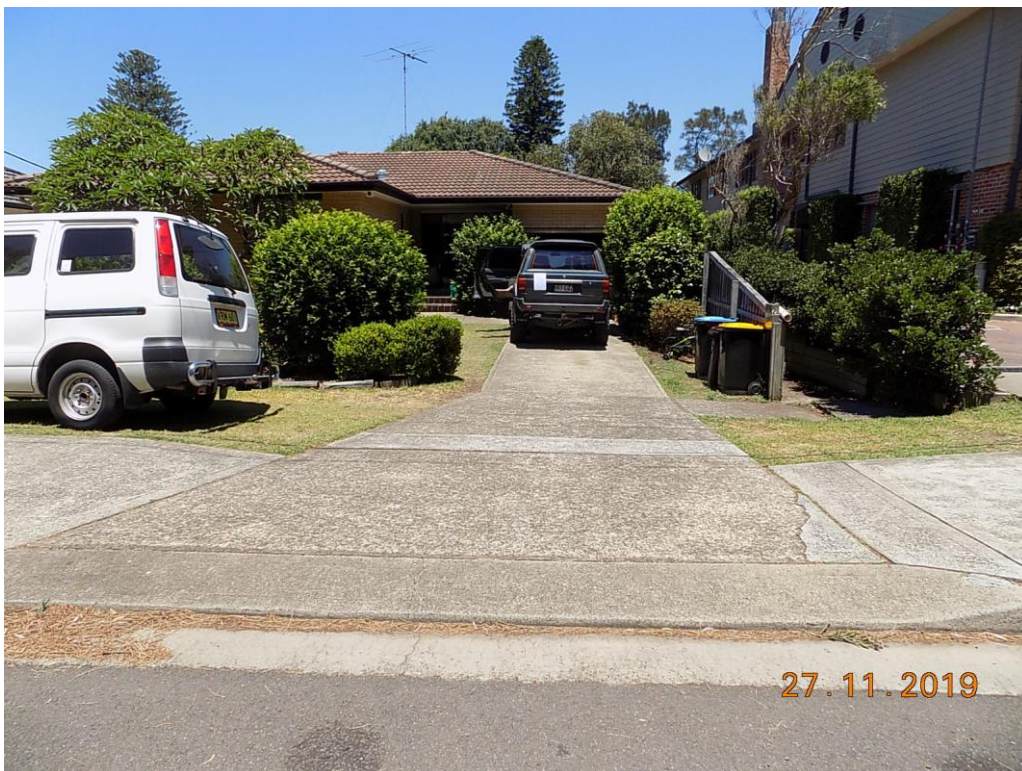
Photo 6

- 2.5** **25 Bassett Street (Residential)** – At the road frontage, a concrete driveway runs to a garage attached to the W side of the house (Photo 6). Between the road frontage and the house is a near-level lawn and garden area (Photo 7). Another near-level lawn extends off the S side of the house to the S common boundary (Photo 8).

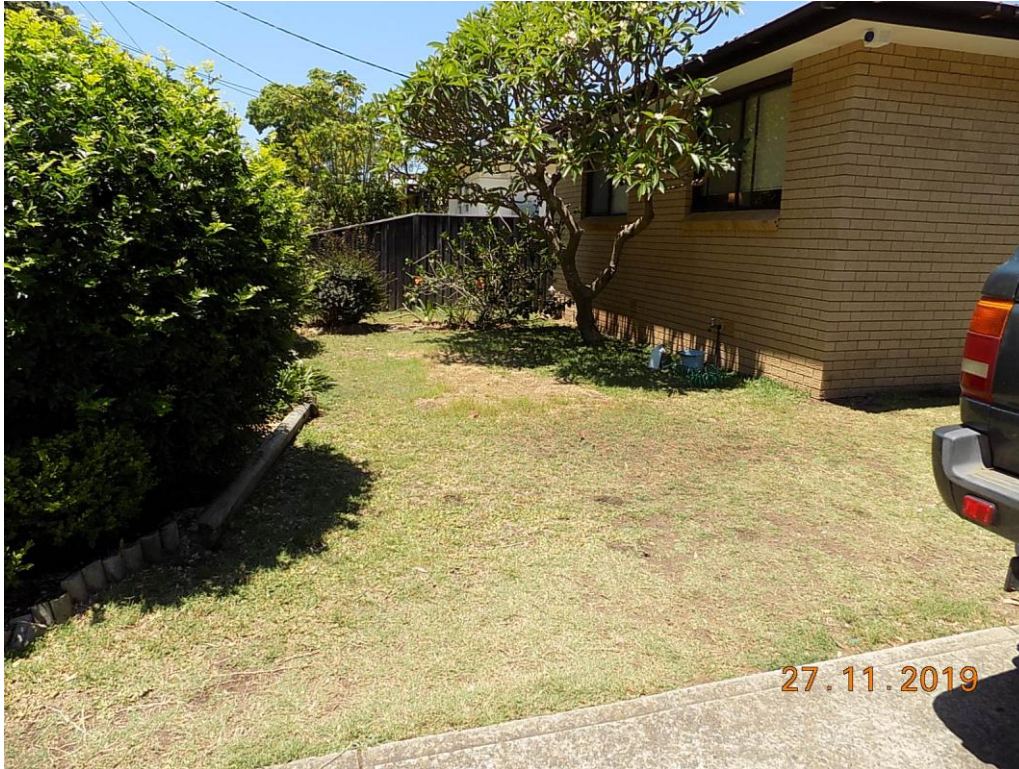
Photo 7

AUGER HOLE 1 (~RL4.1) – AH1 (Photo 7)

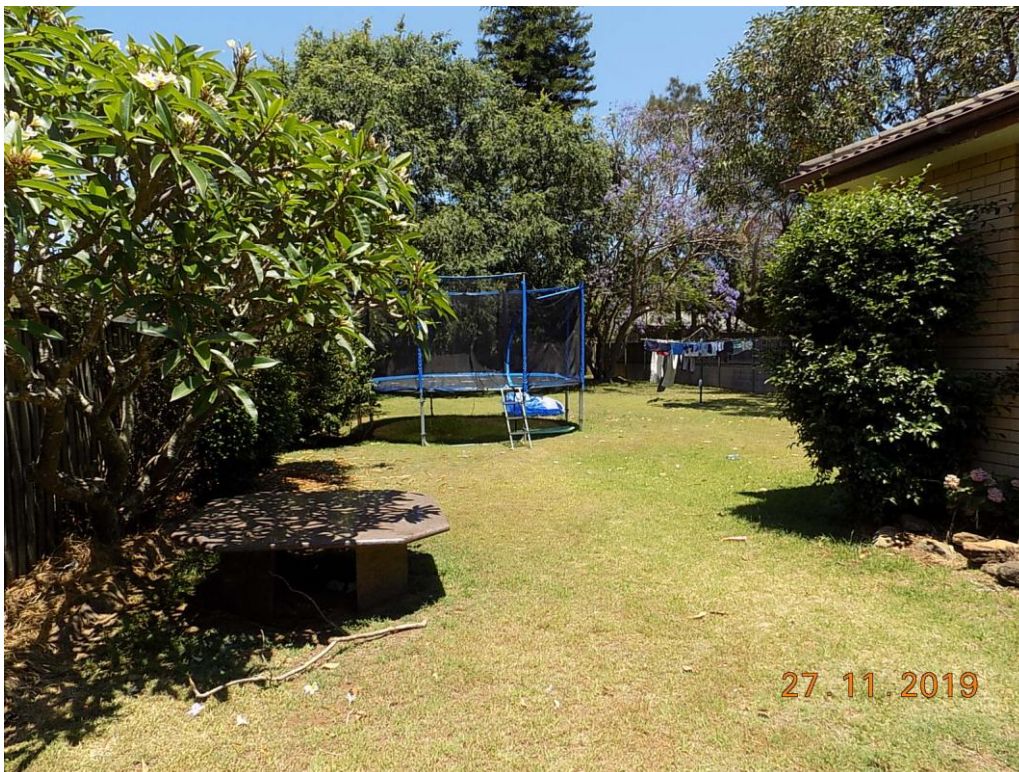
Photo 8

AUGER HOLE 2 (~RL3.9) – AH2 (Photo 8)

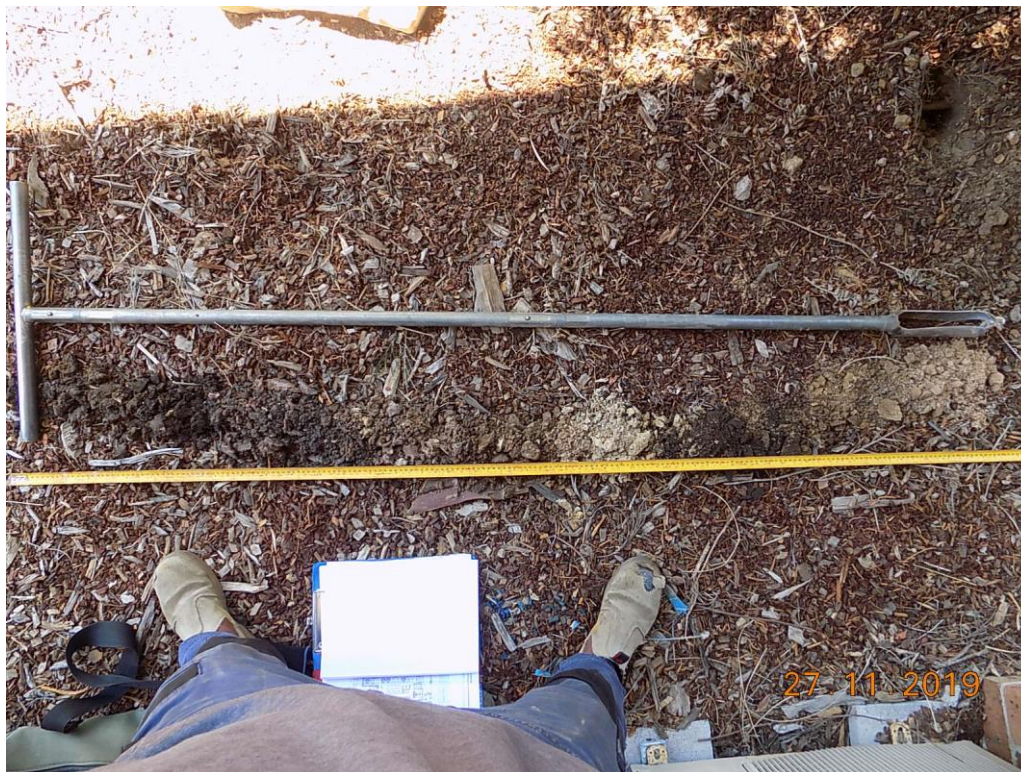
Depth (m)	Material Encountered
0.0 to 1.3	FILL , disturbed clayey soil, white, brown, and dark brown, very soft to stiff, dry, fine to coarse grained with fine trace organic matter, trace shale, and rock fragments.
1.3 to 1.6	SANDY SOIL , dark brown, medium dense to dense, dry, fine to medium grained with fine trace organic matter.
1.6 to 2.0	SAND , yellow and brown, dense, dry, coarse grained.

End of hole @ 2.0m in dense sand. No watertable encountered.

Photo 13: AH1 – Downhole is from left to right

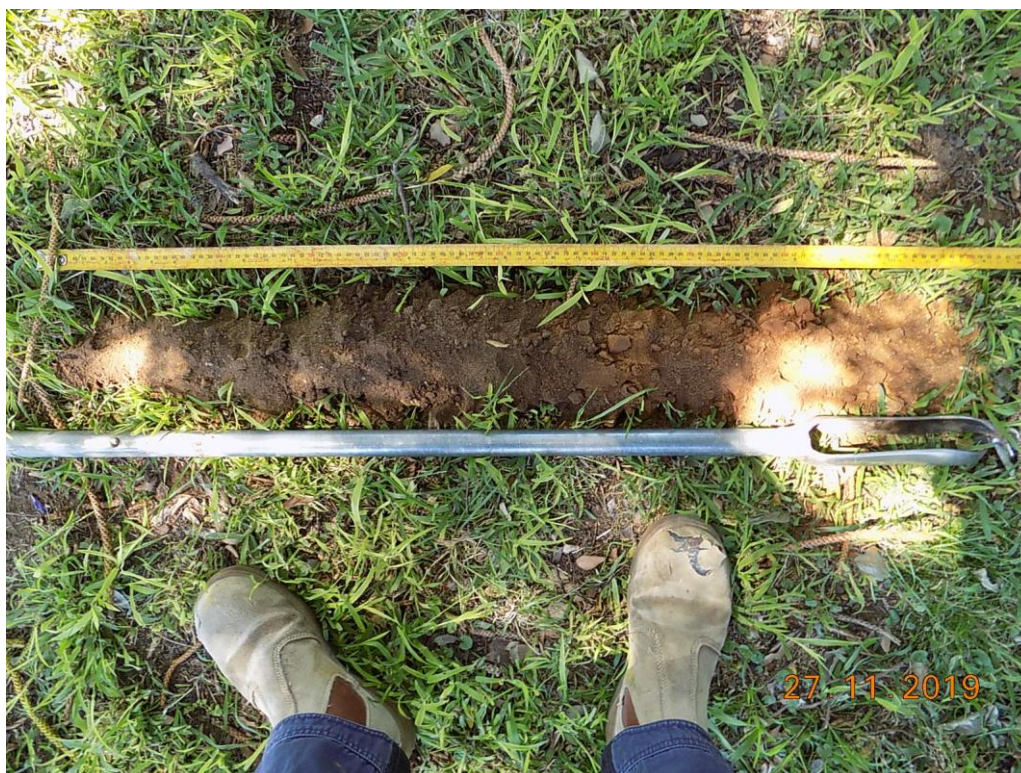
Depth (m)	Material Encountered
0.0 to 1.0	FILL , disturbed sand, brown, dense, dry, coarse grained with fine trace organic matter and rock fragments.

End of hole @ 1.0m in sand fill. No watertable encountered.

Photo 14: AH2 – Downhole is from left to right

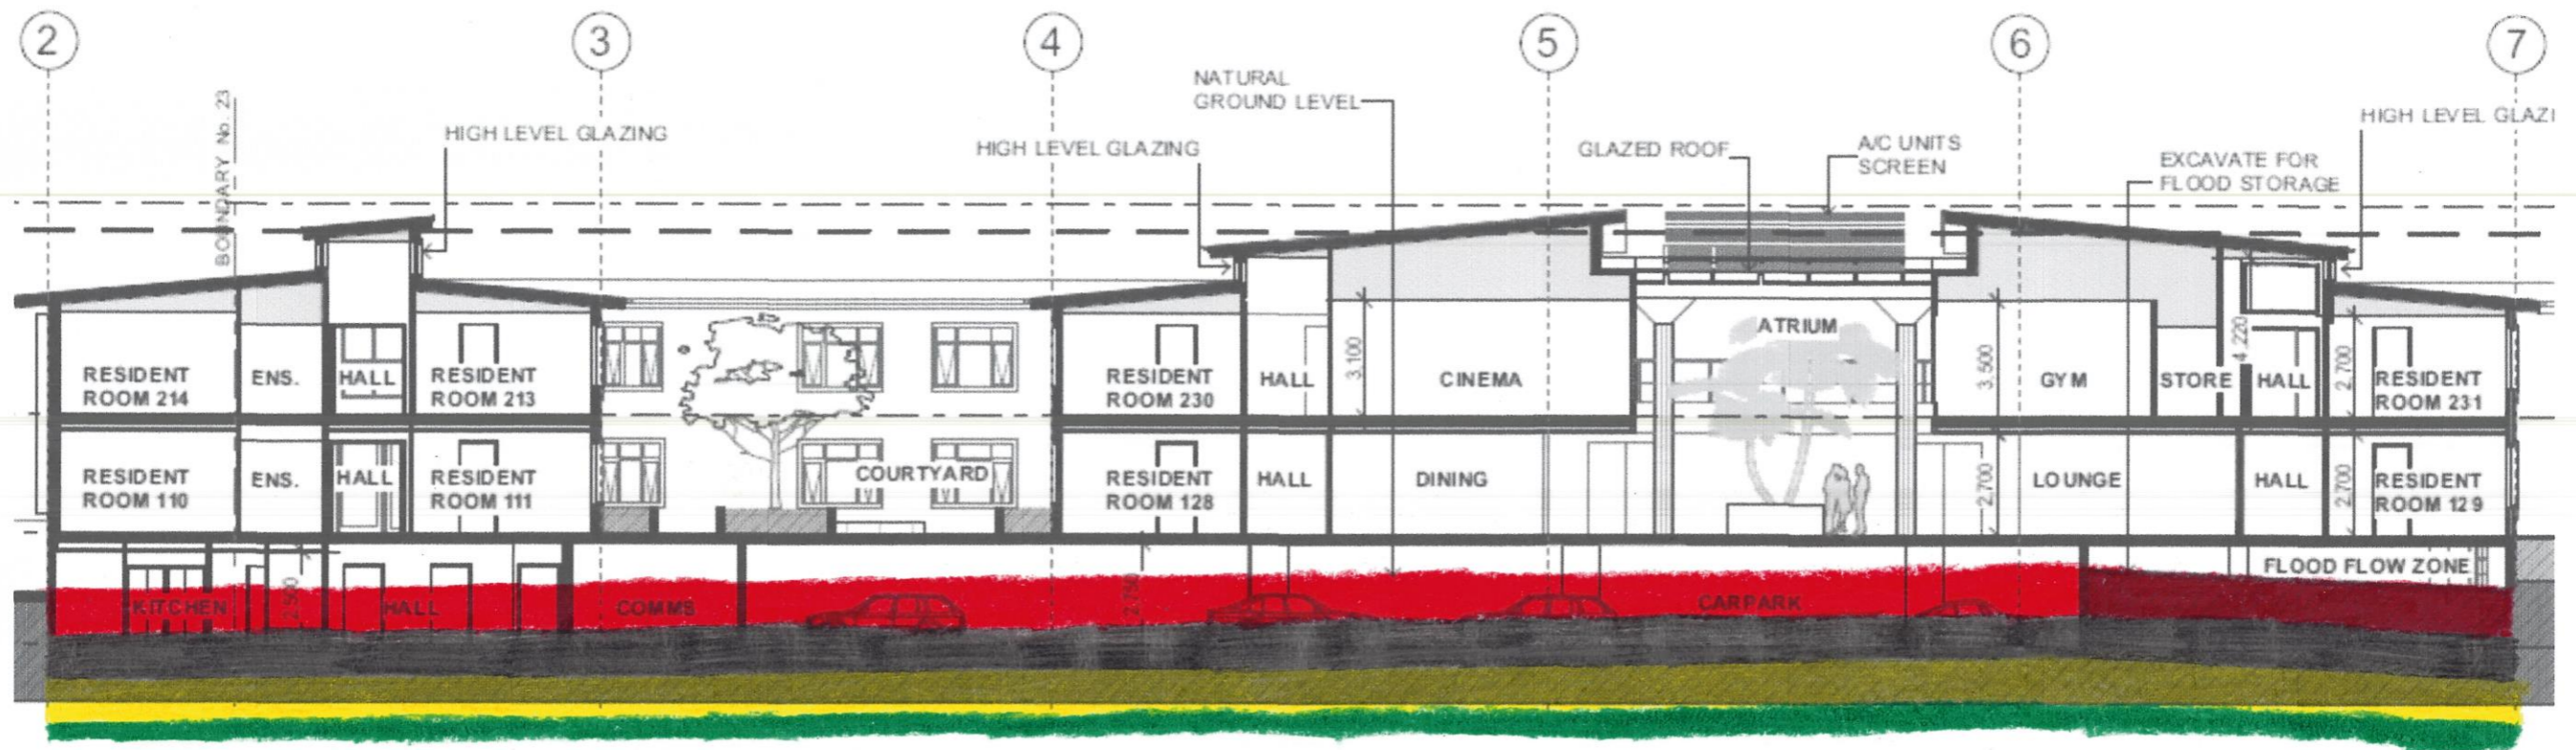
TYPE SECTION – Diagrammatical Interpretation of expected Ground Materials

The site is underlain by manmade fill across the property over sands that were encountered to the extent of the testing. The property has been levelled with manmade filling to a maximum depth of ~1.3m. The fill overlies loose sands to a maximum depth of ~2.4m over medium dense sands to a maximum depth of ~3.9m before quickly becoming dense. Rock was not encountered to the extent of the tests at 4.2m. See the Type Section attached for a diagrammatical representation of the expected ground materials.
