GEOTECHNICAL RISK MANAGEMENT POLICY FOR PITTWATER
FORM NO. 1 – To be submitted with Development Application

GEOTECHNICAL INVESTIGATION:

Alterations and Additions at 45 Park Avenue, Avalon

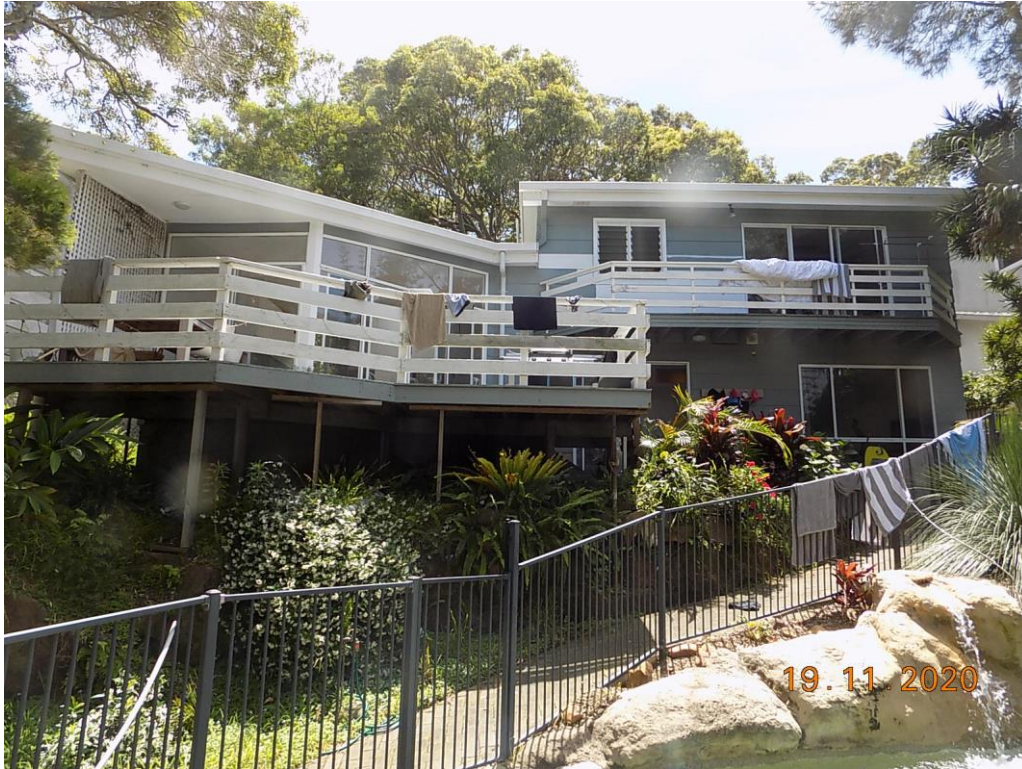
Photo 3

- 2.1 The site was inspected on the 19th November, 2020.
- 2.2 This residential property is on the low side of the road has a SW aspect. The block is located on the gentle to moderately graded upper SW flank and crest of a NW to SE trending ridge. The natural slope falls across the property from the road frontage at gentle angles that gradually increase to moderate angles across the downhill side of the property. The slope below the property continues at gradually decreasing angles for ~150m to the toe of the slope.
- 2.3 At the road frontage, a concrete and brick-paved driveway runs to a parking area on the uphill side of the house (Photo 1). Between the road frontage and the house is a gently sloping garden area (Photo 2). The part two-storey brick and timber framed and clad house is supported on brick walls and brick piers (Photo 3). No

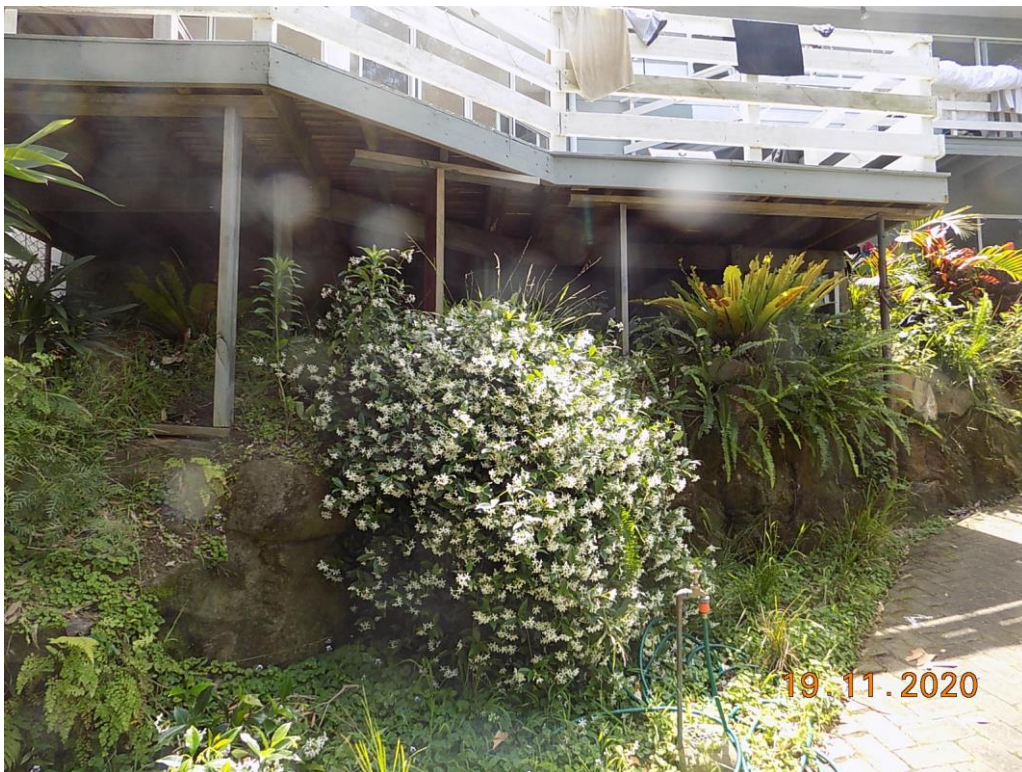
Photo 4

significant signs of movement were observed in the supporting brick walls and the supporting brick piers stand vertical. A timber deck that extends off the downhill side of the house was observed to be supported directly onto outcropping competent Medium Strength Sandstone bedrock (Photo 4). The outcrop steps down the slope. The maximum rock face height at a step is ~1.5m. No significant geological defects were observed in the outcropping rock and it is considered to be stable. An excavation has been made in the slope below the outcrop for a pool (Photo 5). The water level of the pool indicates no ground movement has occurred in the shell of the pool since its construction. Filling has been placed around the downhill side of the pool to form a level lawn area. The fill is supported by a stable ~0.7m high treated timber retaining wall (Photo 6). A small outbuilding below the pool will be demolished as part of the proposed works (Photo 7). A lawn area falls from the downhill side of the retaining wall and outbuilding (Photo 8) to a moderately sloping garden that extends to the lower common boundary.

Piers supported off Medium Strength Sandstone are suitable footings for the proposed deck extension and secondary dwelling. Over the footprint of the deck, this material is expected from the surface to a maximum depth of ~1.3m below the current surface. Where footings

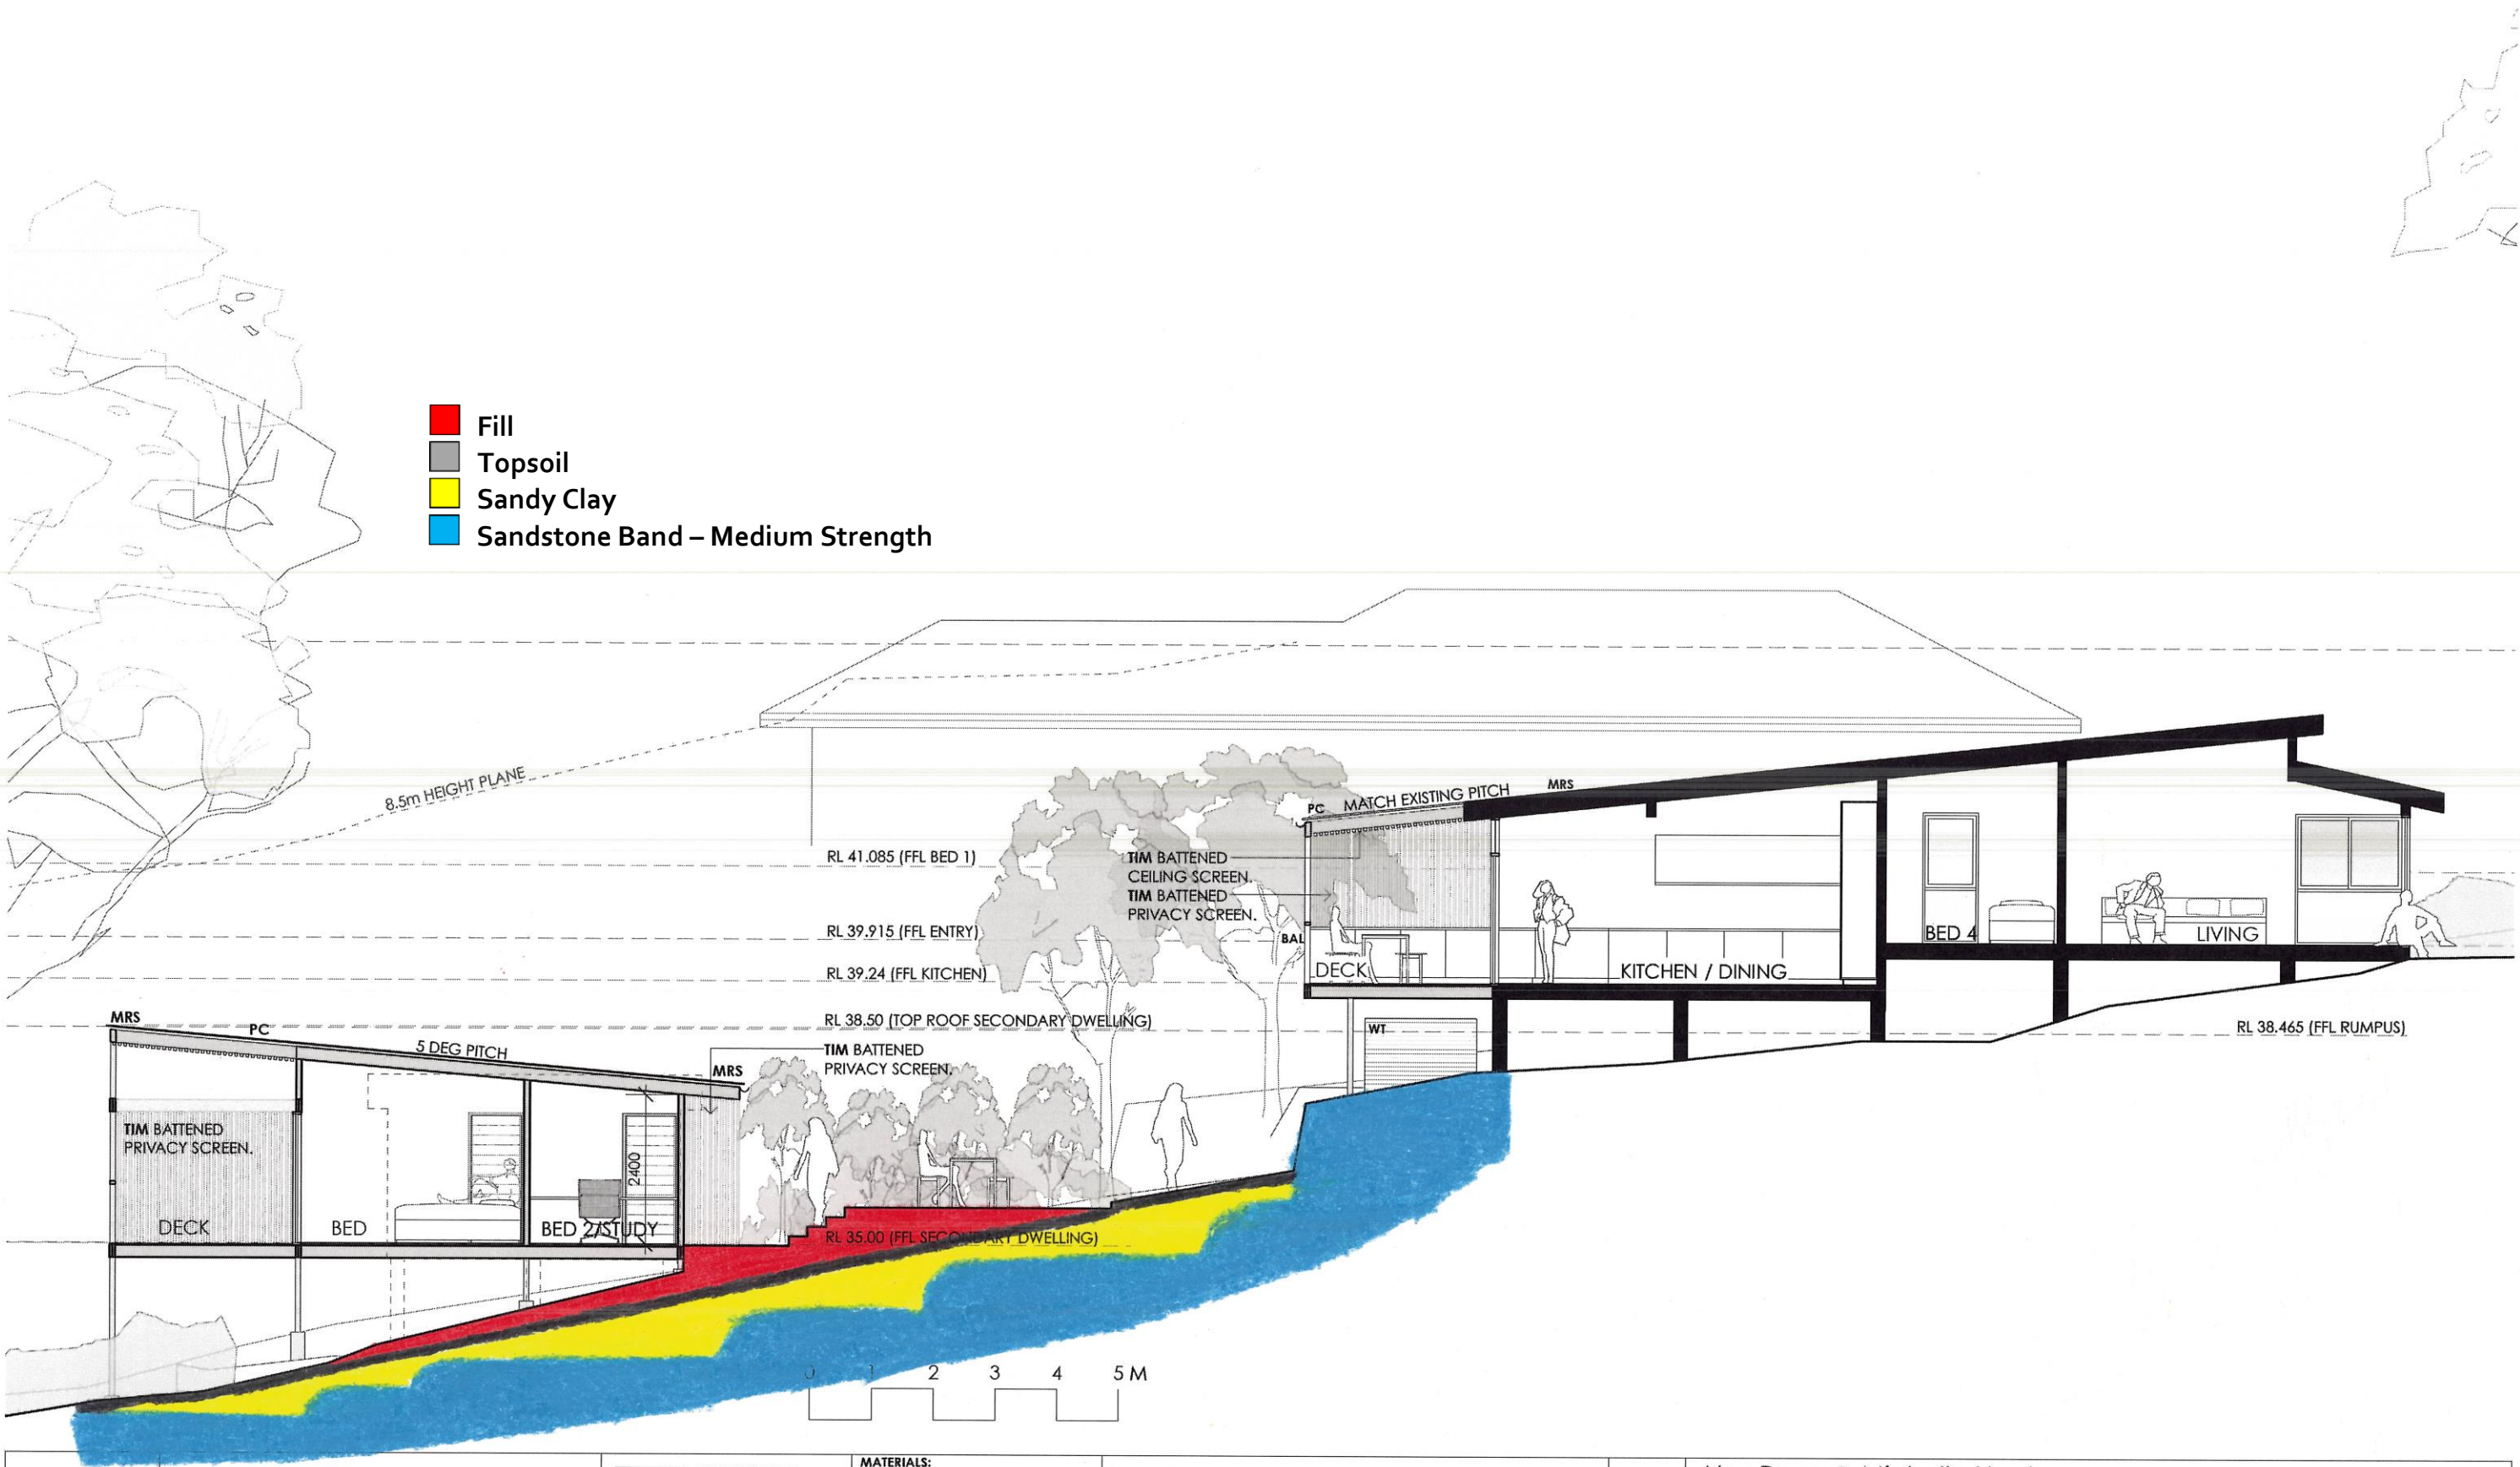
TYPE SECTION – Diagrammatical Interpretation of expected Ground Materials

The surface features of the block are controlled by the outcropping and underlying sandstone bedrock that steps down the property forming sub-horizontal benches between the steps. Where the grade is steeper, the steps are larger and the benches, narrower. Where the slope eases, the opposite is true. Where the rock is not exposed, it is overlain by soils and clays that fill the bench step formation. Filling has been placed across the downhill side of the property for landscaping. In the test locations where rock was not exposed at the surface, it was encountered at depths of between 0.1 to 1.3m below the current surface, being variable due to the presence of fill and the stepped nature of the underlying bedrock. The outcropping sandstone on the property is estimated to be medium strength or better and similar strength rock is expected to underlie the majority of the site. See Type Section attached for a diagrammatical representation of the expected ground materials.
