## Geotechnical Investigation Report

Proposed New Residence

Lot 02, 10 Fern Creek Road, Warriewood NSW

Report No. R22009.02.Rev0

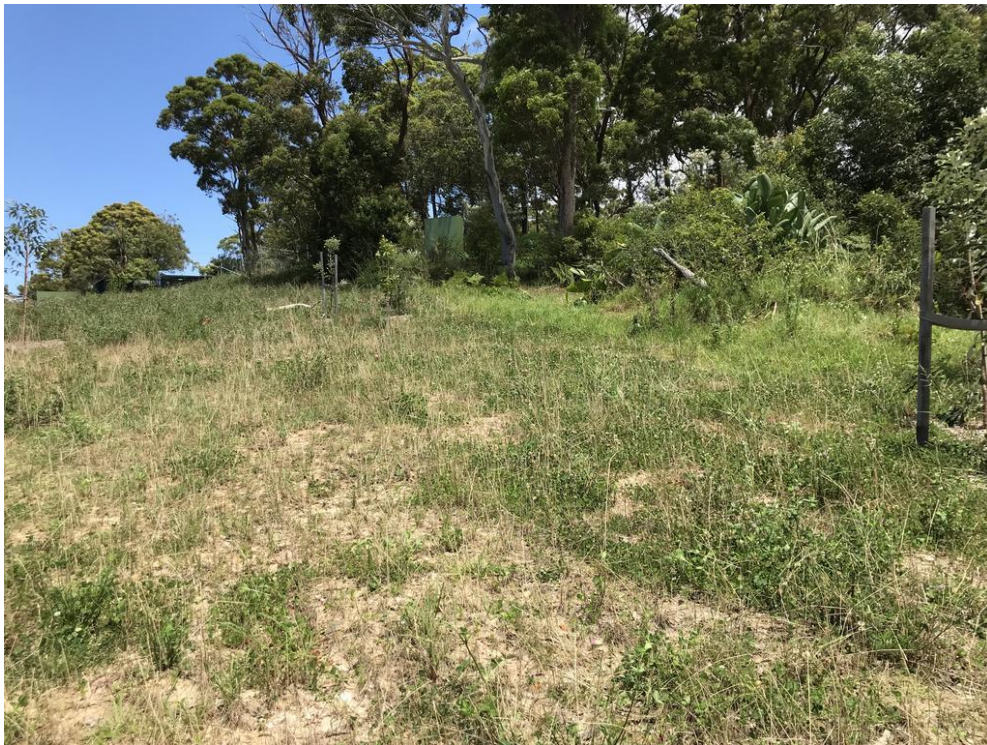
Site vegetation comprised grasses, weeds and native trees along the north-east and southern boundaries. The trees were in upright position. The following site photographs show the general site conditions at the time of field work:

Photograph 1 – General site conditions, looking south
